Aviation Investigation Factual Report

Location:	Battleground, Washington	Accident Number:	WPR19LA200
Date & Time:	July 20, 2019, 16:20 Local	Registration:	N873BC
Aircraft:	Beech 33	Aircraft Damage:	Substantial
Defining Event:	Powerplant sys/comp malf/fail	Injuries:	2 None
Flight Conducted Under:	Part 91: General aviation - Personal

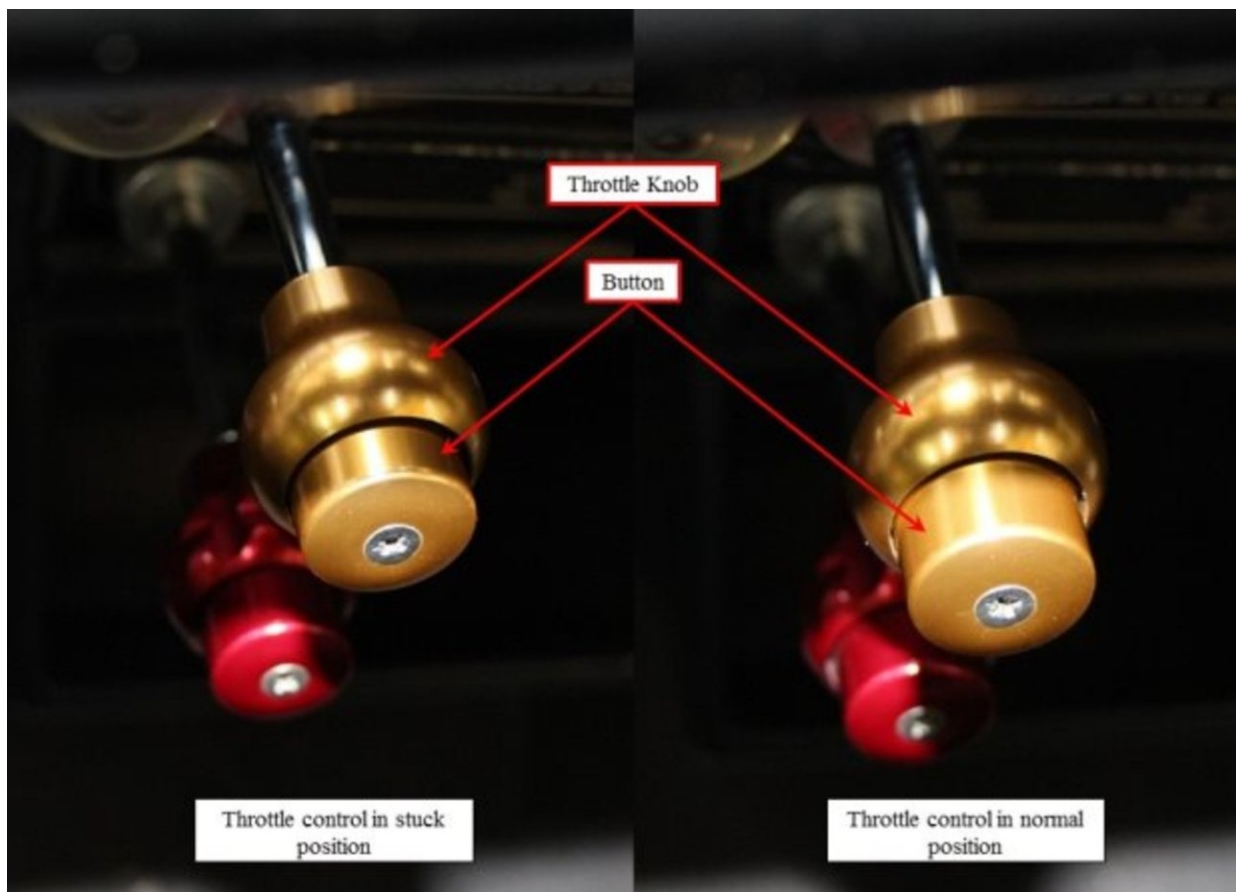
A second engine run was accomplished to examine the security of the throttle control mechanism. During this test, the throttle was reduced from 1,800 rpm to 800 rpm using the pushbutton mechanism, which became stuck in a halfway depressed position. With the button stuck in this position, an engine power reduction was attempted by rotating the knob counterclockwise. This movement would normally reduce engine power; however, only a corresponding minor increase in power was observed. This test was repeated multiple times with the same result.

Figure 1: Throttle Control in Both Stuck and Normal Positions

Disassembly of the throttle mechanism revealed that the spring and washer were present and had been installed correctly. The spring did not display any debris or anomalous wear that could have inhibited its movement. The throttle cable was secured with the nut and washer; however, the nut was loose and could be easily manipulated by hand. According to the

manufacturer, a loose nut would prevent the knob from being held against the throttle shaft. This could allow the knob to spin freely when rotated by the pilot, thus preventing the throttle cable from moving in and out. If the nut was completely loose, the knob could separate from the throttle shaft. However, the loose nut would generally not impact the functionality of the button if the knob was not near the point of separation.
