# Aviation Investigation Final Report

<b>Location:</b>	Fairhope, Alabama	<b>Accident Number:</b>	CEN19LA265
<b>Date &amp; Time:</b>	July 30, 2019, 16:30 Local	<b>Registration:</b>	N6754J
<b>Aircraft:</b>	Piper PA28	<b>Aircraft Damage:</b>	Substantial
<b>Defining Event:</b>	Loss of engine power (partial)	<b>Injuries:</b>	2 None
<b>Flight Conducted Under:</b>	Part 91: General aviation - Instructional

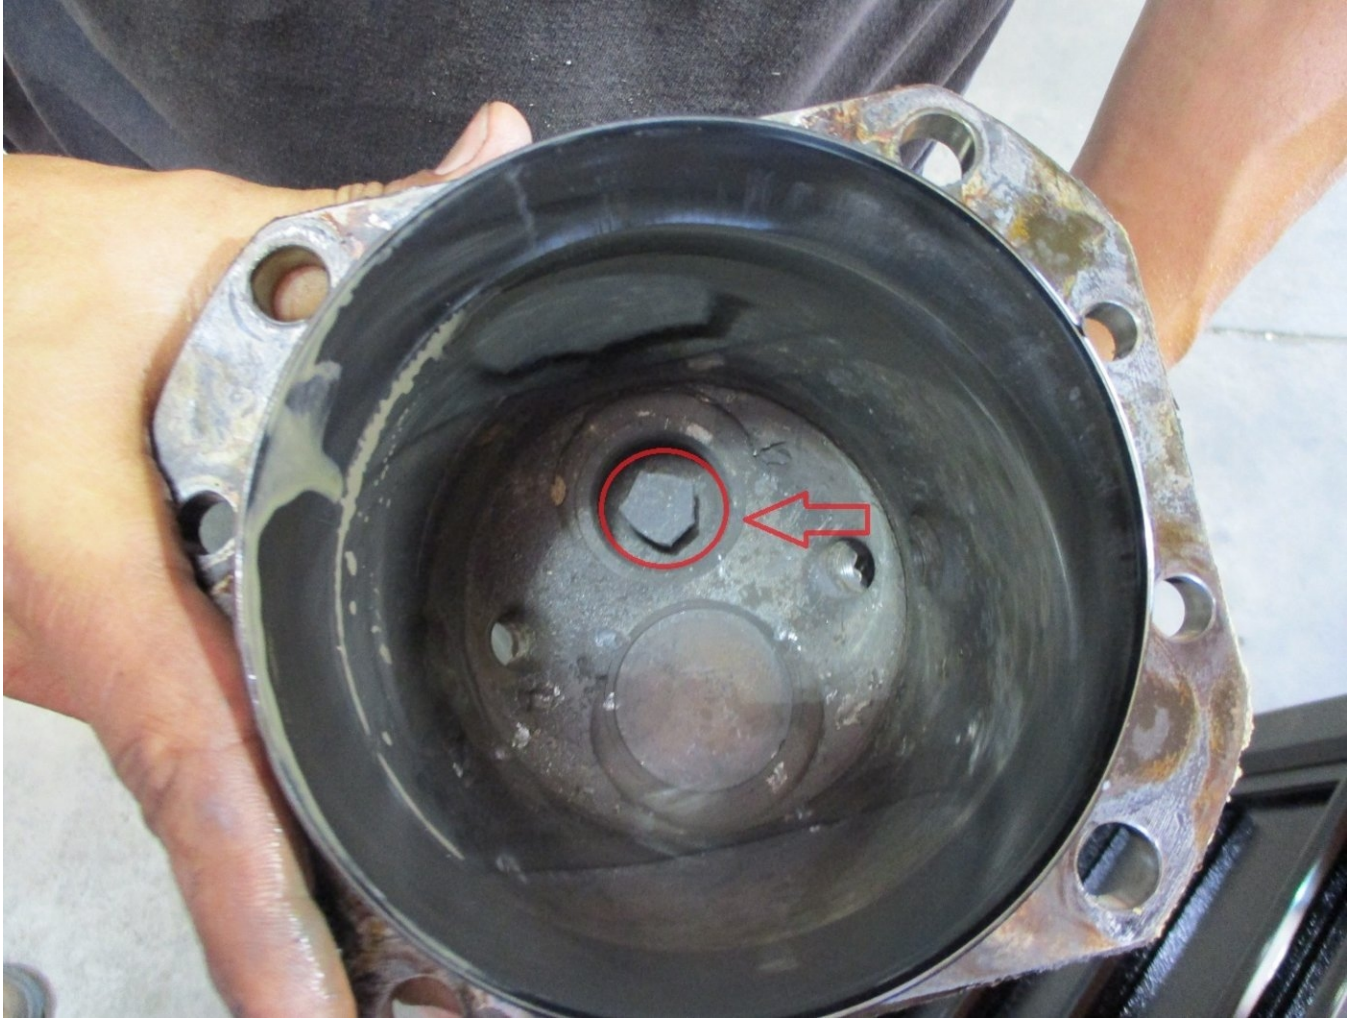
Postaccident engine examination revealed a failed No. 3 cylinder exhaust valve and extensive erosion on the No. 4 cylinder exhaust valve. The engine had accumulated 2,600 hours since the last overhaul, which was 600 hours beyond the manufacturer's recommended time before overhaul.

Failure of the No. 3 exhaust valve and the subsequent loss of engine power due to engine operation with an excessively lean fuel mixture over a period of time.

An examination of the airplane by a Federal Aviation Administration inspector, found damage to the airplane's left wing and engine mount. Further examination of the engine's No. 3 cylinder revealed a failed exhaust valve. The examination also found extensive erosion on the No. 4 cylinder exhaust valve. He also noted that the engine had 2,600 hours since the last overhaul, adding that the engine manufacturer's recommended overhaul is 2,000 hours, and the flight school consistently ran the engines past the recommended overhaul time.

Figure 1: Failed Exhaust valve FAA photo
