Aviation Investigation Final Report

Location:	Jay, Florida	Accident Number:	ERA19LA246
Date & Time:	August 13, 2019, 11:51 Local	Registration:	N84287
Aircraft:	Cessna 172	Aircraft Damage:	Substantial
Defining Event:	Low altitude operation/event	Injuries:	1 Serious
Flight Conducted Under:	Part 91: General aviation - Positioning

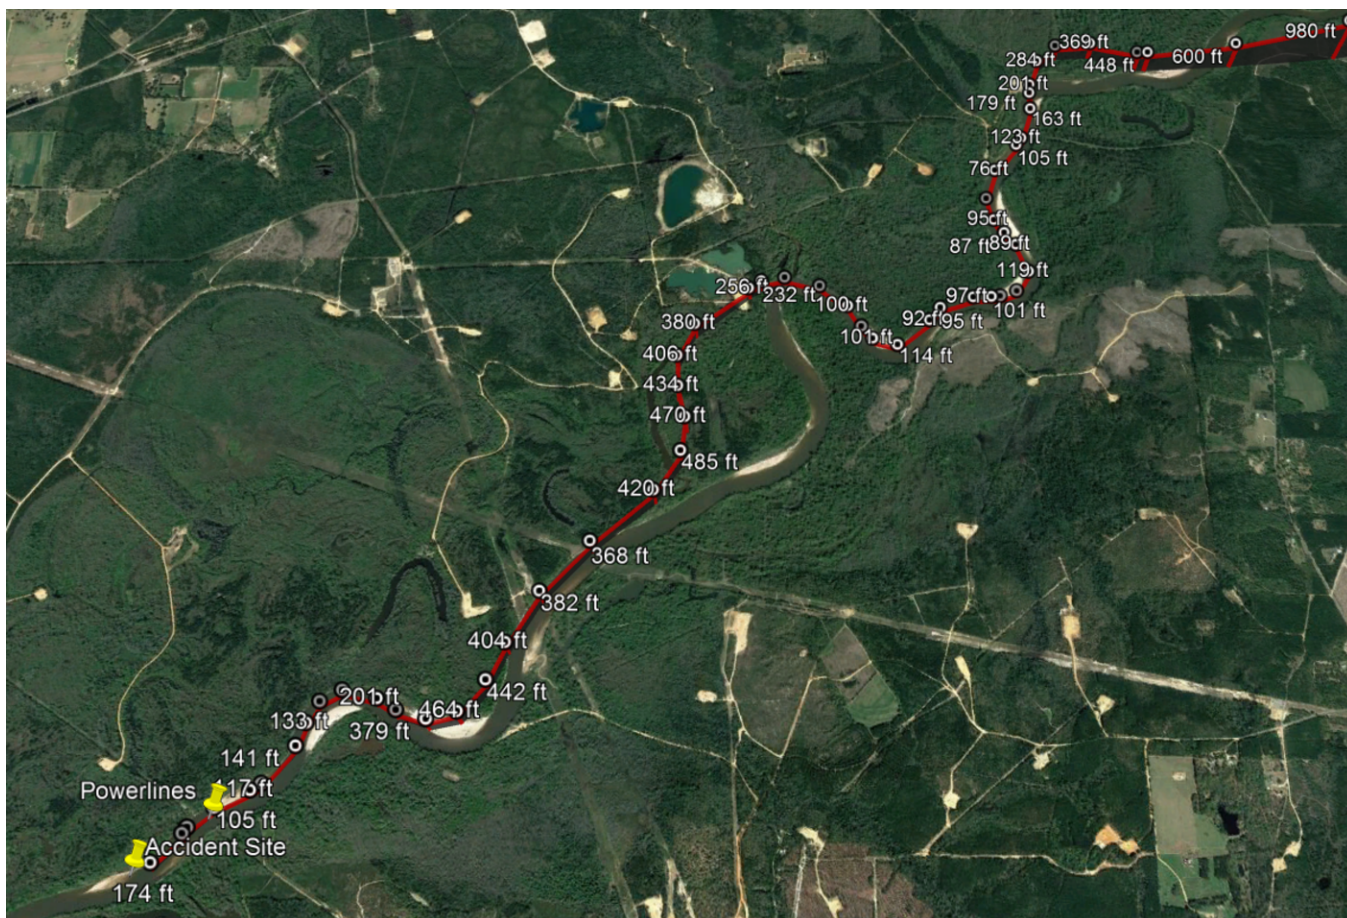
Figure 1. Altitude and Flight Track of Accident Flight

A handheld Garmin GPSmap 496 was recovered from the wreckage and forwarded to the NTSB for data download. GPS data were successfully downloaded and contained altitude, heading, airspeed, and position data (See Figure 1). Review of the data revealed that the flight departed runway 24 at PNS and climbed up to 250 ft msl before turning northwest and continued a climb up to 700 ft msl. The airplane made a climbing left turn to the south up to 900 ft msl before turning southwest on a heading of about 251° as it continued to climb up to 1,294 ft msl and 104 knots. The airplane then descended to 333 ft msl, when it made a left descending turn to about 198°, where it arrived directly over the Escambia River at 76 ft msl and 92 knots. The airplane flew over the river for 1.5 miles at an altitude between 76 ft msl and 160 ft msl. The airplane briefly climbed up to 380 ft msl on a heading of about 205° at a sharp bend in the river, then made a climbing left turn to 485 ft msl, before descending to 368 ft msl on a heading of 301° where it rejoined the path of the river. The airplane continued to descend and follow the path of the river down to 117 ft msl, and 110 knots, about 700 ft before the power lines. Immediately before impact with the power lines, the airplane was at 105 ft msl, on a heading of about 228° at 87 knots. The last recorded altitude, airspeed, and heading data shows an altitude of 188 ft msl, airspeed of 57 knots and a heading of about 224°. From the moment the airplane became established directly over the river until impact with the power lines, it had flown over the river for about 4.5 nm.

The elevation of the river at the power lines is about 45 ft msl and the power lines were about 60 ft above ground level.
