# Aviation Investigation Final Report

<b>Location:</b>	Elizabethton, Tennessee	<b>Accident Number:</b>	ERA19FA248
<b>Date &amp; Time:</b>	August 15, 2019, 15:37 Local	<b>Registration:</b>	N8JR
<b>Aircraft:</b>	Textron Aviation Inc 680A	<b>Aircraft Damage:</b>	Destroyed
<b>Defining Event:</b>	Runway excursion	<b>Injuries:</b>	3 Minor, 2 None
<b>Flight Conducted Under:</b>	Part 91: General aviation

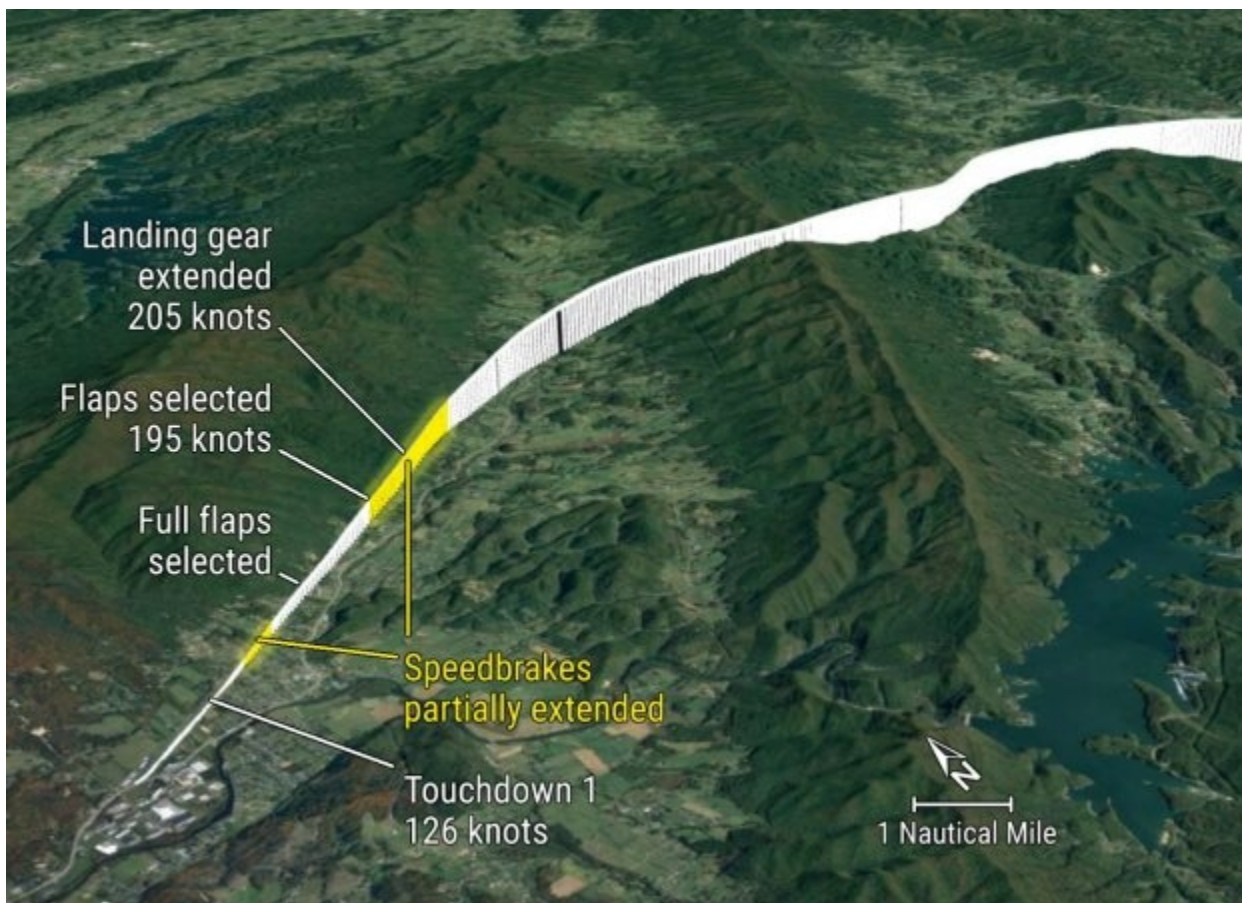
Figure

1

: N8JR's approach, including speed and use of

speedbrakes

(in

yellow

), landing gear,

and flaps.

As the flaps were extending, the TAWS forward looking terrain alert rate of terrain closure caution alert sounded twice (at 1536:59 and at 1537:09), then a warning alert sounded (at 1537:11). The airplane was at an altitude of 2,159 ft msl (471 ft agl). Following these alerts, the copilot selected full flaps and the descent rate and airspeed decreased. At 1537:26, the copilot stated, "and I don't need to tell ya, we're really fast," and the pilot responded, "I'm at idle." Six seconds later, the pilot asked, "do I need to go around?" and the copilot responded, "no." At 1537:31, about 270 ft agl, the speedbrakes were partially extended for 5 seconds (to 140 ft agl). The pilot then stated, "I got the speed brakes out," to which the copilot responded, "well you should get rid of those because we don't wanna get a CAS [Crew Alerting System] m- or a thing sent to ya." Eight seconds before touchdown, at 1537:41, the pilot stated, "alright, I'll be on the T-Rs [thrust reversers] quickly." For the computed airplane weight, the reference speed ( $V_{ref}$ ) for the final approach was 108 knots; the airplane's airspeed at the runway's displaced threshold was 126 knots. Five seconds before touchdown, the airplane's descent rate was over 1,500 ft per minute (fpm).

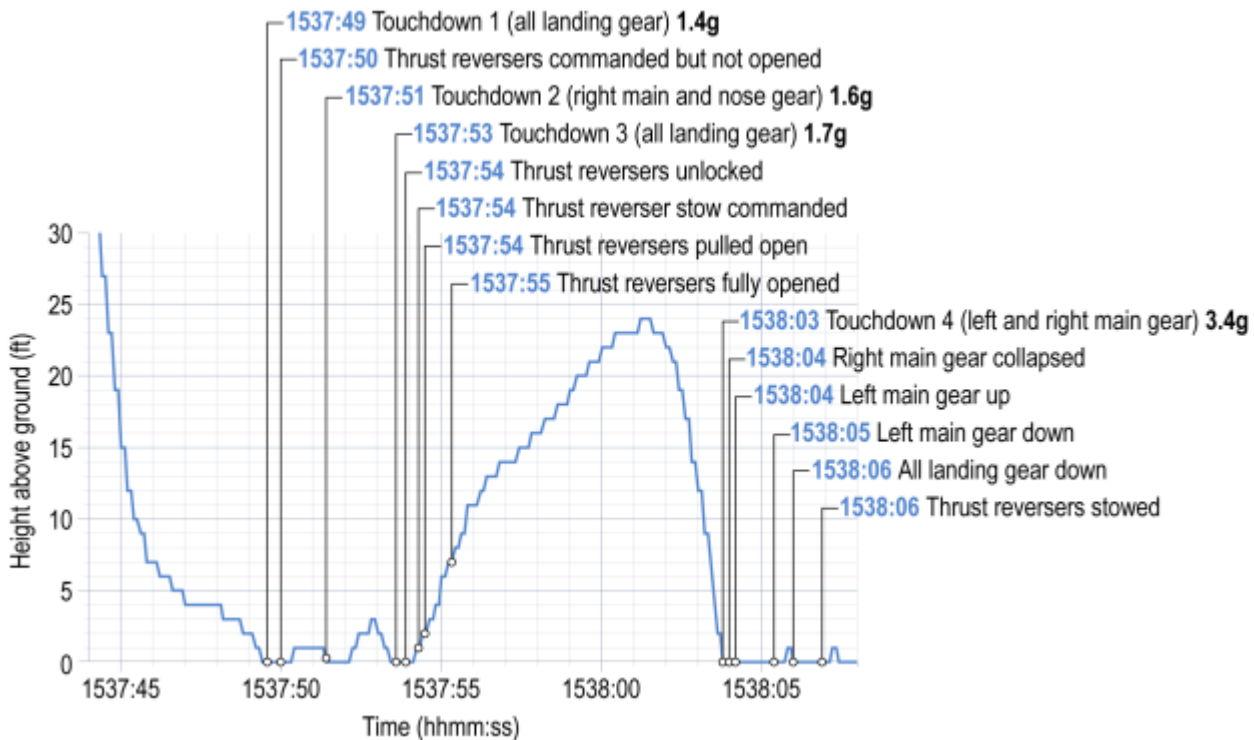
Figure 2. Graph depicting the airplane's thrust reverser actions, landing gear touchdowns, and vertical acceleration (bold) during its bounced landing.

When the airplane touched down initially at 1537:49, it was travelling 126 knots (18 knots above  $V_{ref}$ ) and had a descent rate of 600 fpm (the maximum allowed per the airplane flight manual [AFM]). All three landing gear registered "on-ground" simultaneously with a vertical acceleration of 1.4 gravitational acceleration (g), and thrust reverser deployment was commanded 0.4 second after the landing gear first touched the ground as the throttles were moved to the reverse idle position; however, the airplane bounced after touching down for 0.6 second and was airborne again before the thrust reverser command could be executed.

When the airplane touched down a second time, 1.2 seconds later at 1.6 g, the nose landing gear touched down first, followed immediately by the right main landing gear. The left main landing gear never registered on-ground during the touchdown, and the airplane bounced and became airborne again after 0.4 second.

The airplane touched down a third time, 1.8 seconds later at 1.7 g and about 1,000 ft down the runway with about 3,100 ft of paved surface remaining. The thrust reversers unlocked 0.4 second after all three landing gear registered on-ground because the reverser deployment command from the first touchdown was still active. Almost immediately after the thrust reversers unlocked, the pilot advanced the throttles to idle, sending a thrust reverser stow command at 1537:54; however, the landing gear status changed to "in-air" almost simultaneously when the command was executed.

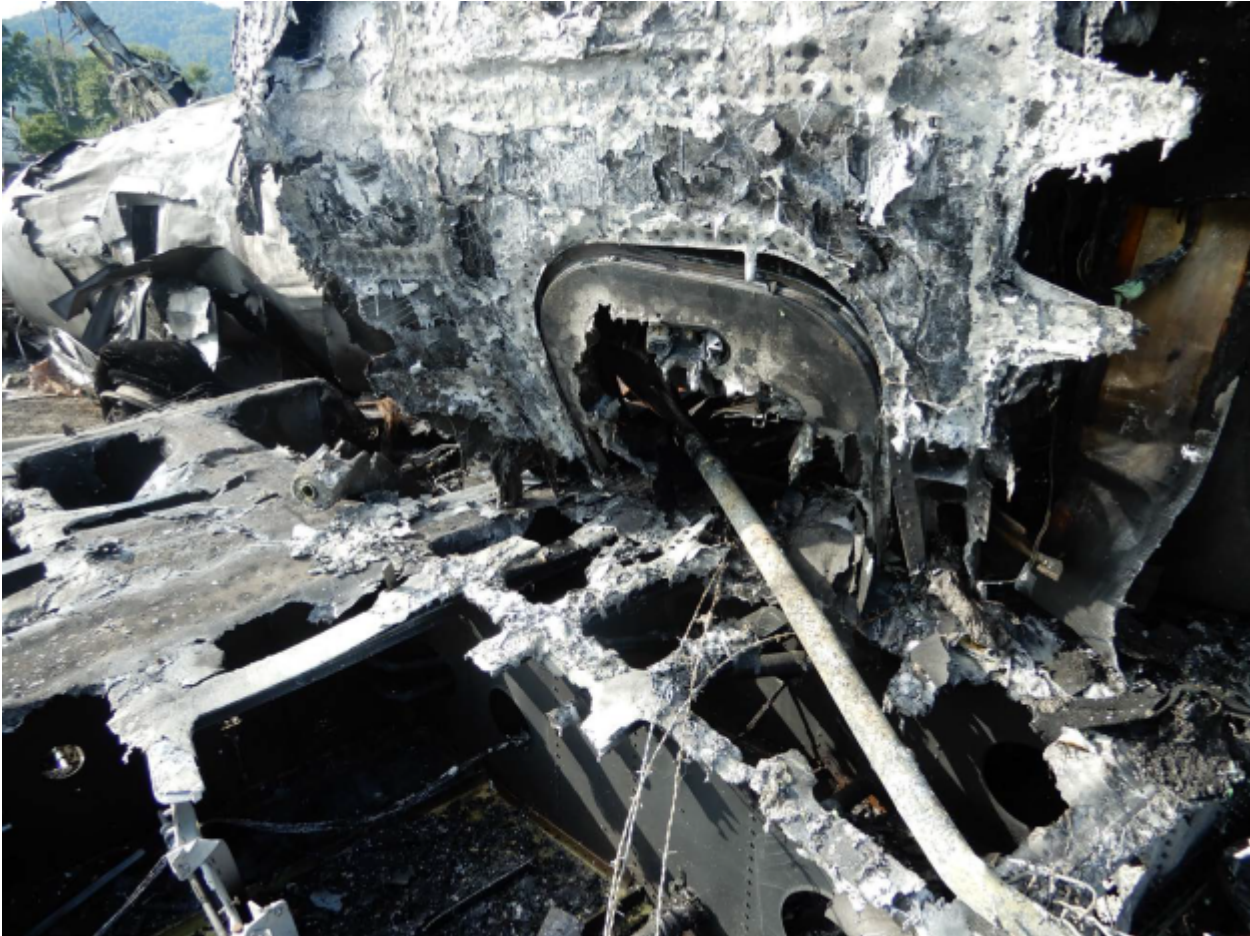
The pilots and passenger continued to struggle with the emergency escape hatch and observed heavy smoke coming from the lavatory, followed by flames. The copilot attempted to open the cabin entry door a second time, and he was able to push the door partially open with enough clearance to get all the occupants out. In a postaccident interview, the copilot reported that the exterior handle was likely pushing against the ground at the time, preventing it from opening fully.

Figure 3: Emergency escape hatch impaled by a metal fence post.
