Aviation Investigation Final Report

Location:	Elizabethton, Tennessee	Accident Number:	ERA19FA248
Date & Time:	August 15, 2019, 15:37 Local	Registration:	N8JR
Aircraft:	Textron Aviation Inc 680A	Aircraft Damage:	Destroyed
Defining Event:	Runway excursion	Injuries:	3 Minor, 2 None
Flight Conducted Under:	Part 91: General aviation

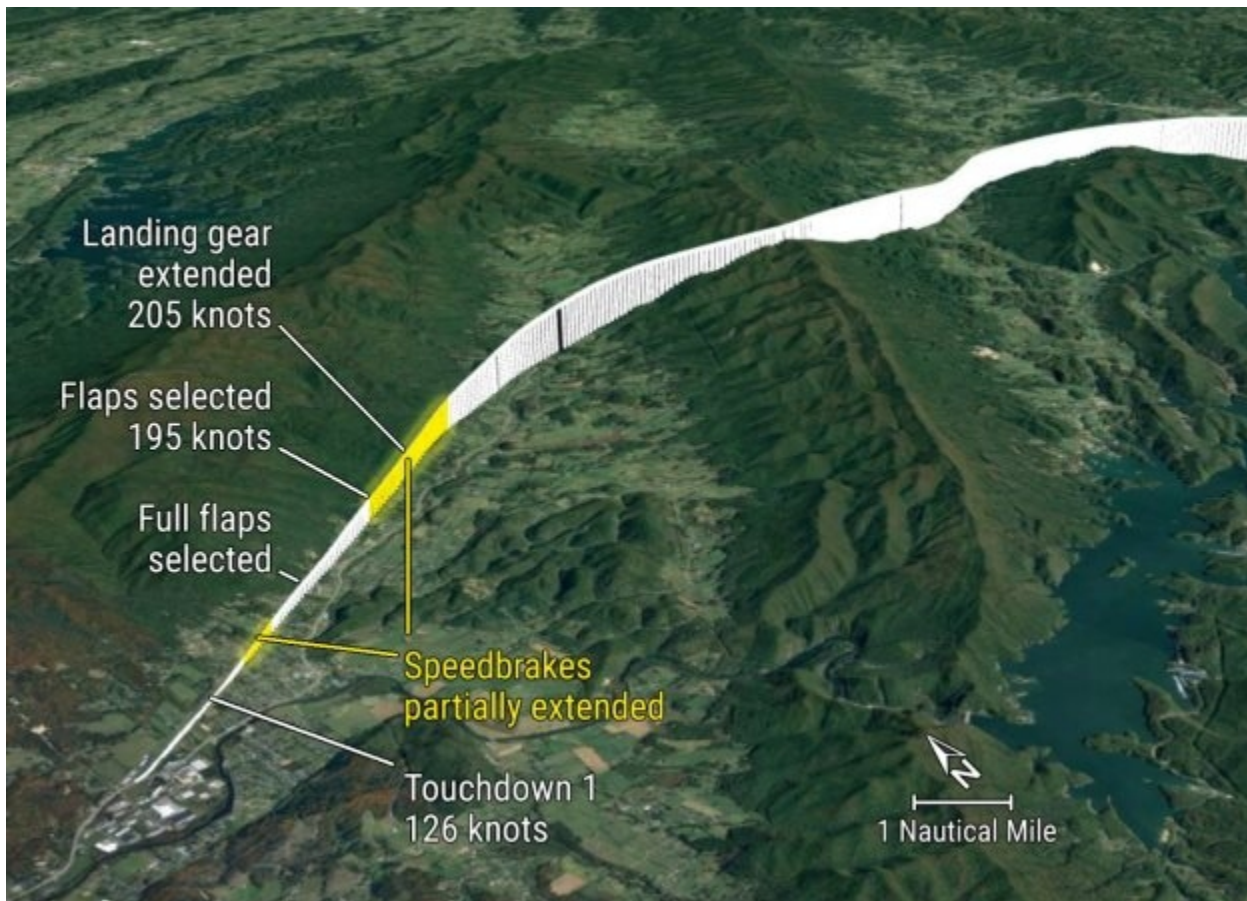
Figure

1

: N8JR's approach, including speed and use of

speedbrakes

(in

yellow

), landing gear,

and flaps.
