# Aviation Investigation Final Report

<b>Location:</b>	Burnsville, North Carolina	<b>Accident Number:</b>	ERA19LA257
<b>Date &amp; Time:</b>	August 22, 2019, 12:54 Local	<b>Registration:</b>	N404PE
<b>Aircraft:</b>	Cirrus SR22	<b>Aircraft Damage:</b>	Substantial
<b>Defining Event:</b>	Loss of control in flight	<b>Injuries:</b>	2 None
<b>Flight Conducted Under:</b>	Part 91: General aviation - Personal

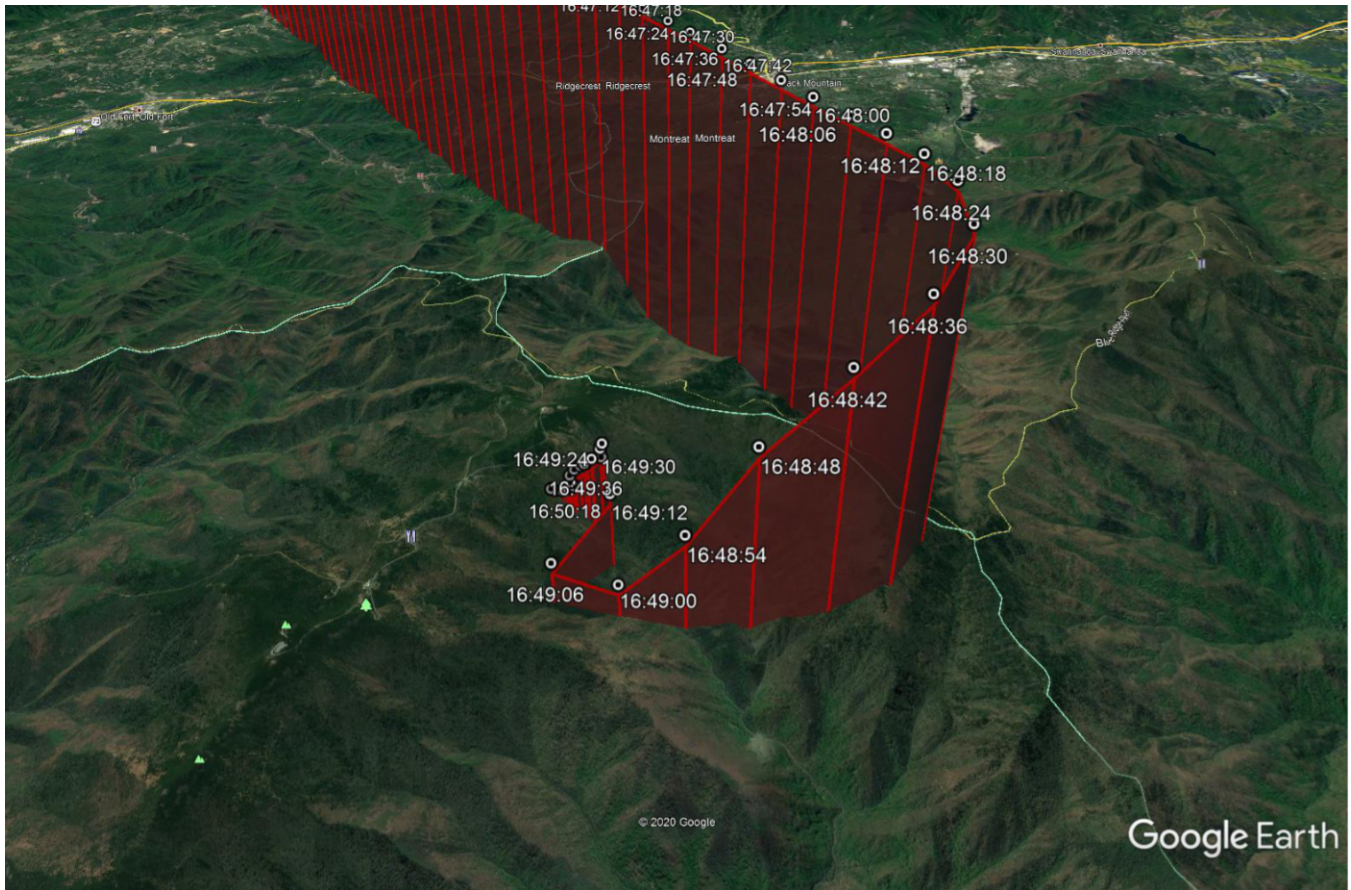
Figure 1. Cruise Flight and Descent Profiles (GPS plots in UTC)

Engine and GPS data recovered from the airplane’s multifunction display (MFD) revealed that, after departure, the airplane climbed to 16,800 ft pressure altitude and remained at that altitude for several minutes. About 1248:24, the airplane entered a sharp, steep, descending right turn. The data indicated an 11,050-ft loss of altitude over approximately 36 seconds, while manifold pressure, fuel flow, and exhaust gas temperatures (EGT) all decreased. The loss of altitude was arrested at 5,237 ft, and the data indicated that the airplane climbed to 8,275 ft following the recovery. At the top of the climb following recovery, EGT and engine rpm values fell to those consistent with a loss of engine power, and another descent was depicted.

According to the airplane manufacturer, the descent rates stabilized about 1249:36 were consistent with a descent under parachute.

During the initial descent, engine rpm increased to 3,220 rpm, which was 520 rpm above the engine manufacturer’s maximum limit of 2,700 rpm.

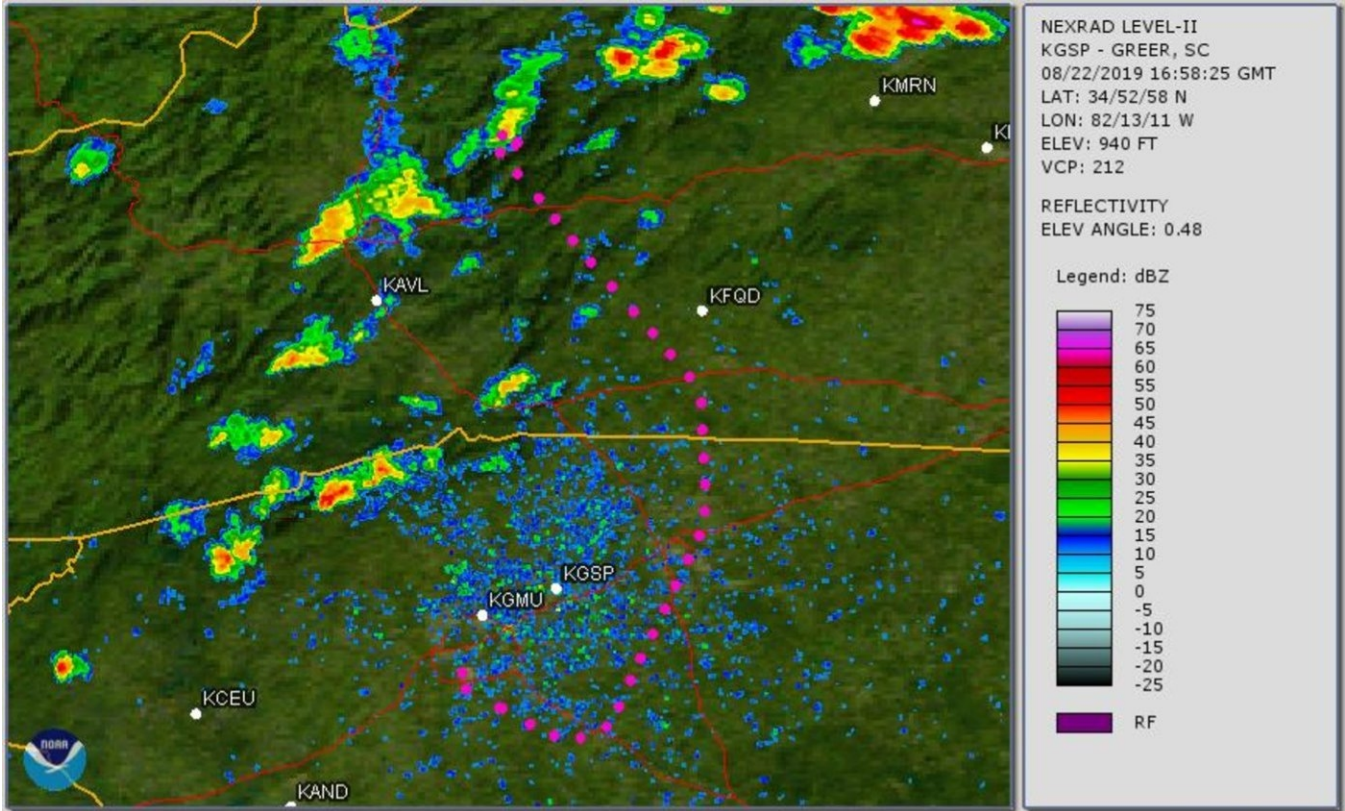
Review of weather information indicated that, before the upset, the airplane entered an area of radar echoes with reflectivities of 46.5 dBZ and likely encountered strong updrafts, severe turbulence, and severe icing associated with the thunderstorm activity. The pilot’s decision to use the airplane’s onboard satellite weather information, which has known latencies that can result in outdated data, for tactical weather avoidance resulted in the airplane encountering these conditions and the pilot’s loss of airplane control.

Examination of the airplane's flight track overlaid in base reflectivity imagery as seen in figure 2 revealed that the airplane entered an area of echoes of approximately 40dBZ and greater, and abruptly turned to its right and descended rapidly from 17,000 ft about 1249.

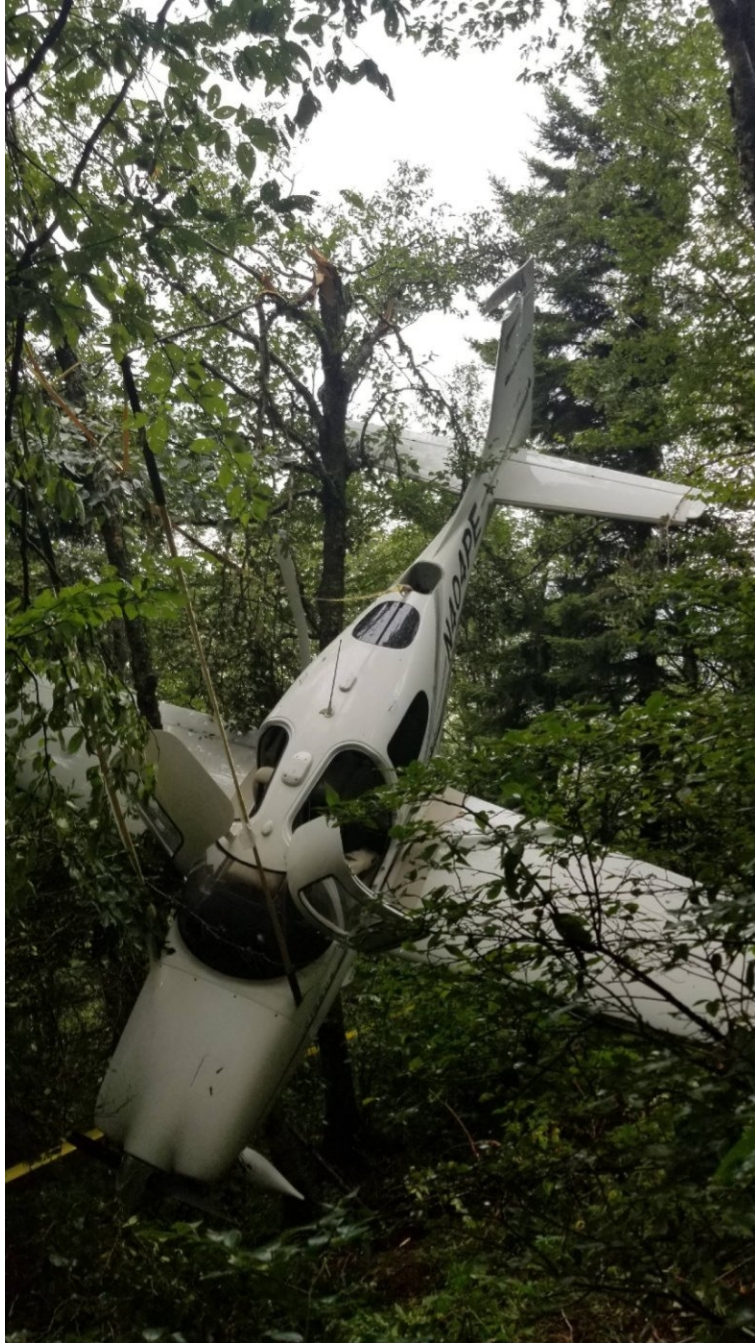
Figure 3 – View of Airplane as Found (courtesy U.S. Park Service)

Examination of photographs revealed damage to the nose landing gear, cowling, and the airframe skin where the parachute's risers tore free during its deployment.

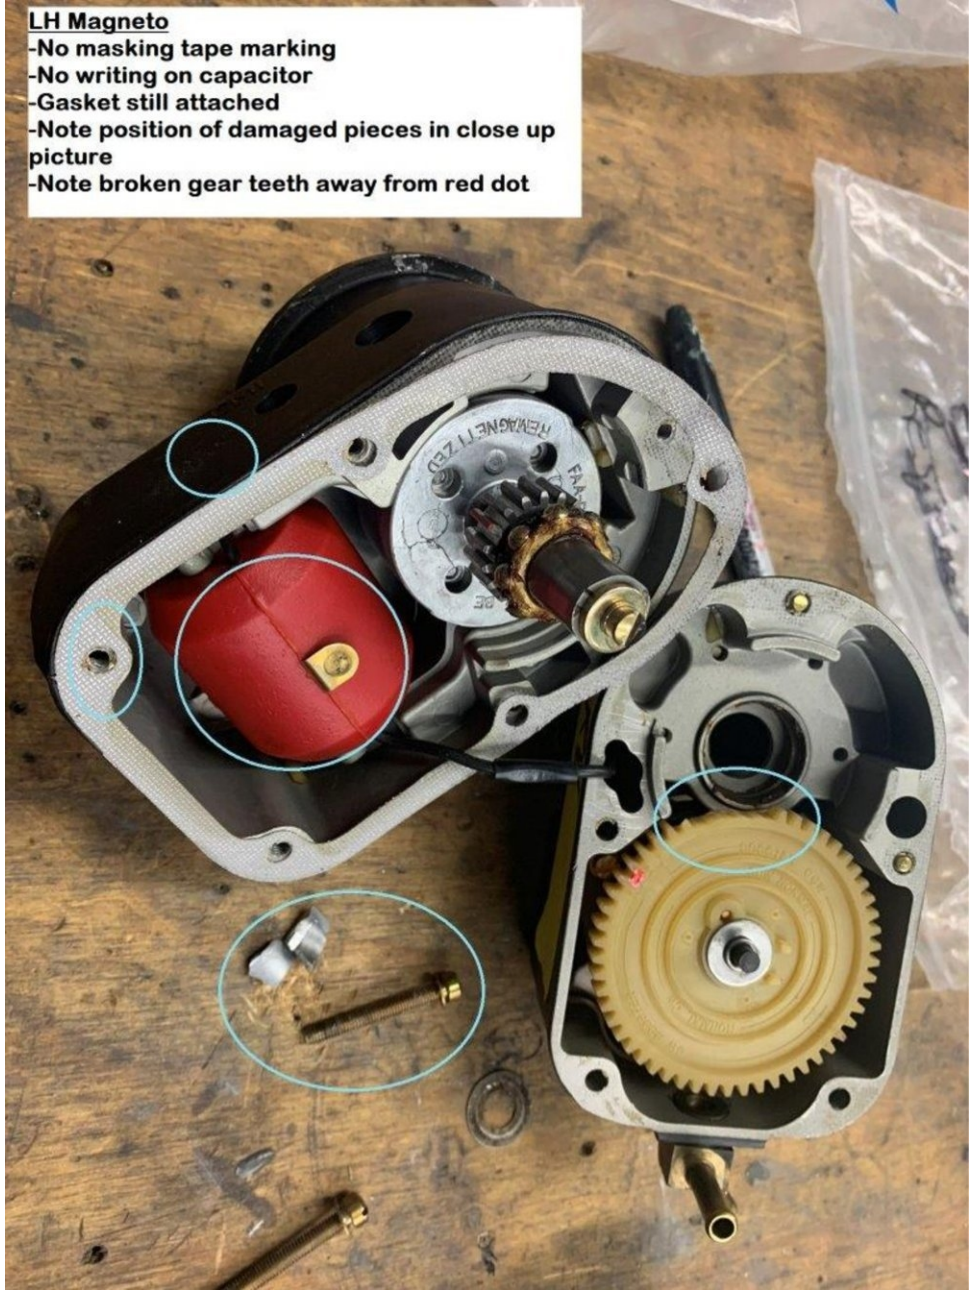
Figure 4. View of Left Magneto During Disassembly (courtesy Myers Aviation)

Examination of onboard data and the engine magnetos revealed that the engine experienced an overspeed during the uncontrolled descent, which resulted in the catastrophic failure of both magnetos and the subsequent total loss of engine power.

The magnetos were disassembled, and the internal damage displayed by each was consistent throughout. The magneto rotating magnets each had fractured pieces separated just below the pinion drive gears. The plastic drive gear driven by the pinion gear in each magneto displayed stripped and fractured teeth.

After recovery, an engine run was attempted on the airframe, and it was unsuccessful. The magnetos were replaced, and the engine subsequently started immediately, accelerated smoothly, and ran continuously without interruption.
