# Aviation Investigation Final Report

<b>Location:</b>	McKenzie Bridge, Oregon	<b>Accident Number:</b>	WPR19FA244
<b>Date &amp; Time:</b>	August 27, 2019, 18:35 Local	<b>Registration:</b>	N4108F
<b>Aircraft:</b>	Cessna 172	<b>Aircraft Damage:</b>	Destroyed
<b>Defining Event:</b>	Collision during takeoff/land	<b>Injuries:</b>	2 Fatal
<b>Flight Conducted Under:</b>	Part 91: General aviation - Personal

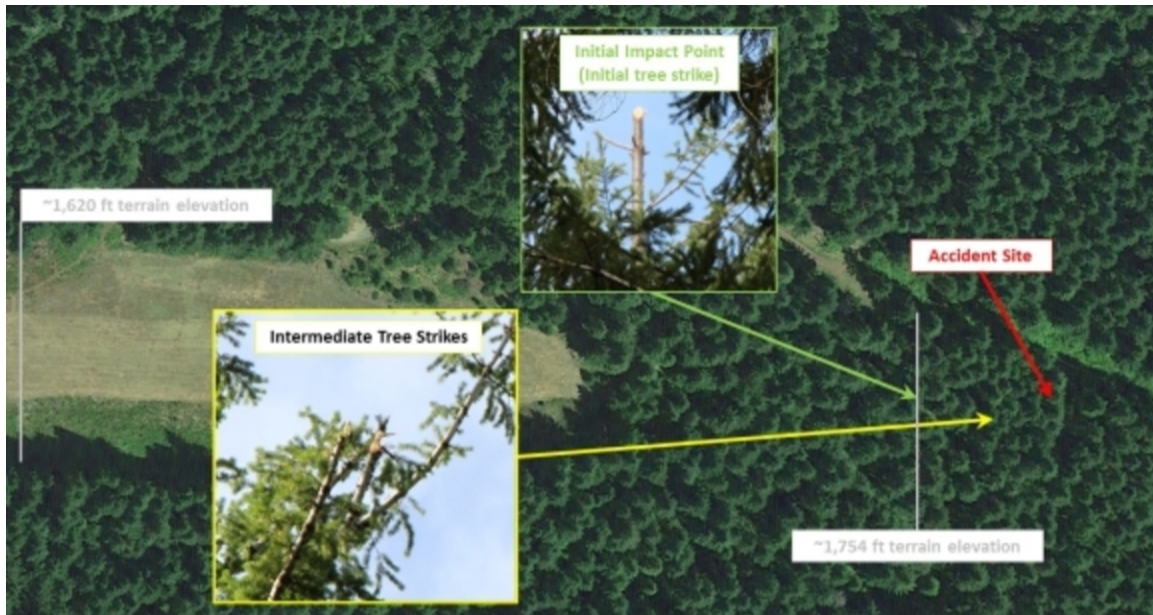
Figure 1: Wreckage Path Diagram

The airplane came to rest inverted in a wooded area about 615 ft east of the departure end of runway 6. The initial impact point (IIP) was marked by a tree about 120 ft tall with a severed top. (See Figure 1) A section of the left wingtip was found about 40 ft southwest of the IIP and displayed a depression in the leading edge of the wingtip. An intermediate impact point was observed along the debris path and marked by several broken tree branches at the top of a tree about 120 ft tall, about 75 ft southeast of the IIP. The main wreckage was located about 150 ft from the IIP and was mostly consumed by the postcrash fire but comprised all major structural components of the airplane.

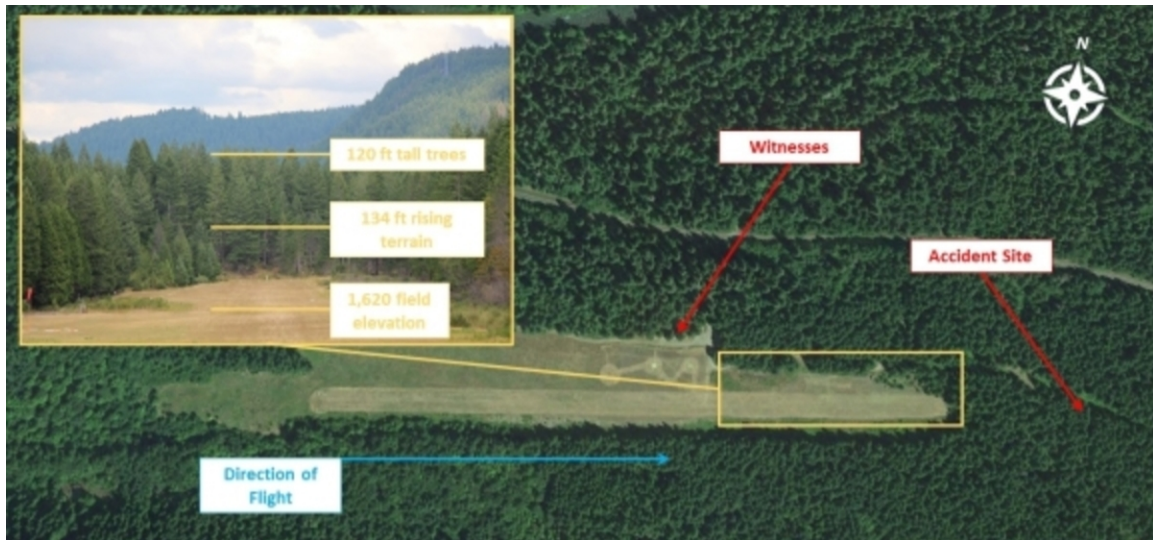
*Figure 2: Terrain Elevations along Flight Path*

Calculations based on takeoff and climb performance charts from the pilot's operating handbook showed that the airplane required a total takeoff distance of about 1,330 ft to clear a 50-ft obstacle at the end of the runway. However, the chart did not account for the 134 ft of rising terrain and 120-ft-tall trees at the end of the runway or the ambient temperature of about 98°F. The calculated density altitude on the day of the accident was 4,481 ft, which would have reduced the airplane's climb performance. Given these conditions, it is unlikely that the airplane was capable of clearing the rising terrain and tall trees at the end of the runway on the day of the accident.

Runway 6 was an upslope runway with 134-ft-tall rising terrain and 120-ft-tall trees beyond the departure end. According to the Federal Aviation Administration chart supplement that was current at the time of the accident, the airport remarks section indicated, "land east-takeoff west." Airport signage along the runway stated, "DEPARTURES FROM THIS END [the west end] NOT RECOMMENDED."
