Aviation Investigation Final Report

Location:	Lady Lake, Florida	Accident Number:	ERA19FA265
Date & Time:	September 6, 2019, 13:12 Local	Registration:	N767FS
Aircraft:	Vans RV-12	Aircraft Damage:	Destroyed
Defining Event:	Loss of control in flight	Injuries:	1 Fatal
Flight Conducted Under:	Part 91: General aviation - Personal

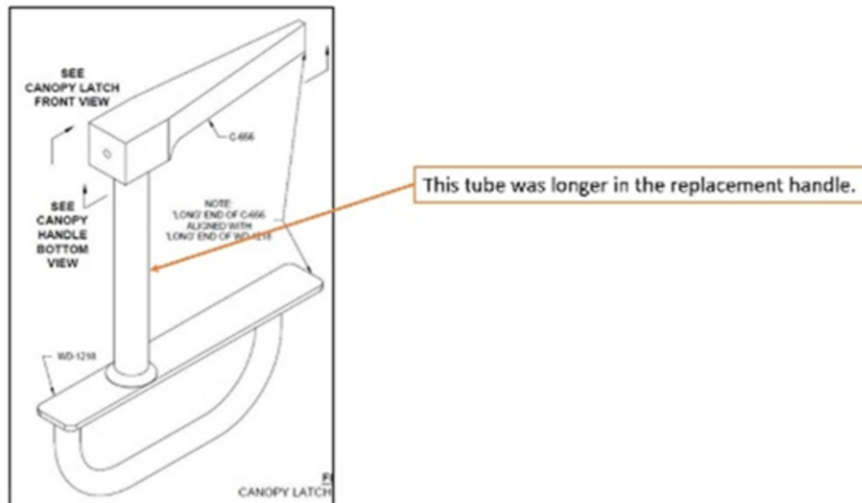
Figure 1. Original Latch Handle Design

Follow-up examination of the metal canopy roll bar frames and latching mechanism revealed that the fixed portion of the canopy bow was separated at the midspan attachment point. The left side of the roll bar was impact twisted 180° while the right side of the roll bar displayed little deformation in shape. The latch block remained affixed to the left side of the roll bar. The canopy bow that connected to the fixed portion of the canopy at the latching mechanism was fractured at the handle but displayed no twisting. The latch handle was intact and slightly bent in the portion of the handle opposite where it latched over the latch block.

Examination of the canopy and latch handle revealed that, although the pilot had purchased the latch replacement kit, only the handle from the new latch kit was installed, and additional washers were added that were not a part of the replacement kit. On the new latch, the tube that protruded through the canopy was ¼ inch longer than the original handle tube. (see Figure 1.) The pre-impact functionality of the modified latching mechanism could not be established.
