Aviation Investigation Final Report

Location:	Azusa, California	Accident Number:	WPR19LA255
Date & Time:	September 11, 2019, 13:00 Local	Registration:	N1168U
Aircraft:	Sikorsky S58	Aircraft Damage:	Substantial
Defining Event:	Part(s) separation from AC	Injuries:	1 None
Flight Conducted Under:	Part 91: General aviation - Ferry

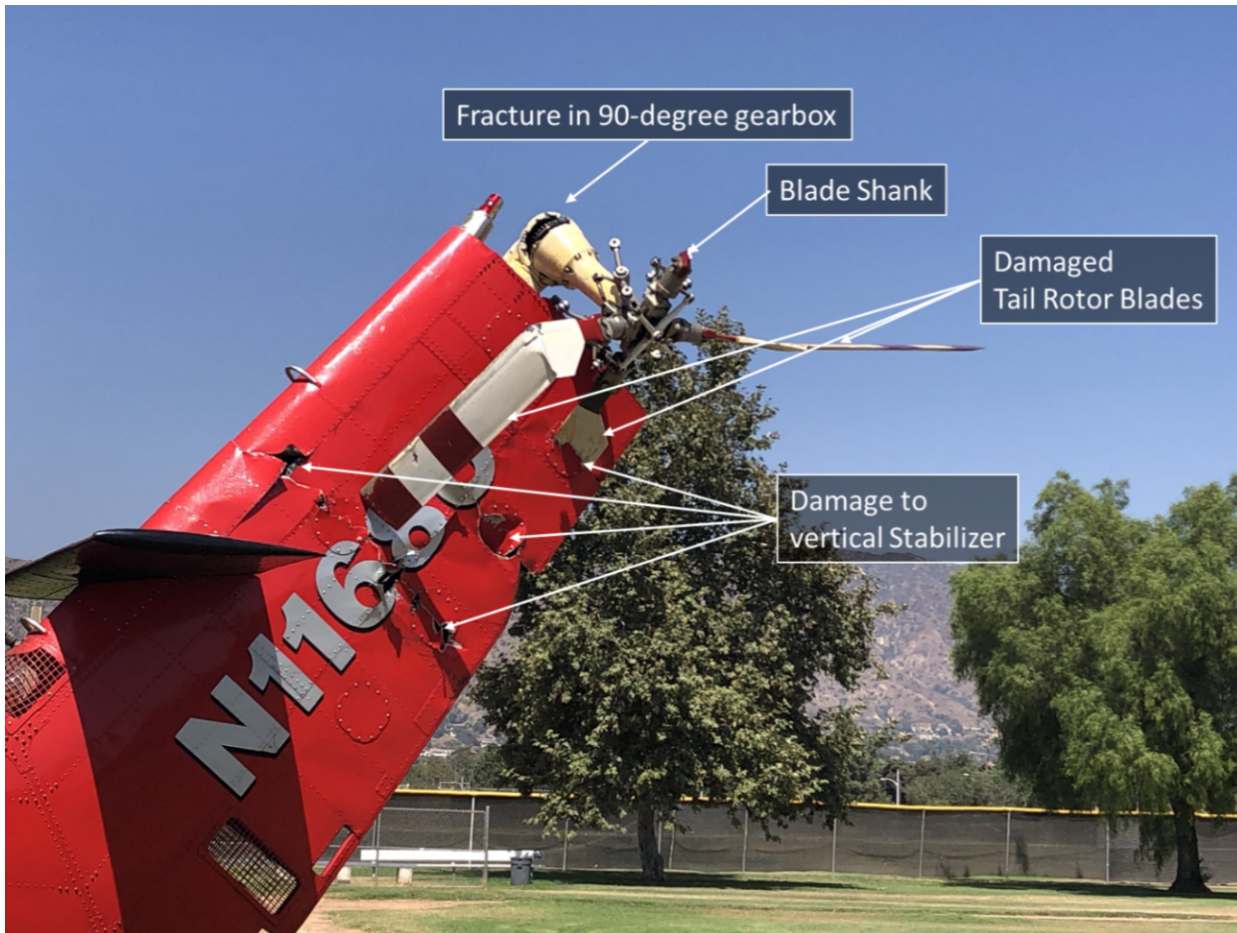
A postflight inspection revealed that one tail rotor blade had separated from the tail rotor assembly and that the remaining three tail rotor blades, which remained attached to the tail rotor assembly, exhibited dents and chordwise bends. The 90° gearbox had fractured, exposing the internal gears, and the vertical stabilizer was impact damaged. (See figure 1.)

Figure 1. Left-side view of the tail rotor assembly, 90° degree gear box, and the vertical stabilizer (Source: Pilot).

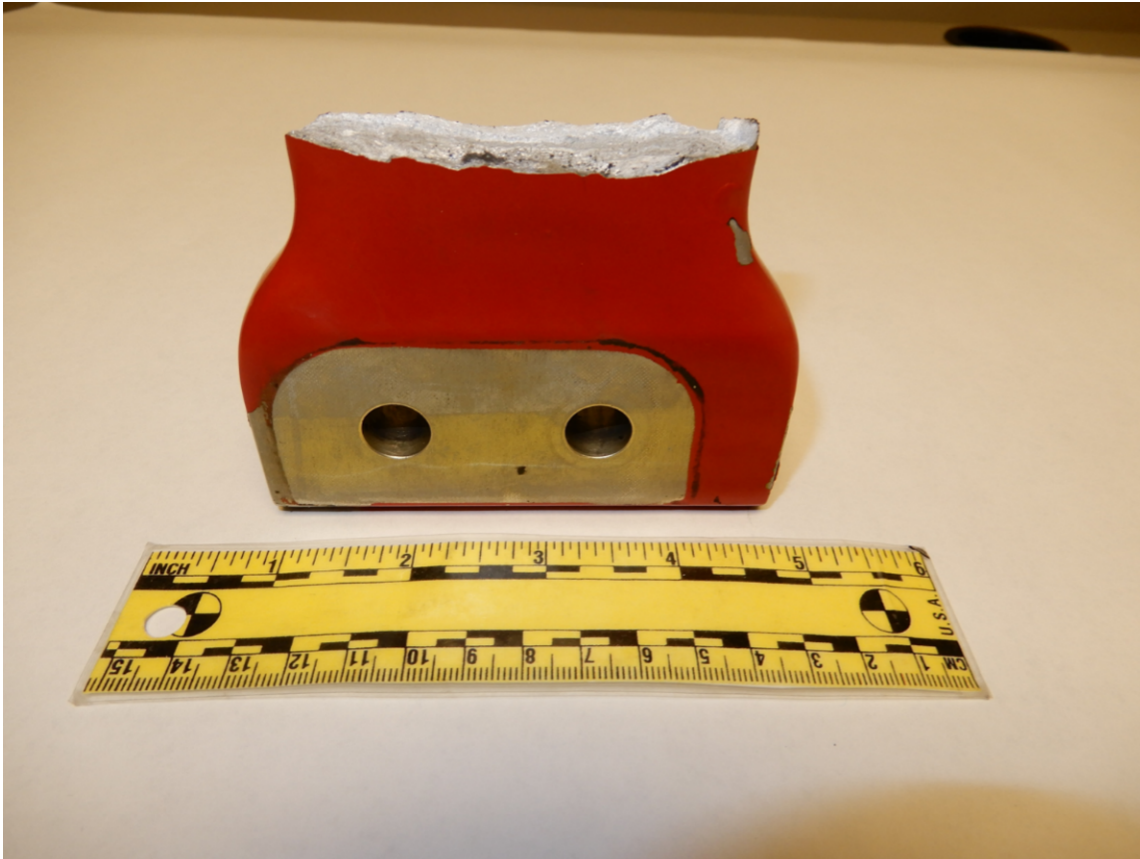
The in-flight separation of a section of the tail rotor blade due to a fatigue crack, which resulted in the pilot’s forced autorotation into a field.

The separated section of the tail rotor blade was not recovered. The shank and the other three blades of the tail rotor assembly were shipped to the National Transportation Safety Board's Materials Laboratory for examination. Fractographic examination of the shank revealed the blade had separated perpendicularly to the blade length along a chord plane located about 3 inches from the bottom of the blade. (See figure 2.)

Figure 2. Side view of tail rotor blade shank.

Examination of the tail rotor shank revealed a thumbnail-shaped pattern emanating from one side of the blade that was consistent with fatigue that had propagated through about three-quarters of the blade. No nicks, gouges, damage, or contamination were observed at the fatigue origin. Further examination of the tail rotor blade shank and the other three tail rotor blades revealed that they met the design specifications identified in the engineering drawings.
