Aviation Investigation Final Report

Location:	La Grande, Oregon	Accident Number:	WPR19FA256
Date & Time:	September 8, 2019, 10:00 Local	Registration:	N6300Z
Aircraft:	Piper PA32	Aircraft Damage:	Destroyed
Defining Event:	VFR encounter with IMC	Injuries:	1 Fatal
Flight Conducted Under:	Part 91: General aviation - Personal

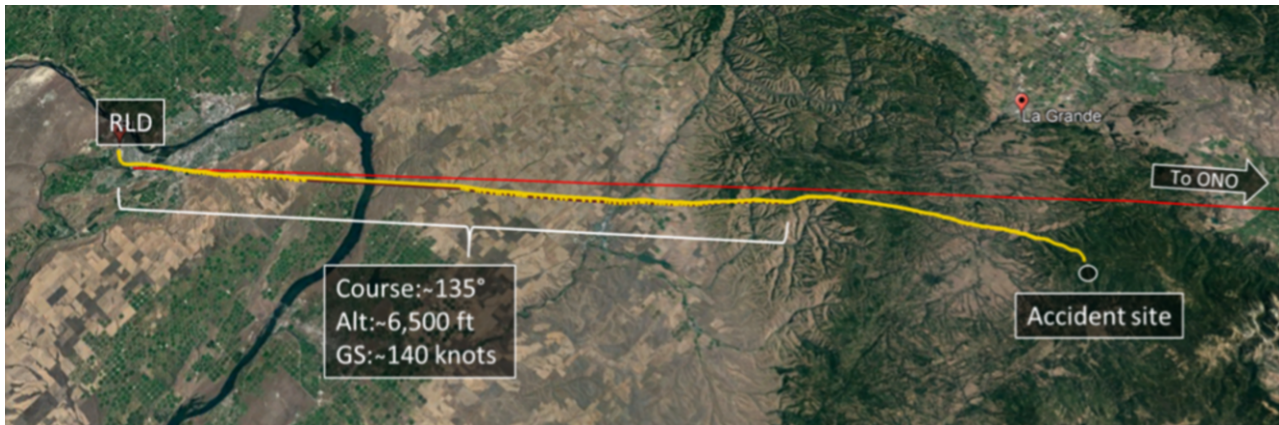
According to a relative, the pilot had flown from Ontario Airport (ONO), Ontario, Oregon, to Richland Airport (RLD), Richland, Washington, and was expected to return on the day of the accident. The pilot departed RLD for ONO, as shown in Figure 1.

Figure 1. Capture of the flight route of N6300Z.

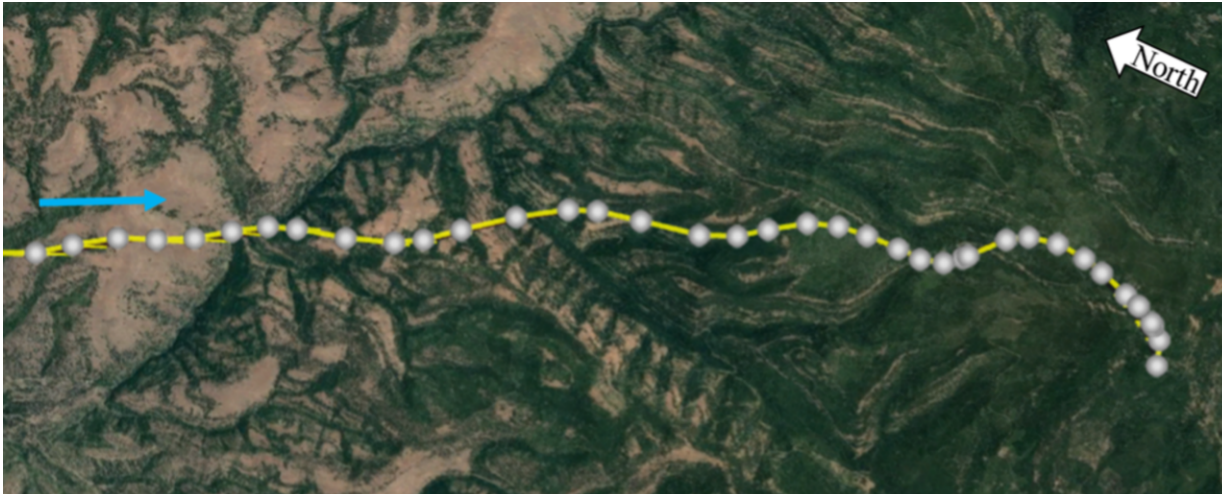
Download from a hand-held GPS unit revealed that the airplane departed RLD at 0941, turned to the southeast, climbed to about 6,500 ft GPS altitude and maintained about 140 knots (kts) ground speed. The airplane followed a heading consistent with a direct track to ONO. About 70 miles southeast of RLD, about 1010, the airplane began to diverge to the south. During the last 5 minutes of the flight, the track varied, as shown in Figure 2. The airplane's altitude was between 6,500 to 7,000 ft, and the ground speed was between 130 and 140 knots.

Figure 2. Capture of the last 5 minutes of the recorded flight route. The blue arrow indicates the direction of travel.

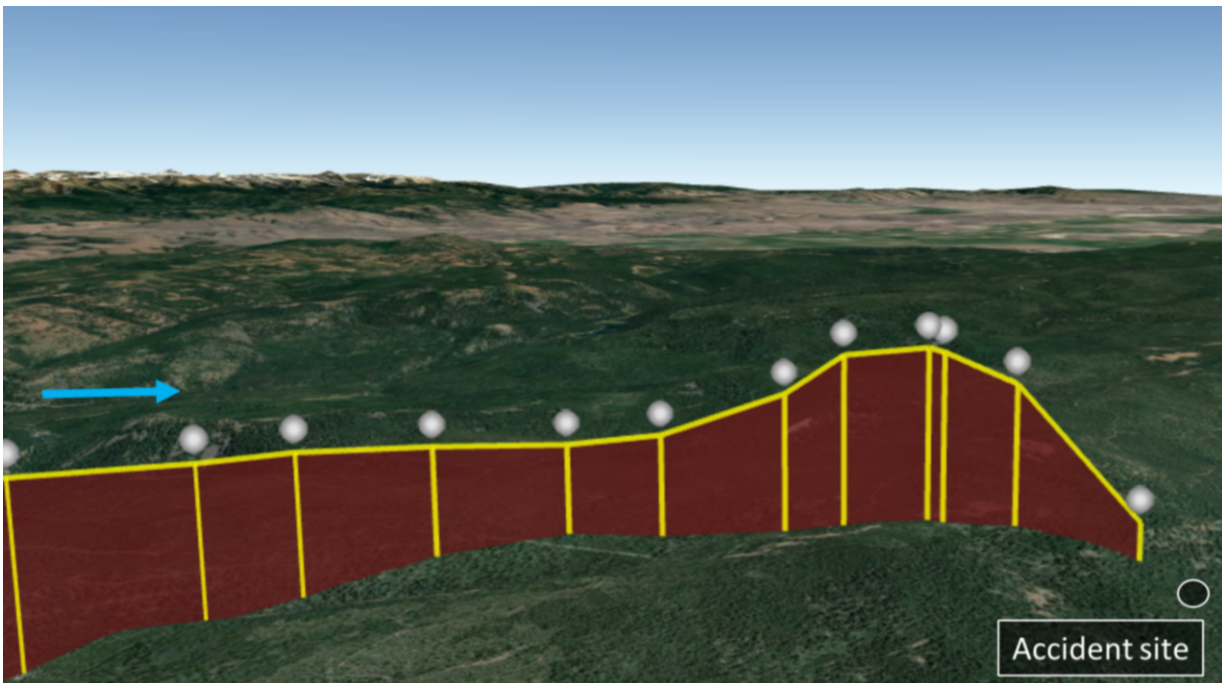
About 1019:01, the airplane was about 7,000 ft, at 122 knots, when it entered a descent. At 1019:18, the airplane had descended to 6,698 ft and accelerated to 143 kts. At 1019:37, the airplane began a climb to 7,444 ft and decelerated to 53 kts. The airplane then began a descent that continued until GPS data ended at 1019:47. The last recorded data indicated that the airplane was at 6,278 ft and 109 kts, and about 450 ft from the accident site, as shown in Figure 3.

Figure 3. Capture of the last minute of the recorded vertical flight path. The blue arrow indicates the direction of travel.

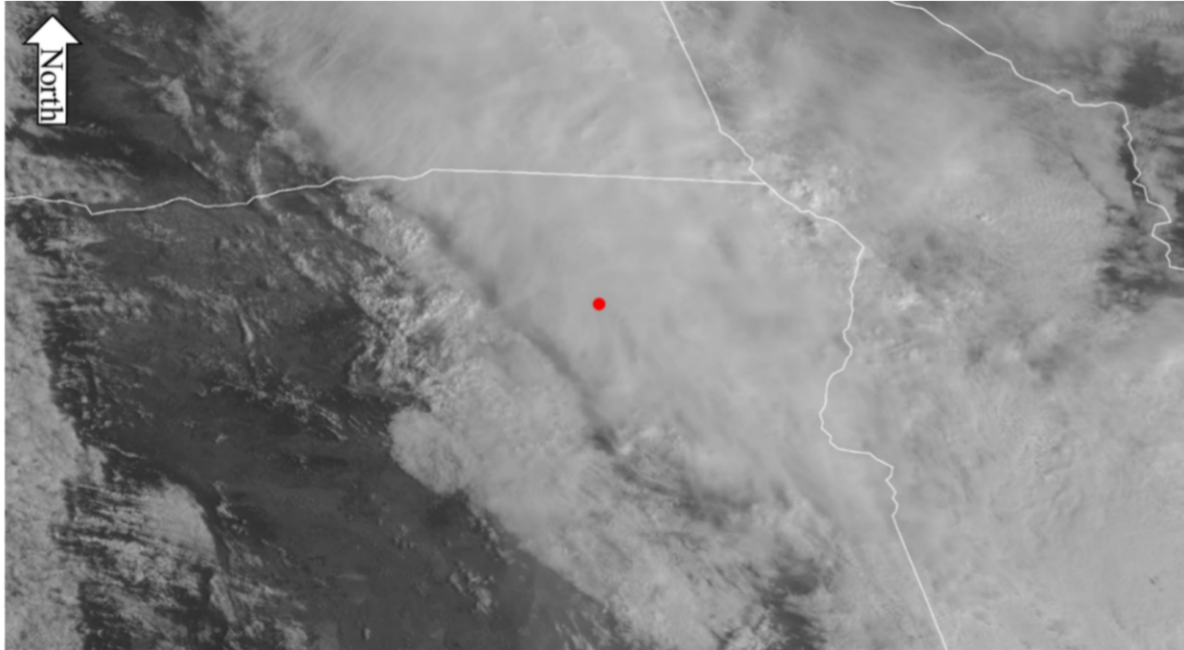
Satellite imagery identified cloudy conditions across the accident region. Infrared imagery depicted minimum brightness temperatures immediately above the accident location of about -31°C, which, when considering the high-resolution rapid refresh sounding, corresponded to cloud top heights near 26,400 ft msl, as shown in Figure 4.

Figure 4. Satellite imagery showing cloud coverage. The accident site is identified by a red dot.

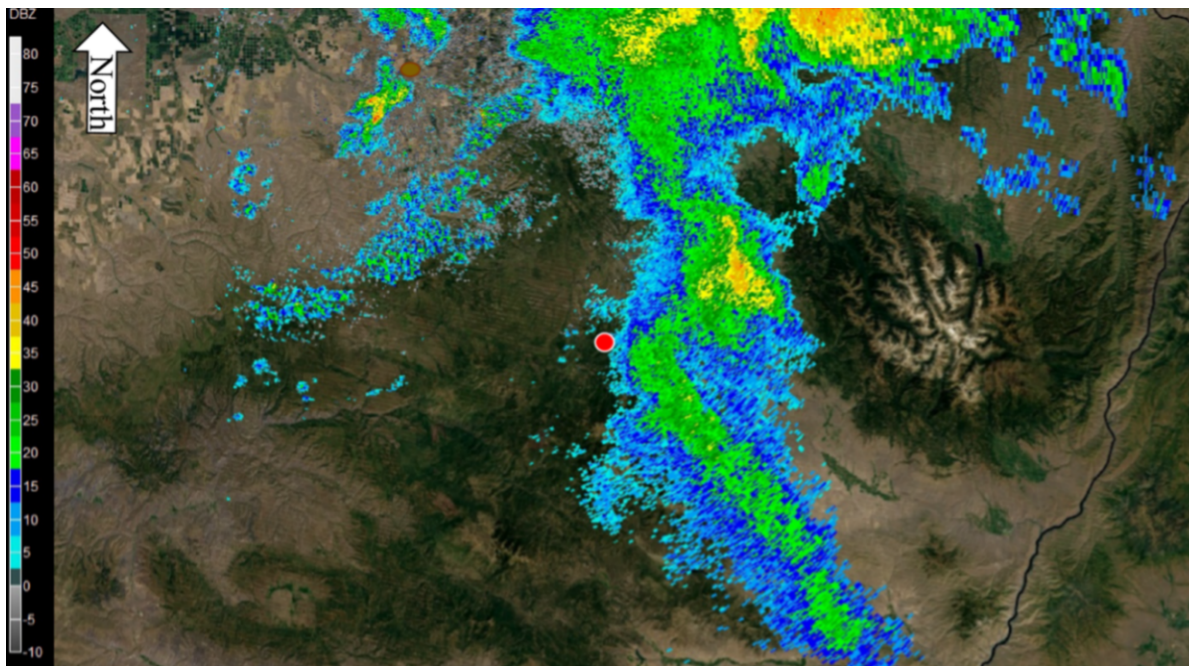
Weather radar from Pendleton, Oregon, located about 40 miles northwest of the accident site at an elevation of 1,580 ft msl, identified the accident site in an area of light precipitation, as shown in Figure 5.

Figure 5. Weather radar showing light precipitation. The accident site is identified by a red dot.
