Aviation Investigation Final Report

Location:	La Grande, Oregon	Accident Number:	WPR19FA256
Date & Time:	September 8, 2019, 10:00 Local	Registration:	N6300Z
Aircraft:	Piper PA32	Aircraft Damage:	Destroyed
Defining Event:	VFR encounter with IMC	Injuries:	1 Fatal
Flight Conducted Under:	Part 91: General aviation - Personal

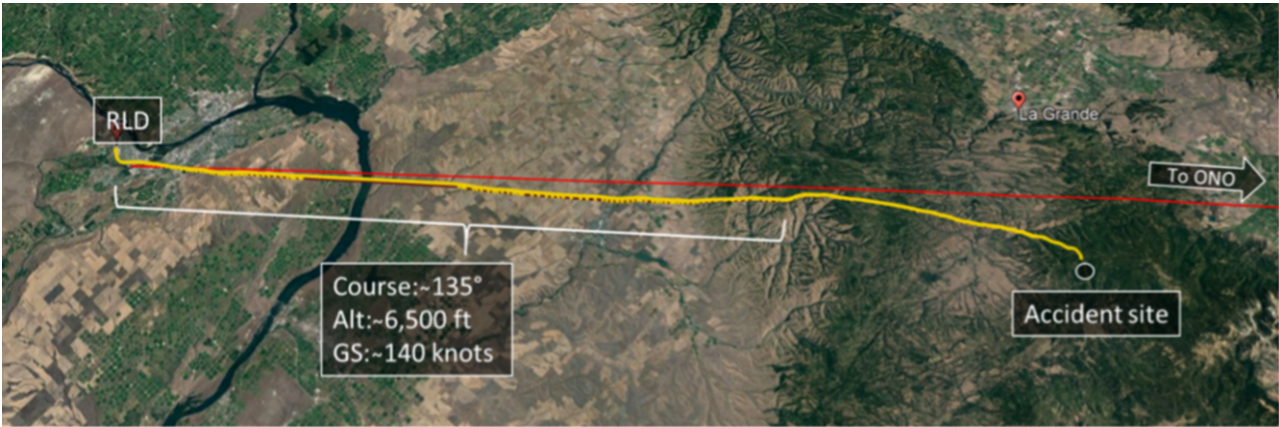
According to a relative, the pilot had flown from Ontario Airport (ONO), Ontario, Oregon, to Richland Airport (RLD), Richland, Washington, and was expected to return on the day of the accident. The pilot departed RLD for ONO, as shown in Figure 1.

Figure 1. Capture of the flight route of N6300Z.

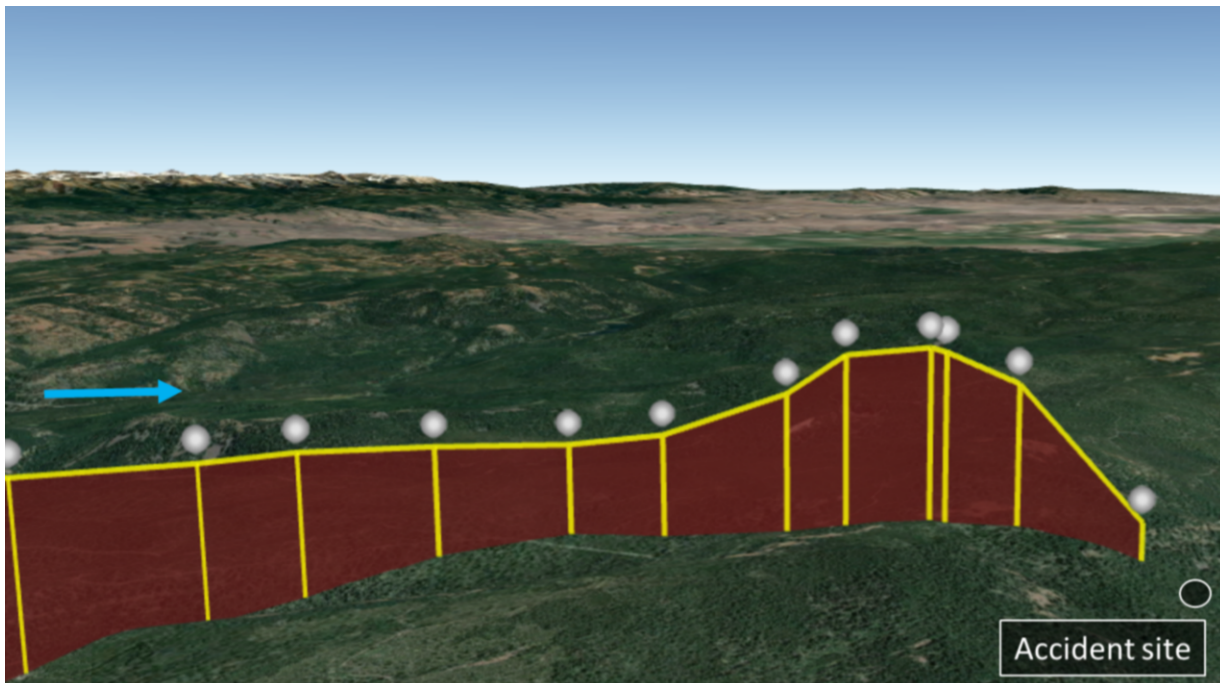
About 1019:01, the airplane was about 7,000 ft, at 122 knots, when it entered a descent. At 1019:18, the airplane had descended to 6,698 ft and accelerated to 143 kts. At 1019:37, the airplane began a climb to 7,444 ft and decelerated to 53 kts. The airplane then began a descent that continued until GPS data ended at 1019:47. The last recorded data indicated that the airplane was at 6,278 ft and 109 kts, and about 450 ft from the accident site, as shown in Figure 3.

Figure 3. Capture of the last minute of the recorded vertical flight path. The blue arrow indicates the direction of travel.

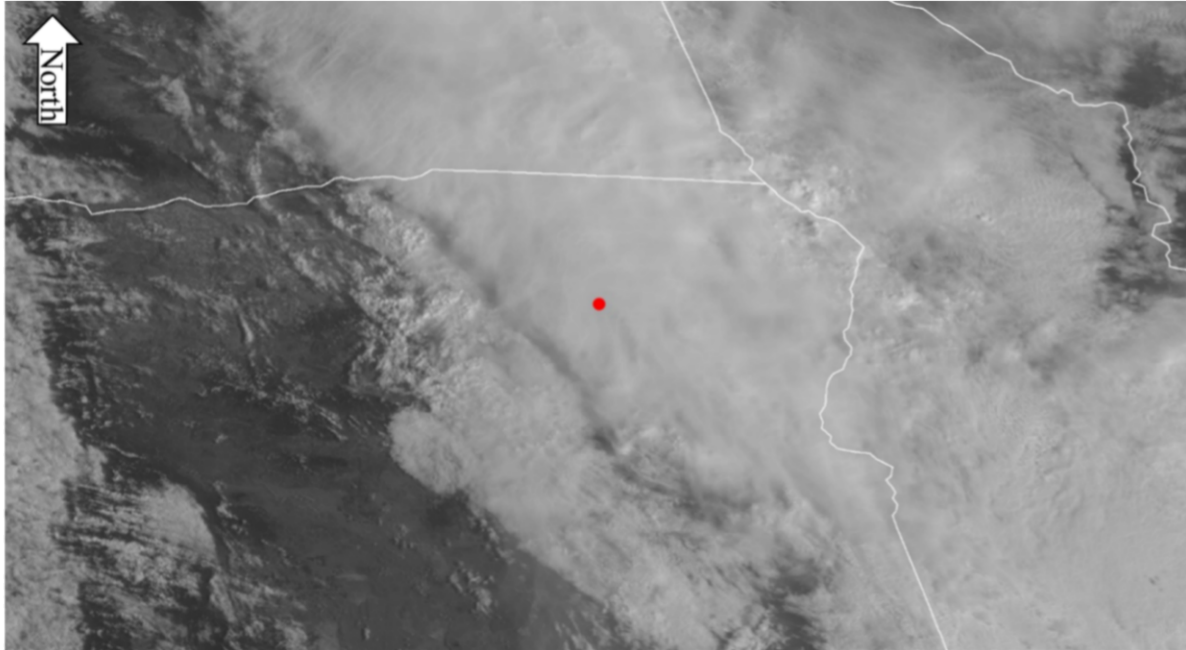
Satellite imagery identified cloudy conditions across the accident region. Infrared imagery depicted minimum brightness temperatures immediately above the accident location of about -31°C, which, when considering the high-resolution rapid refresh sounding, corresponded to cloud top heights near 26,400 ft msl, as shown in Figure 4.

Figure 4. Satellite imagery showing cloud coverage. The accident site is identified by a red dot.

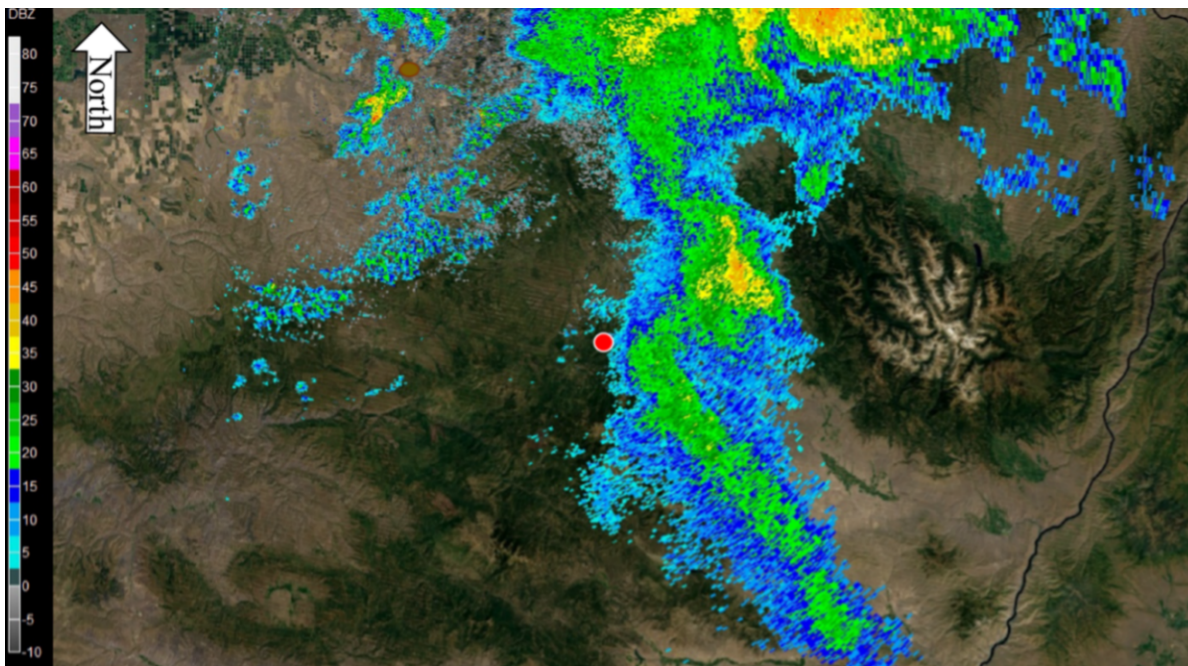
Weather radar from Pendleton, Oregon, located about 40 miles northwest of the accident site at an elevation of 1,580 ft msl, identified the accident site in an area of light precipitation, as shown in Figure 5.

Figure 5. Weather radar showing light precipitation. The accident site is identified by a red dot.
