# Aviation Investigation Final Report

<b>Location:</b>	Windsor Locks, Connecticut	<b>Accident Number:</b>	ERA20MA001
<b>Date &amp; Time:</b>	October 2, 2019, 09:53 Local	<b>Registration:</b>	N93012
<b>Aircraft:</b>	Boeing B17	<b>Aircraft Damage:</b>	Destroyed
<b>Defining Event:</b>	Landing area undershoot	<b>Injuries:</b>	7 Fatal, 5 Serious, 2 Minor
<b>Flight Conducted Under:</b>	Part 91: General aviation - Other work use

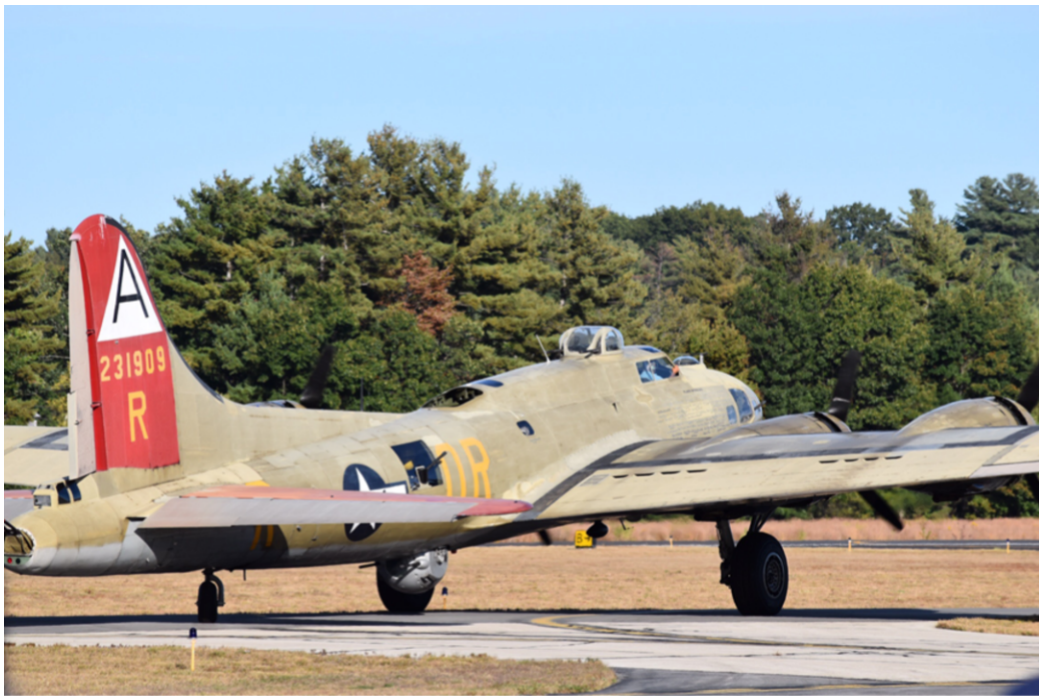
The accident airplane, shown in figure 1, was a vintage, former US military bomber that was on a tour that allowed members of the public to purchase an excursion aboard the airplane for a living history flight experience (LHFE). After the passengers boarded the airplane, they were seated by the crew chief/flight engineer (referred to as the loadmaster). The 20- to 25-minute flight included a planned in-flight walking tour of the airplane.

**Figure 1.** Accident airplane

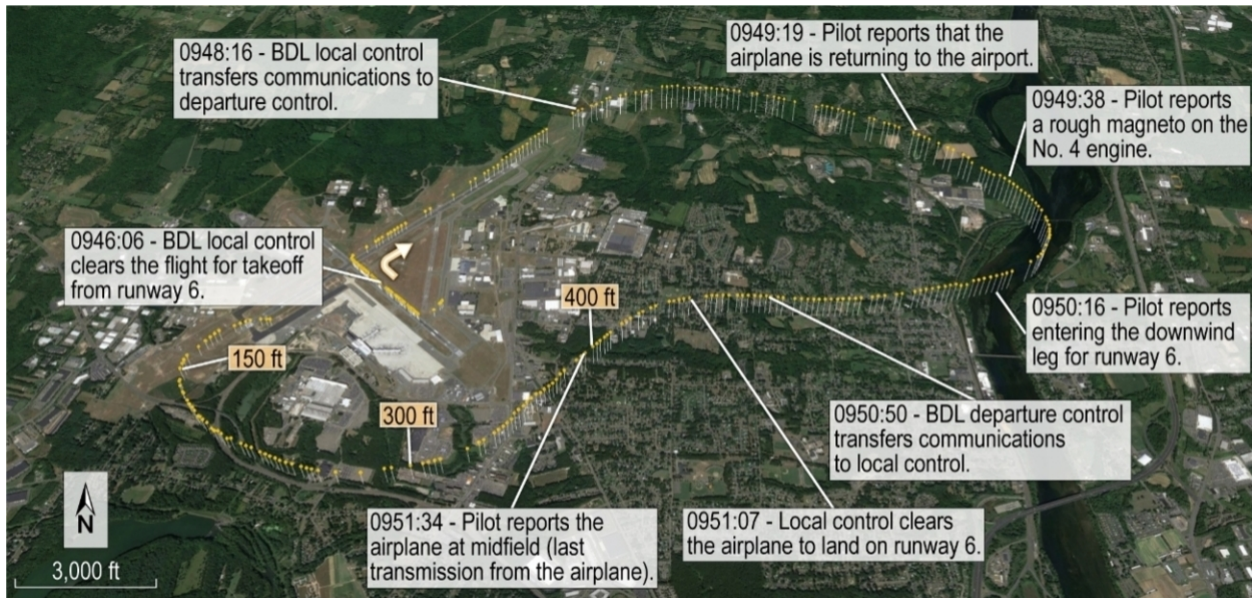
The airplane was descending through an altitude of 300 ft as it turned onto the base leg of the traffic pattern for runway 6. The airplane then turned onto final approach at an altitude of 150 ft; at that time, the airplane was about 0.4 nautical mile from the runway threshold. Figure 2 depicts the airplane’s ADS-B-derived flightpath overlaid onto aerial imagery of the airport and surrounding area along with relevant voice radio transmissions between air traffic control (ATC) and the airplane.

**Figure 2.** ADS-B-derived flightpath and select voice radio transmissions

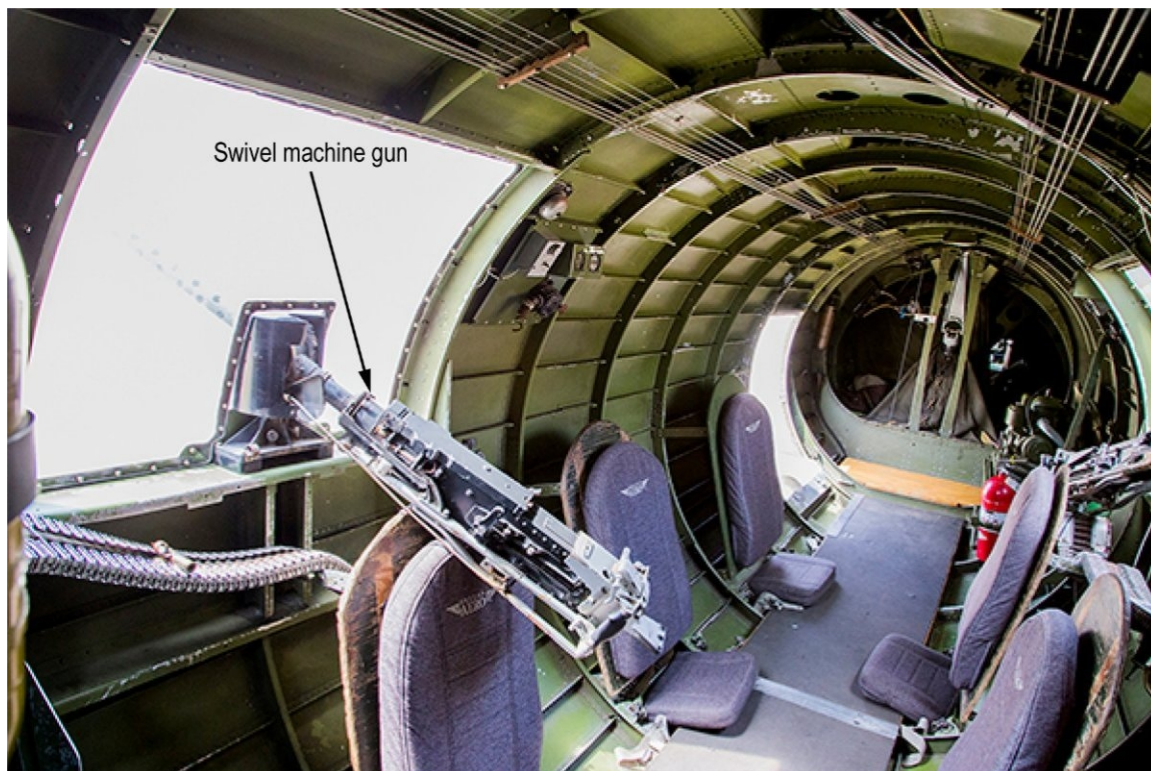
The passenger seats that were not original equipment were installed in the airplane according to an engineering document that conformed with the structural requirements of *Civil Aviation Regulation 4b*. Some of the seats consisted of a 5/8-inch-thick plywood seatback attached to the airframe with aluminum angles and brackets, as shown in figure 3. The other seats were secured directly to the structure on an airplane sidewall or bulkhead. All of the passenger seats included a seatback cushion secured with hook and loop fasteners and a seat bottom cushion secured to a floor panel. The passenger seats were equipped with a two-point military/aerobatic-style lap belt affixed to either the seat or structural areas on or near the floor.

**Figure 3.** Accident airplane interior (forward looking aft)

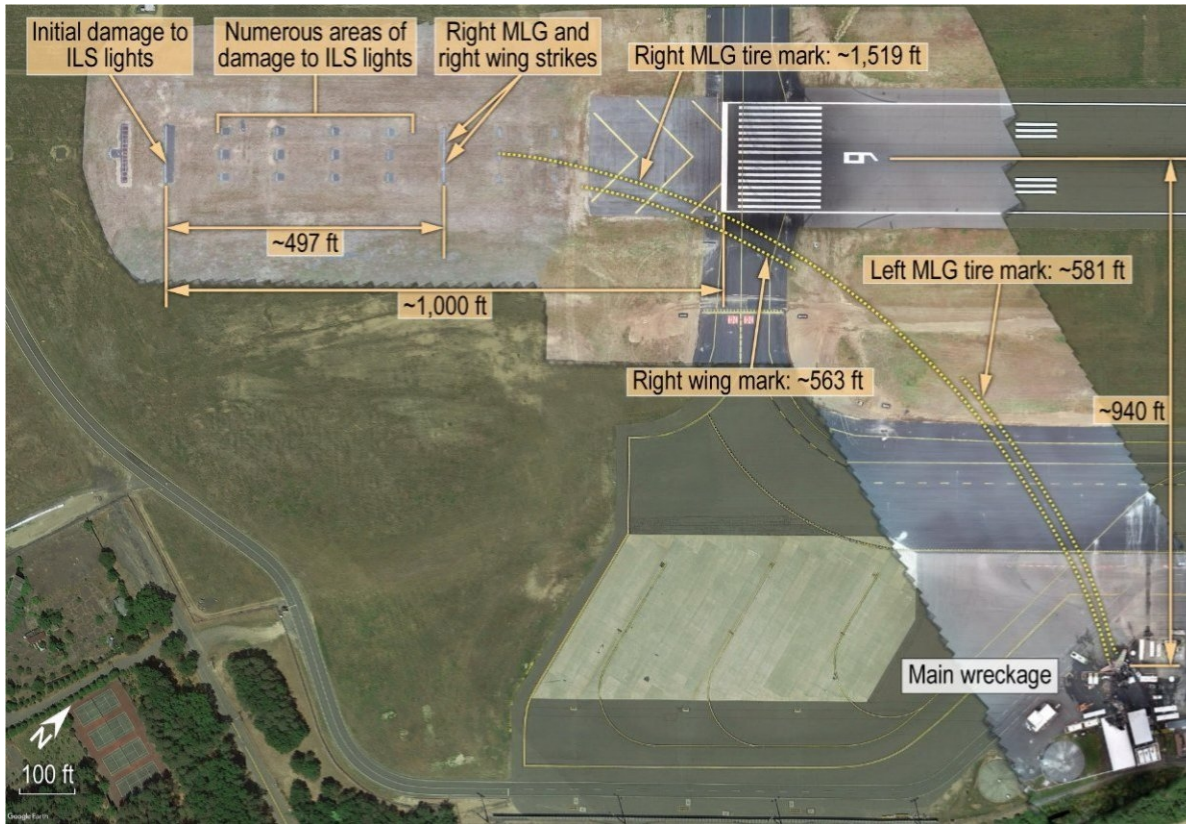
Witness statements and video indicated that the airplane struck the runway 6 approach lights in a right-wing-down attitude about 1,000 ft before the runway. The airplane contacted the ground about 500 ft before reaching runway 6. The engine noise increased, and the airplane accelerated as it veered to the right of the runway. The airplane then collided with vehicles and a deicing fluid tank before coming to rest upright about 940 ft to the right of the runway 6 centerline and oriented to the east. A postcrash fire ensued.

Figure 4 is an overhead image that shows the runway 6 approach area, the areas of impact damage to the instrument landing system (ILS) lighting equipment, and the location of witness marks from the airplane's main landing gear (MLG) and right wing. The figure also shows the airplane's final resting position about 940 ft to the right of the runway 6 centerline. Most of the cabin, cockpit, and right wing were consumed by a postcrash fire, as shown in figure 5.

**Figure 4.** Overhead image depicting the airplane's path to final impact

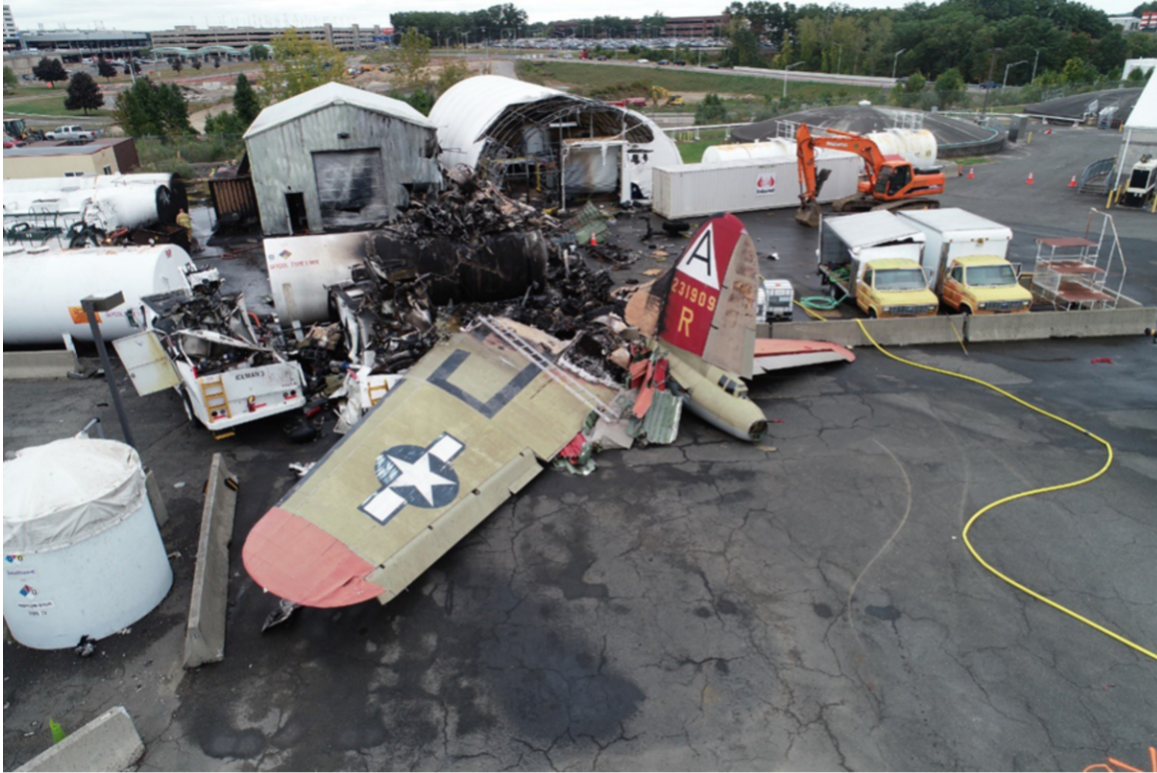
**Figure 5.** Airplane wreckage

Measurement of the left- and right-wing flap jackscrews corresponded to the retracted flap setting. The left-wing flap and aileron remained attached to the wing, and a section of the flap was consumed by the postcrash fire. The right-wing flap remained attached to the wing; the aileron was consumed by the postcrash fire. The empennage, elevator, and rudder remained intact.

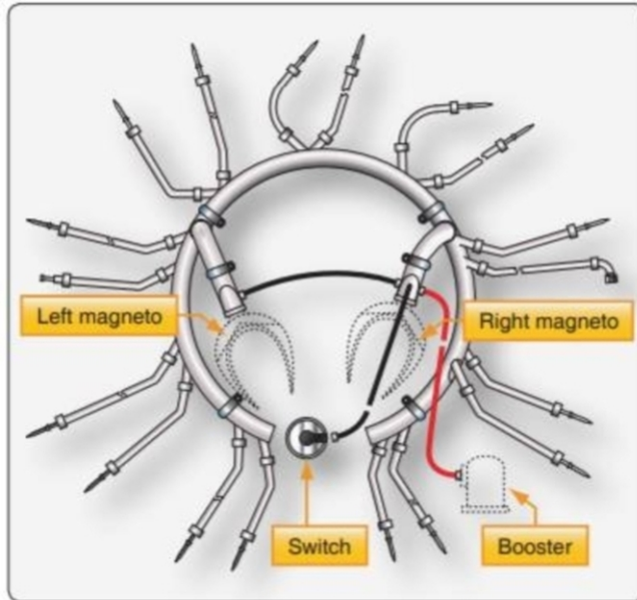
Teardown examination of the No. 4 engine revealed no evidence of abnormal combustion or detonation on the cylinders or pistons. The left magneto's P-lead (the electrical connection between a magneto and the cockpit ignition switches) was partially pulled out of the magneto housing, and the grounding tab was in contact with the housing. Figure 6 shows a generic radial engine ignition system (similar to the one on the accident airplane) and the location of the left and right magnetos (for informational purposes only.) A single strand of safety wire was observed around the retaining nut. A functional test of the magneto showed that the contact between the grounding tab and the housing resulted in the magneto being shorted to ground and unable to function. When a piece of cardboard was placed between the grounding tab and the housing, the ignition leads for all nine cylinders produced a strong spark when the drive spline was rotated.

**Figure 6.** Radial engine ignition system.

The right magneto's P-lead was partially engaged in its fitting, and the grounding tab did not contact the magneto housing. The right magneto's gap between the points was 0.004 inch, which was less than the minimum gap (0.008 to 0.010 inch) that the manufacturer required. When the magneto was tested, the ignition leads for the No. 8 cylinder did not spark; the ignition leads for the other eight cylinders produced sparks that were weak and intermittent. In addition, the right magneto's compensator cam and associated cam follower were worn.
