Aviation Investigation Final Report

Location:	Windsor Locks, Connecticut	Accident Number:	ERA20MA001
Date & Time:	October 2, 2019, 09:53 Local	Registration:	N93012
Aircraft:	Boeing B17	Aircraft Damage:	Destroyed
Defining Event:	Landing area undershoot	Injuries:	7 Fatal, 5 Serious, 2 Minor
Flight Conducted Under:	Part 91: General aviation - Other work use

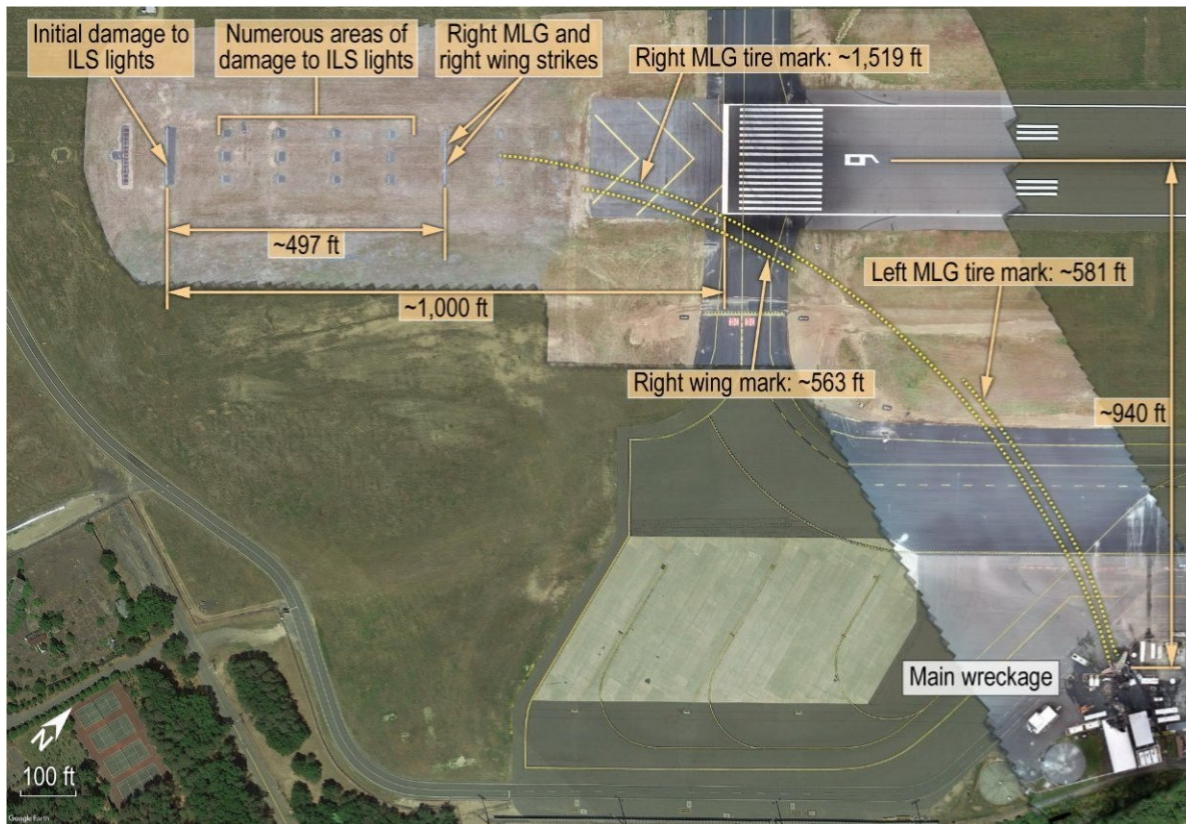
Figure 4. Overhead image depicting the airplane's path to final impact

Witness statements and video indicated that the airplane struck the runway 6 approach lights in a right-wing-down attitude about 1,000 ft before the runway. The airplane contacted the ground about 500 ft before reaching runway 6. The engine noise increased, and the airplane accelerated as it veered to the right of the runway. The airplane then collided with vehicles and a deicing fluid tank before coming to rest upright about 940 ft to the right of the runway 6 centerline and oriented to the east. A postcrash fire ensued.

Figure 4 is an overhead image that shows the runway 6 approach area, the areas of impact damage to the instrument landing system (ILS) lighting equipment, and the location of witness marks from the airplane's main landing gear (MLG) and right wing. The figure also shows the airplane's final resting position about 940 ft to the right of the runway 6 centerline. Most of the cabin, cockpit, and right wing were consumed by a postcrash fire, as shown in figure 5.

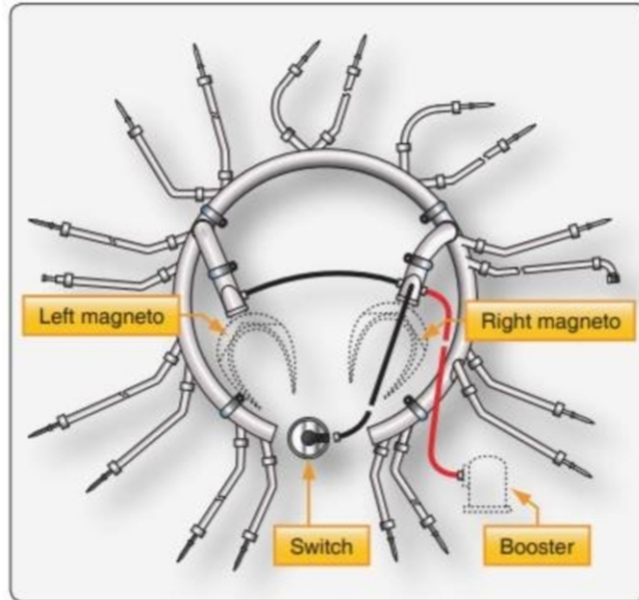
Figure 6. Radial engine ignition system.

Teardown examination of the No. 4 engine revealed no evidence of abnormal combustion or detonation on the cylinders or pistons. The left magneto's P-lead (the electrical connection between a magneto and the cockpit ignition switches) was partially pulled out of the magneto housing, and the grounding tab was in contact with the housing. Figure 6 shows a generic radial engine ignition system (similar to the one on the accident airplane) and the location of the left and right magnetos (for informational purposes only.) A single strand of safety wire was observed around the retaining nut. A functional test of the magneto showed that the contact between the grounding tab and the housing resulted in the magneto being shorted to ground and unable to function. When a piece of cardboard was placed between the grounding tab and the housing, the ignition leads for all nine cylinders produced a strong spark when the drive spline was rotated.

The right magneto's P-lead was partially engaged in its fitting, and the grounding tab did not contact the magneto housing. The right magneto's gap between the points was 0.004 inch, which was less than the minimum gap (0.008 to 0.010 inch) that the manufacturer required. When the magneto was tested, the ignition leads for the No. 8 cylinder did not spark; the ignition leads for the other eight cylinders produced sparks that were weak and intermittent. In addition, the right magneto's compensator cam and associated cam follower were worn.
