# Aviation Investigation Final Report

<b>Location:</b>	Lansing, Michigan	<b>Accident Number:</b>	CEN20FA001
<b>Date &amp; Time:</b>	October 3, 2019, 08:58 Local	<b>Registration:</b>	N700AQ
<b>Aircraft:</b>	Socata TBM 700	<b>Aircraft Damage:</b>	Substantial
<b>Defining Event:</b>	Loss of control in flight	<b>Injuries:</b>	5 Fatal, 1 Serious
<b>Flight Conducted Under:</b>	Part 91: General aviation - Business

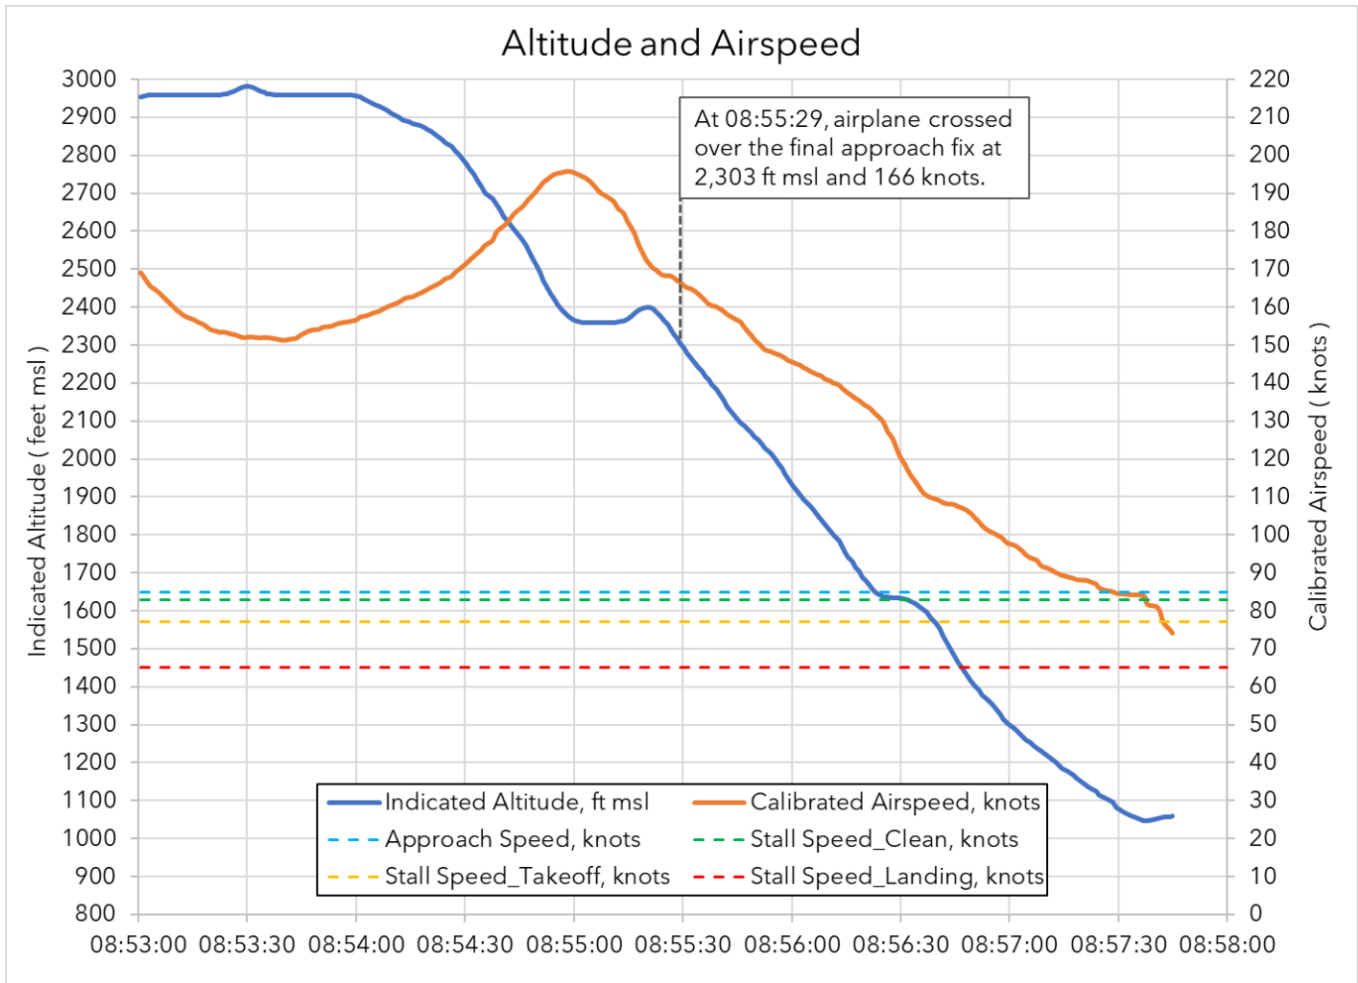
At 0854:27, the approach controller stated, "TBM zero alpha quebec, contact Lansing tower one one niner point niner, good day." The pilot responded, "One nineteen ninety, seven hundred alpha quebec." At 0855:29, the airplane crossed over FAMLI at 2,303 ft msl and continued to descend on the glideslope while established inbound on the localizer toward runway 10R. The airplane had a calculated calibrated airspeed of 166 knots when it crossed over the final approach fix. Between 0855:29 and 0857:45, while inbound on the instrument approach, the airplane continued to decelerate from 166 knots to 74 knots, as shown in figure 1.

**Figure 1.** Altitude and airspeed during instrument approach.

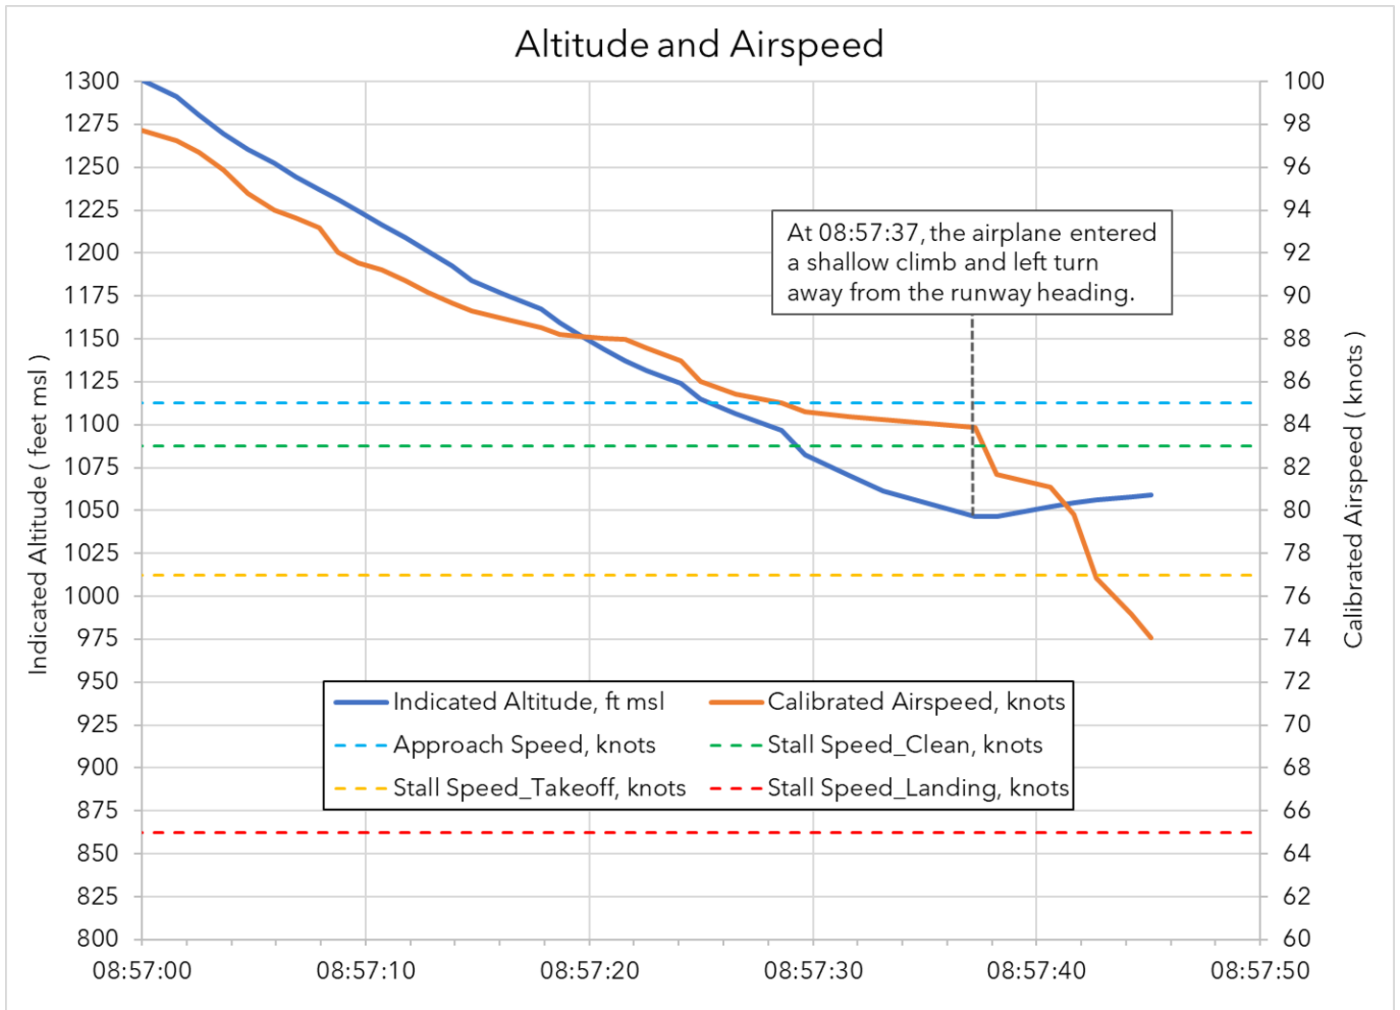
The altitude and airspeed trends during the final moments of the flight were consistent with the airplane entering an aerodynamic stall at a low altitude. Based on the configuration of the airplane at the accident site, the pilot likely was retracting the landing gear and flaps for a go-around when the airplane entered the aerodynamic stall.

The ADS-B data indicated that at 0857:06 the airplane was about 1.3 miles from the runway threshold at 1,250 ft msl (about 400 ft above the runway elevation) and established on the localizer inbound to the runway. At 0857:37, the airplane was 0.5 miles from the runway threshold at 1,047 ft msl (about 180 ft above the runway elevation) and 84 knots when it entered a shallow climb and left turn away from the runway heading. Between 0857:37 and 0857:45, the airplane climbed to 1,059 ft msl and decelerated to 74 knots, as shown in figure 2. At 0857:45, the final ADS-B datapoint was located about 315 ft north of the localizer centerline and 0.35 miles west of the runway 10R threshold. The final ADS-B datapoint was about 475 ft southwest of the initial impact point with terrain. Figure 3 shows ADS-B position data during the airplane's final approach.

**Figure 2.** Altitude and airspeed during final approach.

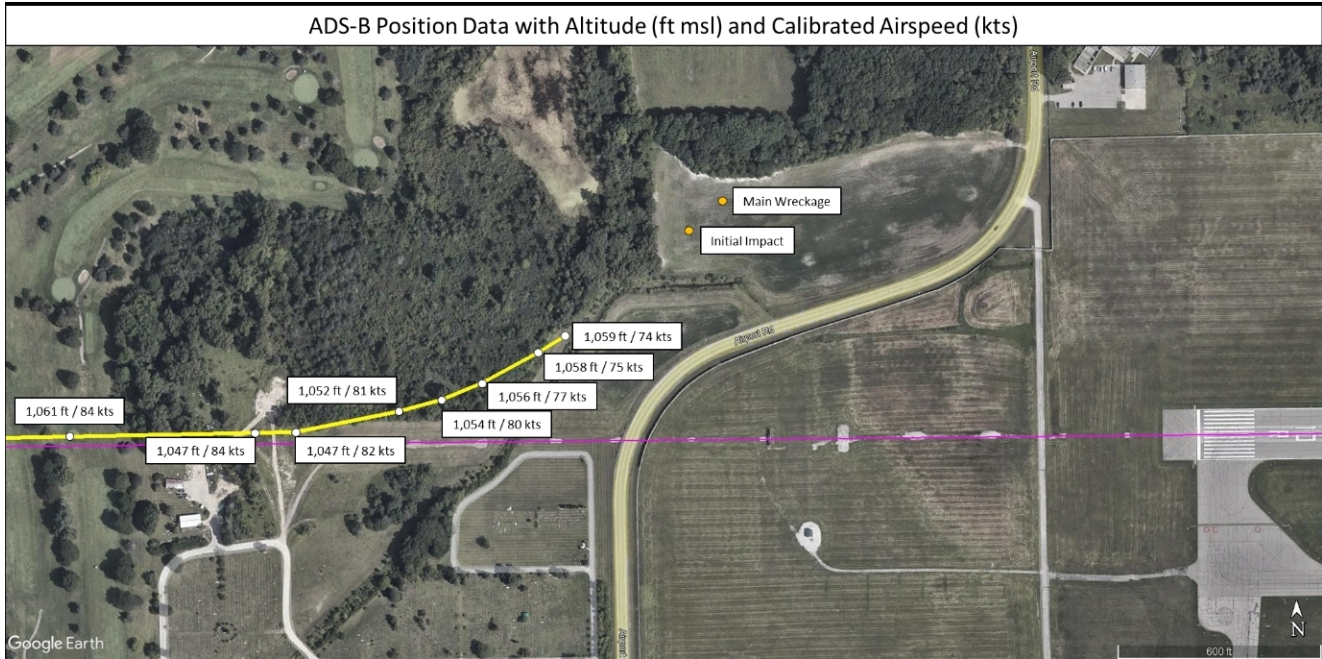
**Figure 3.** ADS-B position data during final approach.

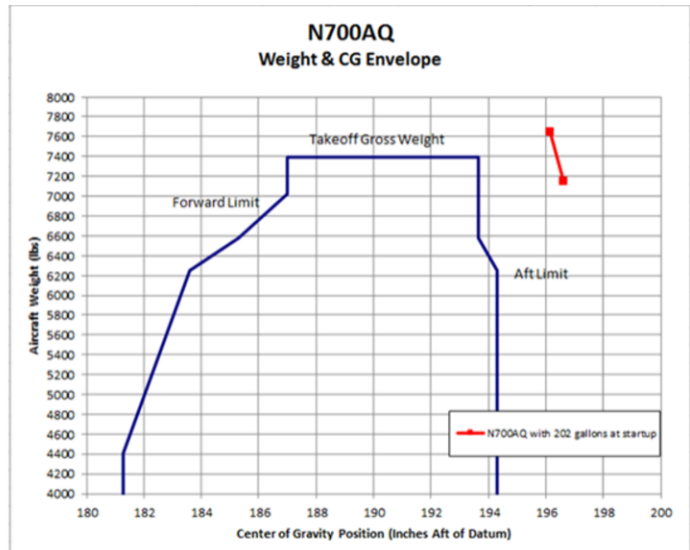
The airplane was operating above the maximum landing weight, and past the aft center-of-gravity limit at the time of the accident which can render the airplane unstable and difficult to recover from an aerodynamic stall. Additionally, without a timely corrective rudder input, the airplane tends to roll left after a rapid application of thrust at airspeeds less than 70 knots, including during aerodynamic stalls. Although an increase in thrust is required for a go-around, the investigation was unable to determine how rapidly the pilot increased thrust, or if a torque-roll occurred during the aerodynamic stall.

The airplane's weight and balance at takeoff were calculated using the reported weights and seat positions for the pilot and the 5 passengers, and 202 gallons (1,374 lbs) of fuel. The takeoff weight and CG location were estimated to be 7,626.28 lbs and 196.18 inches, respectively. At takeoff, the airplane was about 232 lbs over the maximum allowable takeoff weight and about 2.53 inches past the aft CG limit. The engine burned about 70 gallons (476 lbs) of fuel during the flight. The estimated airplane weight and CG location at the time of impact were 7,150.28 lbs and 196.60 inches, respectively. At impact, the airplane was about 126 lbs over the maximum allowable landing weight and 2.95 inches past the aft CG limit (Figure 4).

**Figure 4.** Weight and Balance Calculations and Plot

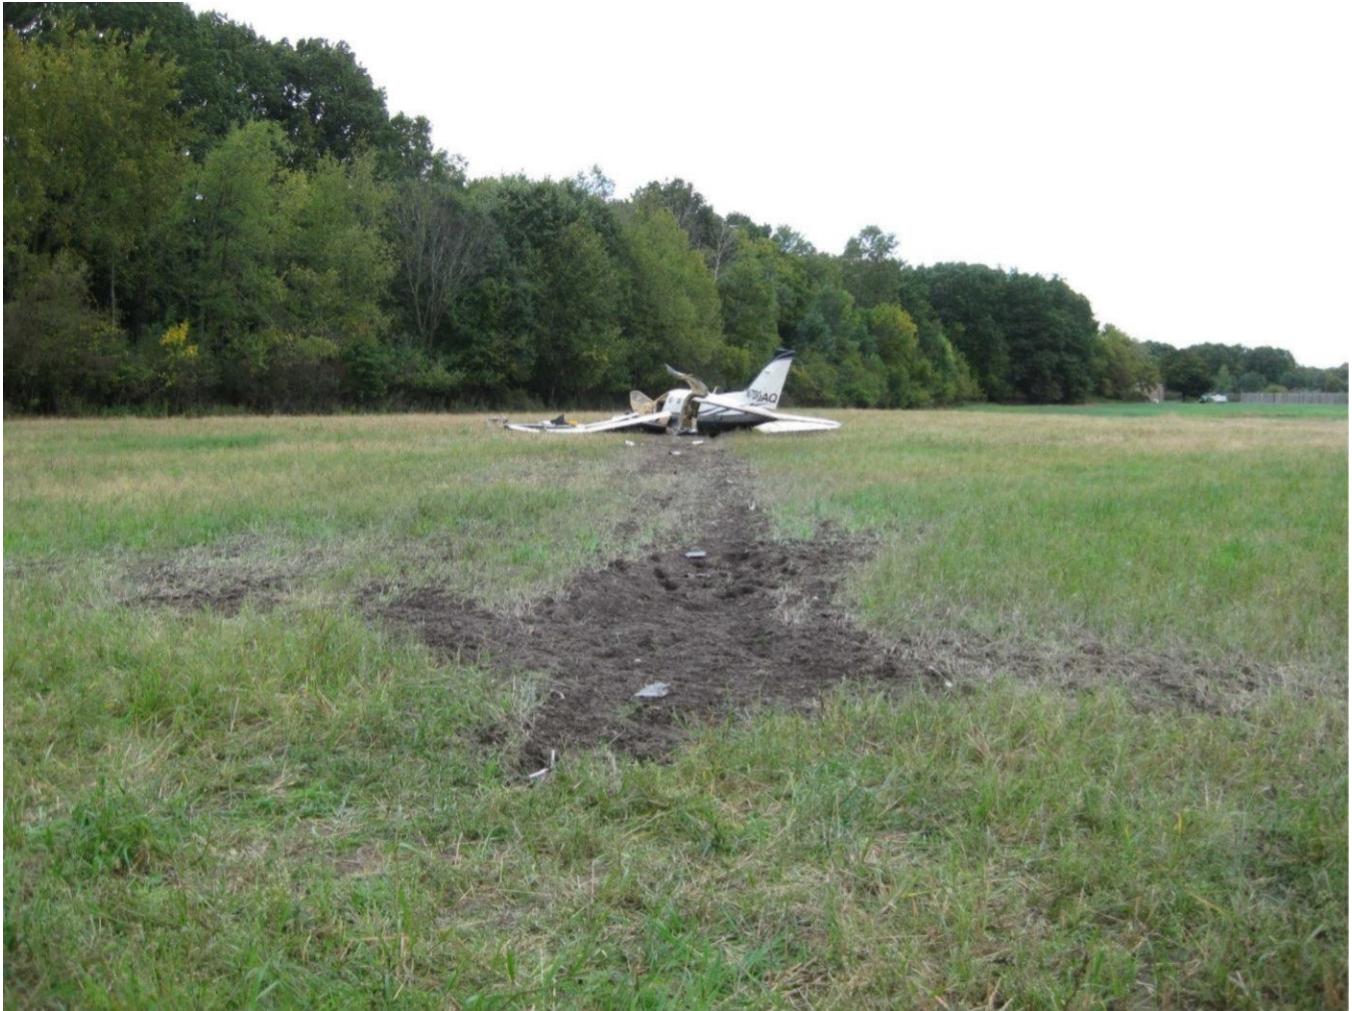
The accident site was in an open grass field located about 0.3 miles west-northwest of the runway 10R threshold. The initial impact point was in a large, depressed grass area that preceded a 135-ft-long ground scar oriented on a 060° bearing. The initial impact area measured 42 ft wide, consistent with the wingspan of the airplane (figure 5). The lower VHF

antenna, the left main landing gear door, and several flap track fairings were located along the wreckage debris path.

**Figure 5.** Initial impact point and ground scar.

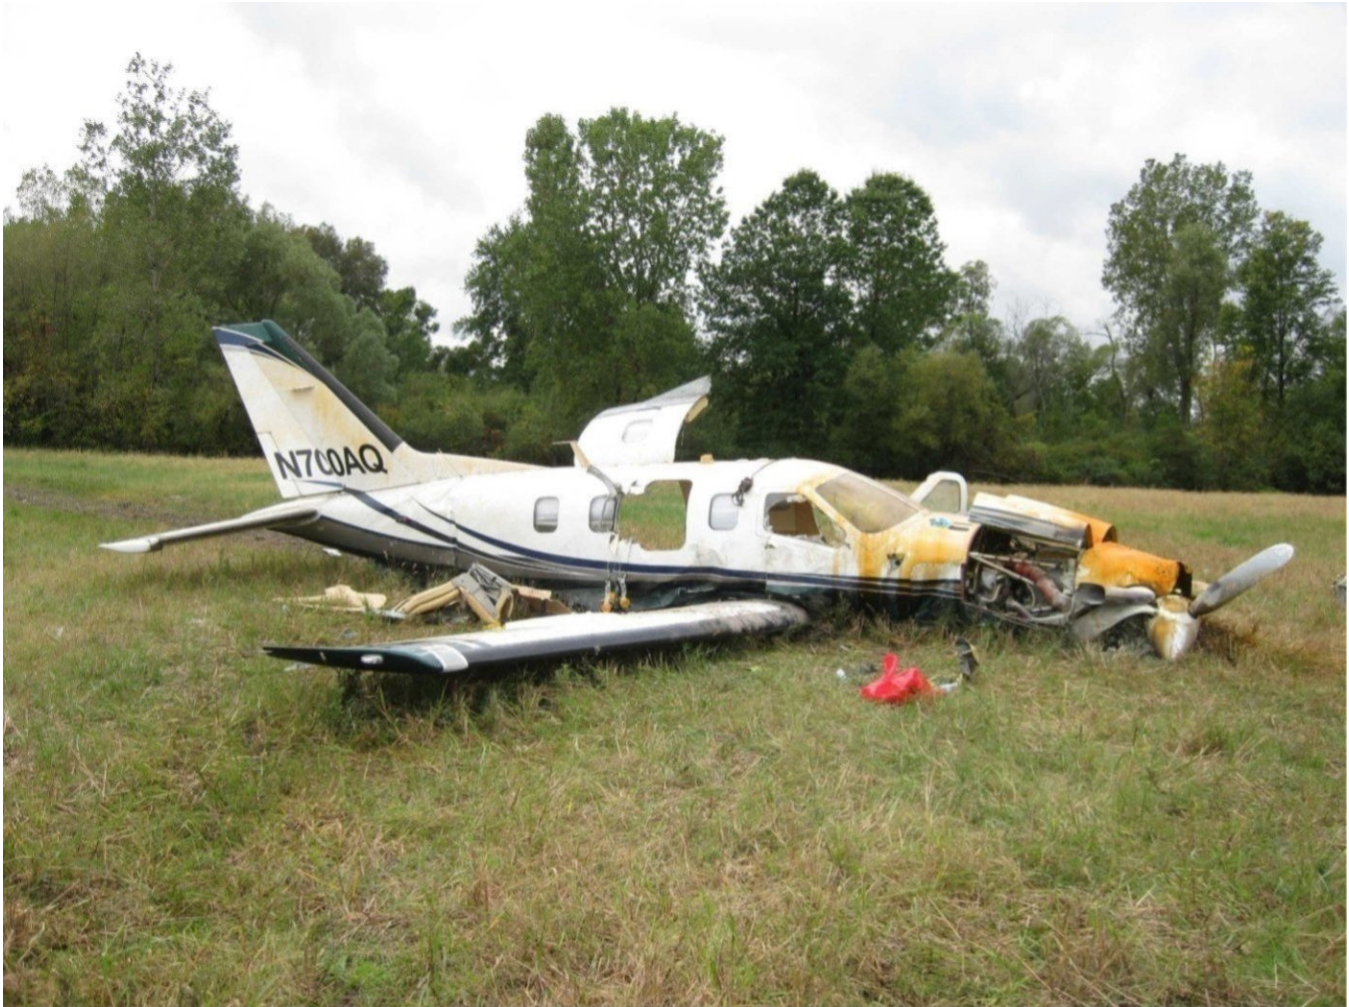
**Figure 6.** Main airplane wreckage.

The main wreckage consisted of the entire airplane (figure 6). Both wings and the empennage remained attached to the fuselage. All flight control surfaces remained attached to their respective hinges. Flight control continuity for the elevator, rudder, and right aileron were confirmed from each flight control surface to the forward cabin. Flight control continuity to the left aileron could not be established due to impact damage; the observed cable separations near the left wing root were consistent with overstress. Both spoilers were retracted and remained connected to their respective ailerons. Both the rudder and elevator trim surfaces were found in their neutral positions.

The flap selector was found in the up and locked position. The wing flap actuator jack screws were found about halfway between the takeoff and landing positions. The landing gear selector switch was found in the gear-up position. The left main landing gear and nose gear were fully retracted and on their respective actuator uplocks. The right main landing gear was retracted into its wheel well, but the right gear was not secured by its respective actuator uplock.

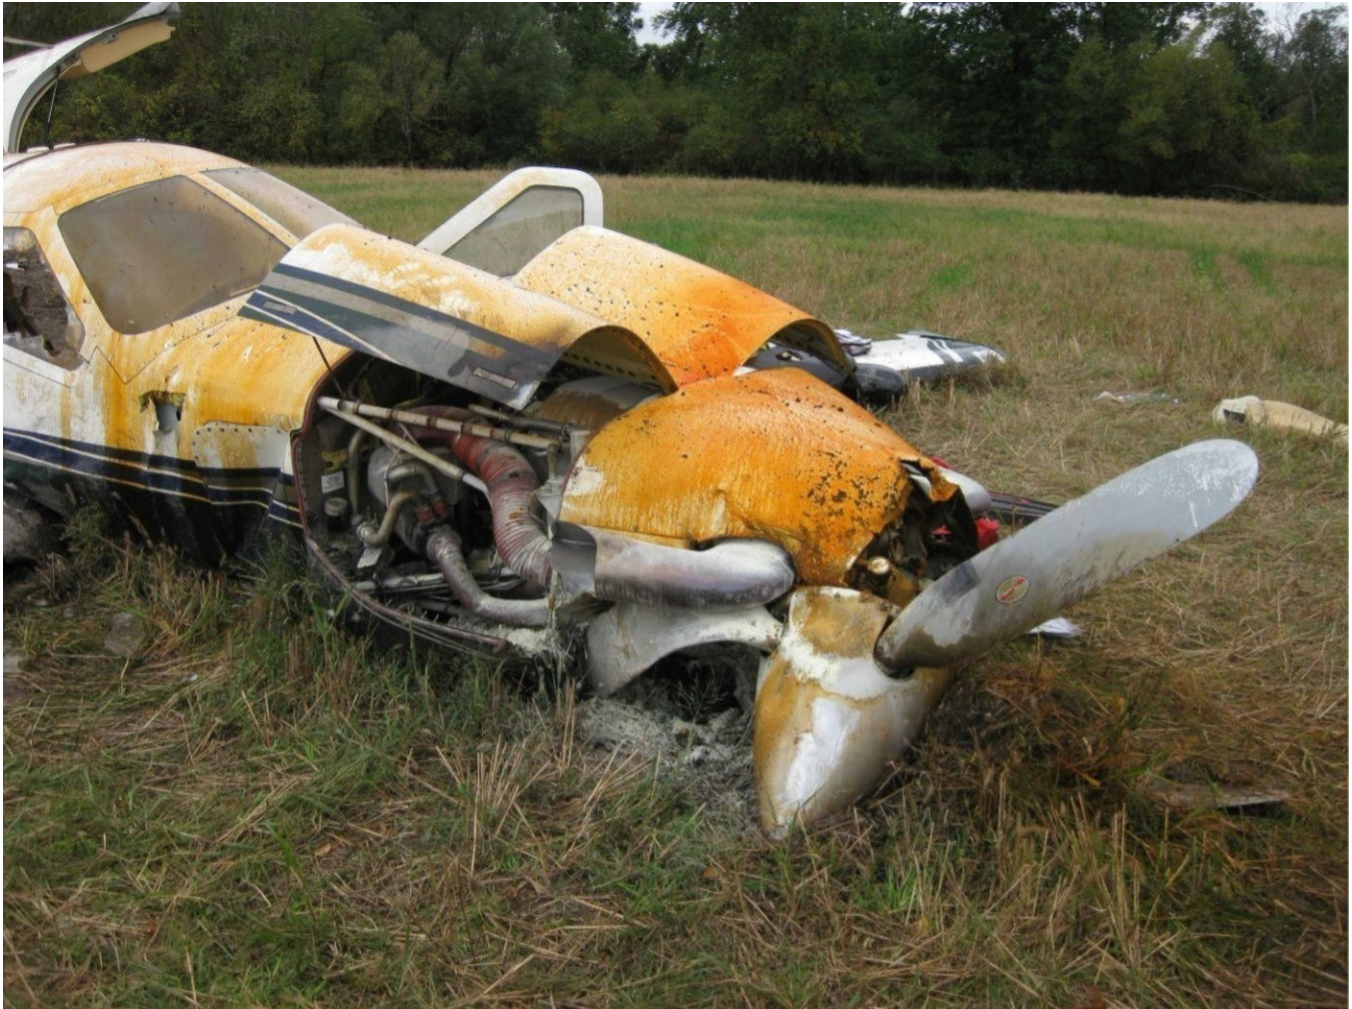
The engine remained attached to its respective engine mounts. There was a complete fracture of the propeller shaft and reduction gearbox housing forward of the 2nd stage reduction gears. There was evidence that engine oil was discharged out of the engine after impact; engine oil was found on the outside of the engine cowling, windscreen, and extending 20 ft in front of the engine (Figure 7). There was compressive impact damage to the exhaust case at the 6 o'clock position. Engine control continuity was established from the cockpit to the fuel control unit. The propeller speed setting lever and reset cables were found separated from the propeller governor, but these cables moved freely when the associated cockpit levers were moved by hand. The compressor rotor turned freely with no anomalies and had continuity with the accessory gearbox. Fuel discharged from hoses when the fuel pump was rotated. The fuel filter bowl was about one-half full, and the fuel appeared clear with no significant debris or phase separation. Both magnetic chip detectors were free of any metallic particles. Some minor foreign object debris was found on the leading edge of several first-stage compressor blades and vegetation debris in the inlet screen.

**Figure 7.** Overview Photo of the Engine and Propeller at Accident Site

The propeller assembly remained attached to the engine propeller shaft that fractured from the engine reduction gear box during impact. One propeller blade was bent in the forward/thrust direction. The remaining three propeller blades were bent in the aft direction. All four propeller blades exhibited chordwise/rotational scoring on the camber side with paint discoloration from the tip to the outboard end of the deice boot. Three blades exhibited chordwise/rotational scoring on the face side. The spinner dome was dented adjacent to one propeller blade with a counterweight impression area with the center/average angle of about  $44^\circ$ . The pitch change rod was in the feathered position. Three propeller blades could be rotated by hand force due to fractured pitch change mechanisms. One propeller blade had been forcefully rotated beyond the reverse stop position, two blades were in a low-pitch position, and one blade was in a feathered position. The beta ring appeared intact and undamaged with the carbon block and beta arm in position. The beta arm and valve moved freely.
