Aviation Investigation Final Report

Location:	Lansing, Michigan	Accident Number:	CEN20FA001
Date & Time:	October 3, 2019, 08:58 Local	Registration:	N700AQ
Aircraft:	Socata TBM 700	Aircraft Damage:	Substantial
Defining Event:	Loss of control in flight	Injuries:	5 Fatal, 1 Serious
Flight Conducted Under:	Part 91: General aviation - Business

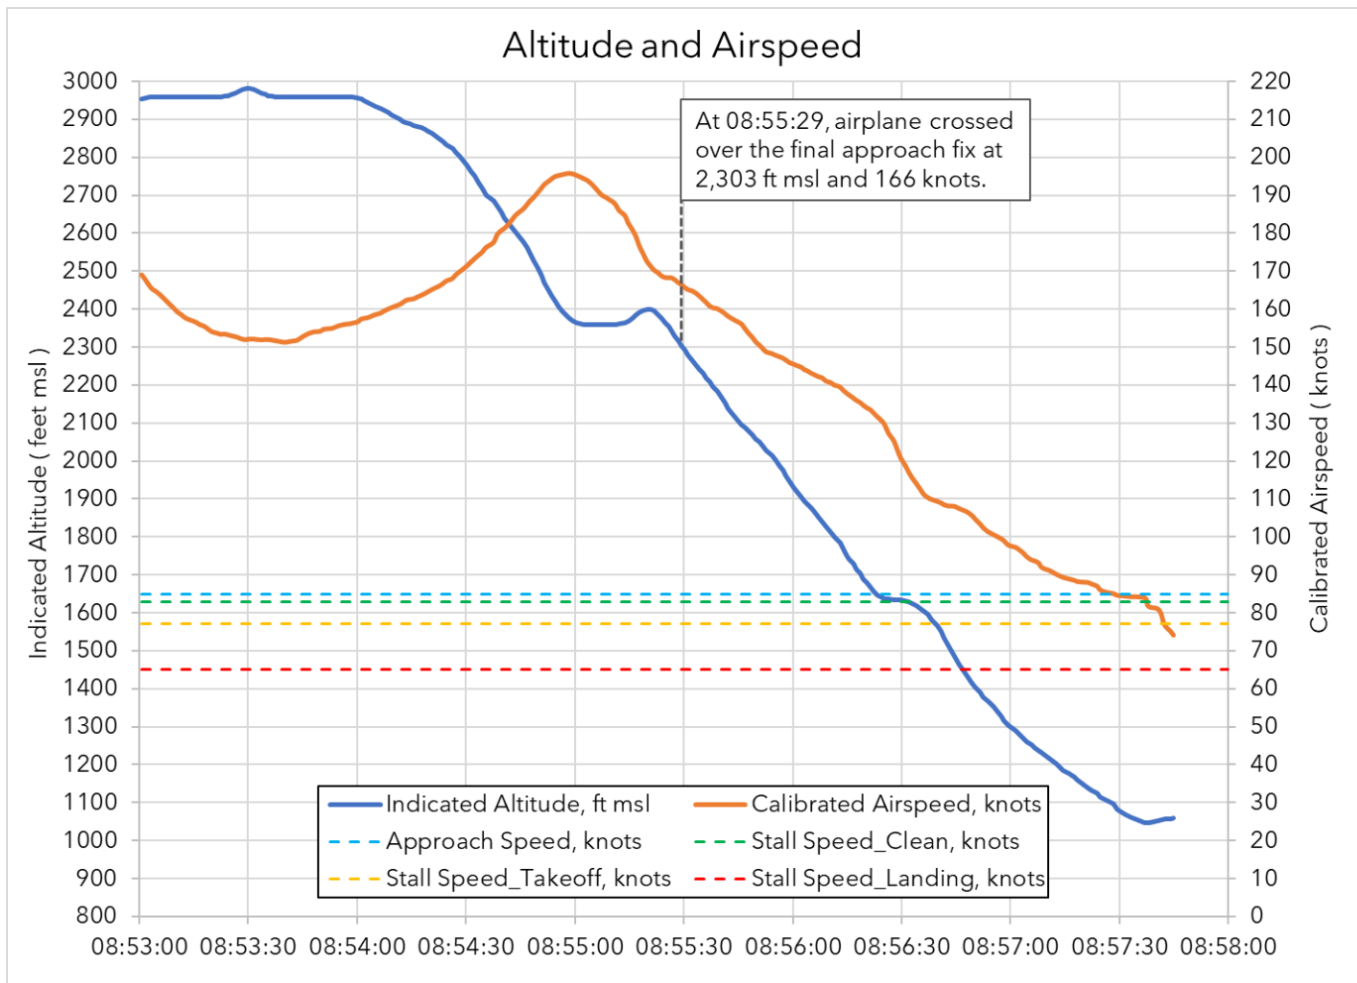
Figure 1. Altitude and airspeed during instrument approach.

At 0854:27, the approach controller stated, "TBM zero alpha quebec, contact Lansing tower one one niner point niner, good day." The pilot responded, "One nineteen ninety, seven hundred alpha quebec." At 0855:29, the airplane crossed over FAMLI at 2,303 ft msl and continued to descend on the glideslope while established inbound on the localizer toward runway 10R. The airplane had a calculated calibrated airspeed of 166 knots when it crossed over the final approach fix. Between 0855:29 and 0857:45, while inbound on the instrument approach, the airplane continued to decelerate from 166 knots to 74 knots, as shown in figure 1.

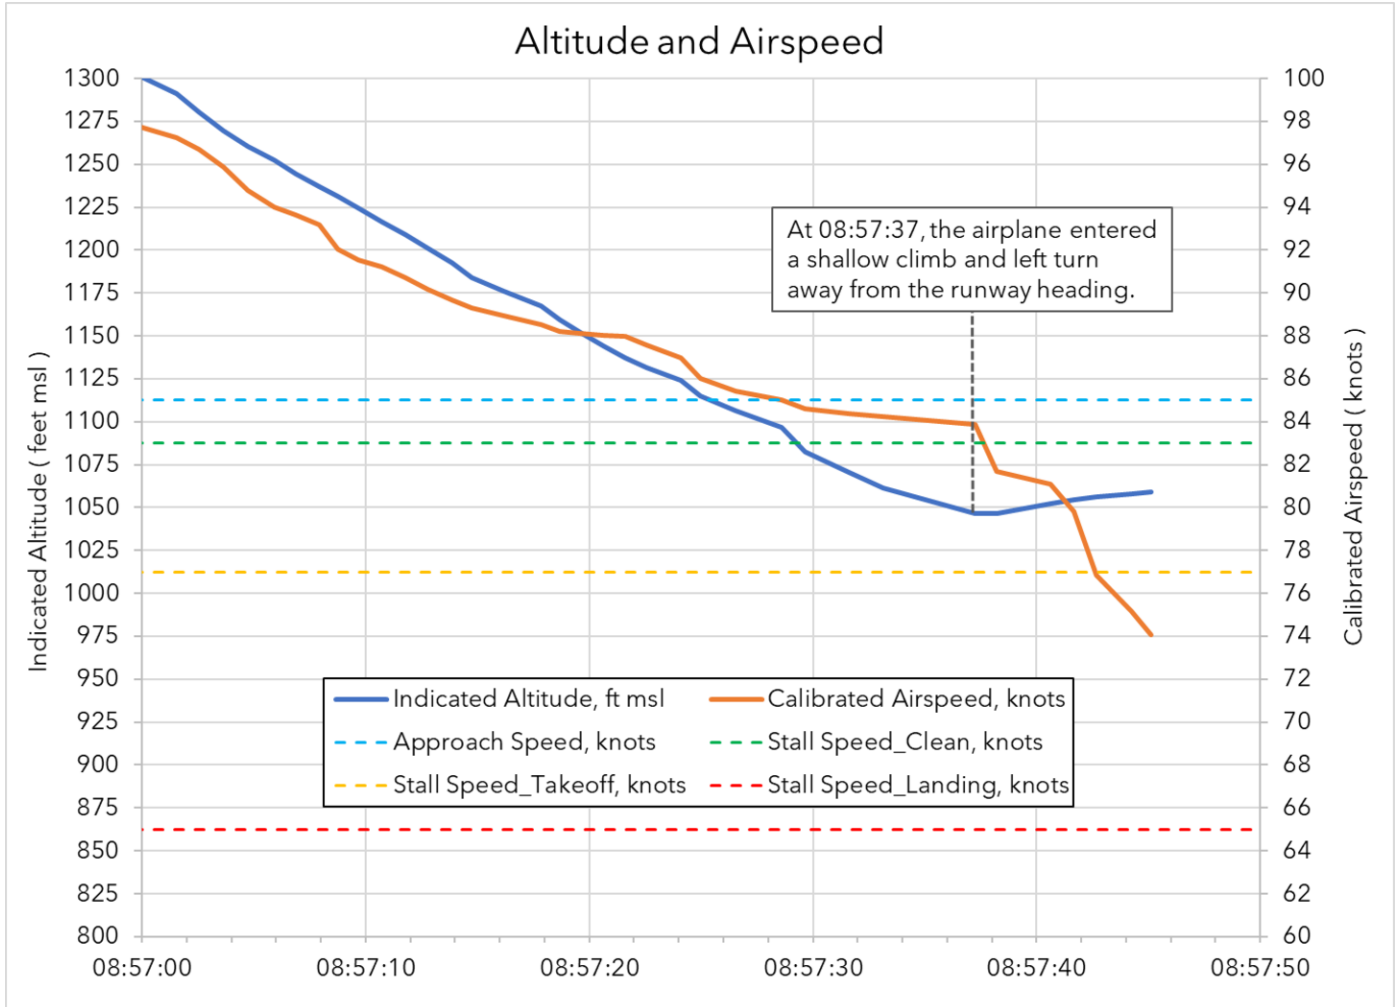
Figure 2. Altitude and airspeed during final approach.

The altitude and airspeed trends during the final moments of the flight were consistent with the airplane entering an aerodynamic stall at a low altitude. Based on the configuration of the airplane at the accident site, the pilot likely was retracting the landing gear and flaps for a go-around when the airplane entered the aerodynamic stall.

The ADS-B data indicated that at 0857:06 the airplane was about 1.3 miles from the runway threshold at 1,250 ft msl (about 400 ft above the runway elevation) and established on the localizer inbound to the runway. At 0857:37, the airplane was 0.5 miles from the runway threshold at 1,047 ft msl (about 180 ft above the runway elevation) and 84 knots when it entered a shallow climb and left turn away from the runway heading. Between 0857:37 and 0857:45, the airplane climbed to 1,059 ft msl and decelerated to 74 knots, as shown in figure 2. At 0857:45, the final ADS-B datapoint was located about 315 ft north of the localizer centerline and 0.35 miles west of the runway 10R threshold. The final ADS-B datapoint was about 475 ft southwest of the initial impact point with terrain. Figure 3 shows ADS-B position data during the airplane's final approach.

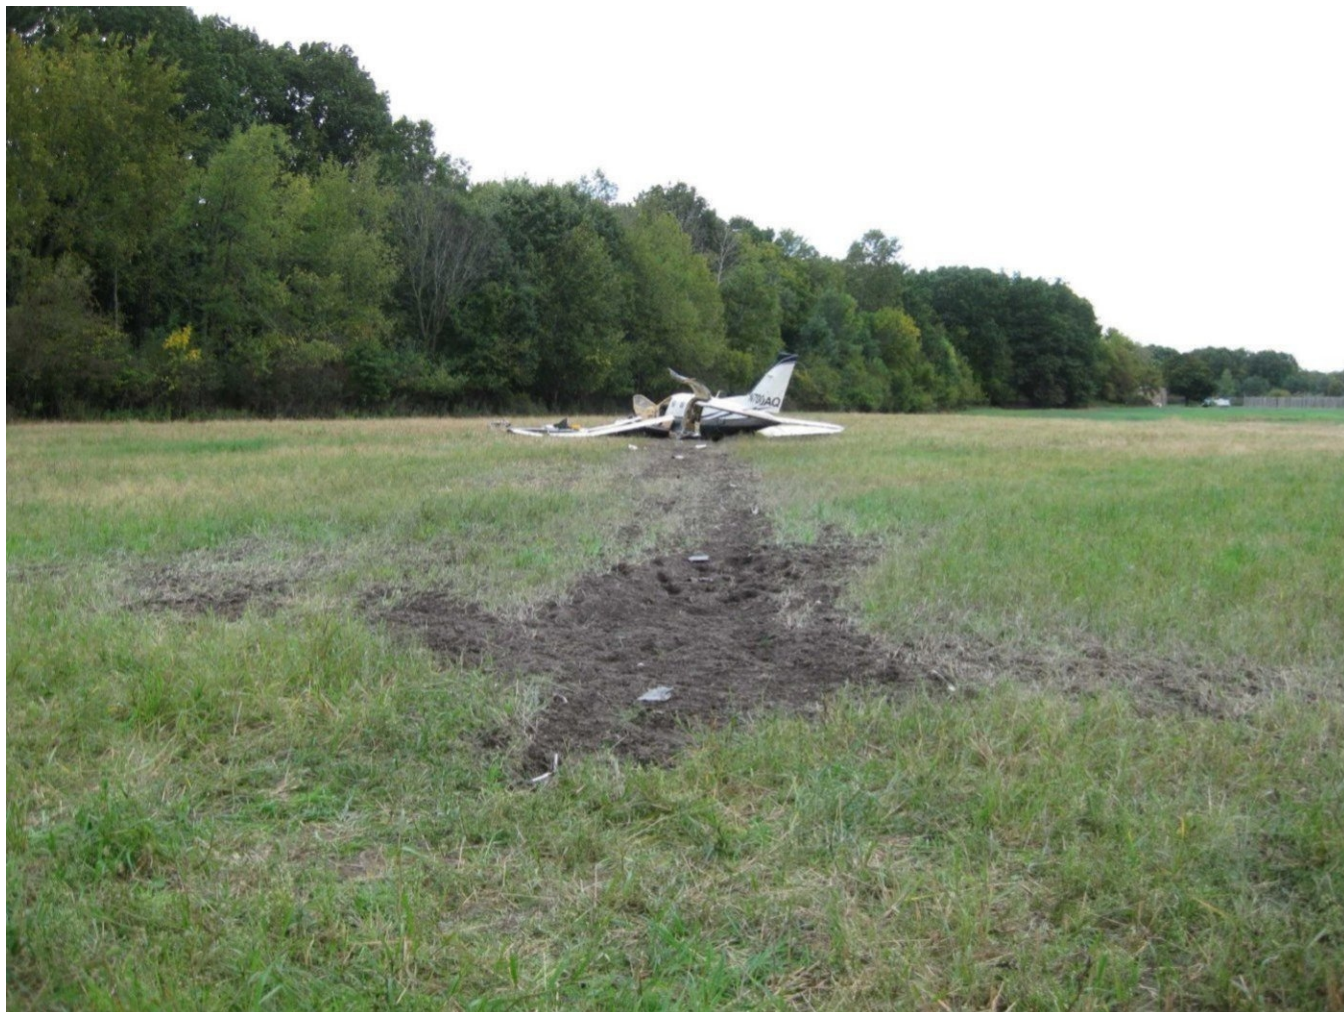
Figure 5. Initial impact point and ground scar.

The accident site was in an open grass field located about 0.3 miles west-northwest of the runway 10R threshold. The initial impact point was in a large, depressed grass area that preceded a 135-ft-long ground scar oriented on a 060° bearing. The initial impact area measured 42 ft wide, consistent with the wingspan of the airplane (figure 5). The lower VHF

antenna, the left main landing gear door, and several flap track fairings were located along the wreckage debris path.

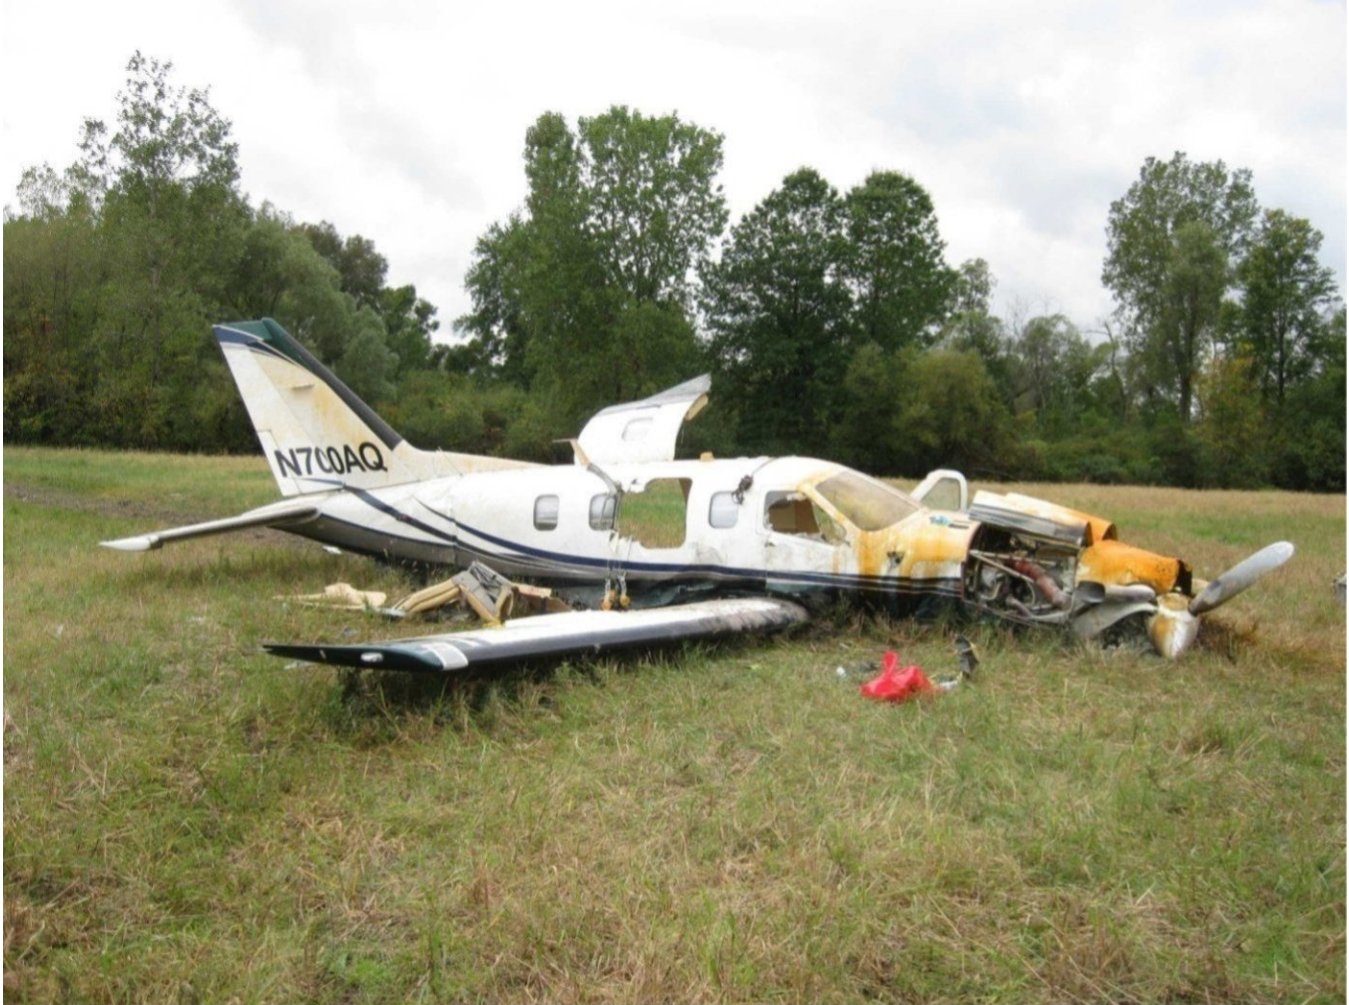
Figure 6. Main airplane wreckage.

The main wreckage consisted of the entire airplane (figure 6). Both wings and the empennage remained attached to the fuselage. All flight control surfaces remained attached to their respective hinges. Flight control continuity for the elevator, rudder, and right aileron were confirmed from each flight control surface to the forward cabin. Flight control continuity to the left aileron could not be established due to impact damage; the observed cable separations near the left wing root were consistent with overstress. Both spoilers were retracted and remained connected to their respective ailerons. Both the rudder and elevator trim surfaces were found in their neutral positions.

The flap selector was found in the up and locked position. The wing flap actuator jack screws were found about halfway between the takeoff and landing positions. The landing gear selector switch was found in the gear-up position. The left main landing gear and nose gear were fully retracted and on their respective actuator uplocks. The right main landing gear was retracted into its wheel well, but the right gear was not secured by its respective actuator uplock.
