# Aviation Investigation Final Report

<b>Location:</b>	Green Bay, Wisconsin	<b>Accident Number:</b>	CEN20FA008
<b>Date &amp; Time:</b>	October 17, 2019, 16:50 Local	<b>Registration:</b>	N82308
<b>Aircraft:</b>	Aeronca 7AC	<b>Aircraft Damage:</b>	Substantial
<b>Defining Event:</b>	Collision during takeoff/land	<b>Injuries:</b>	2 Fatal
<b>Flight Conducted Under:</b>	Part 91: General aviation - Personal

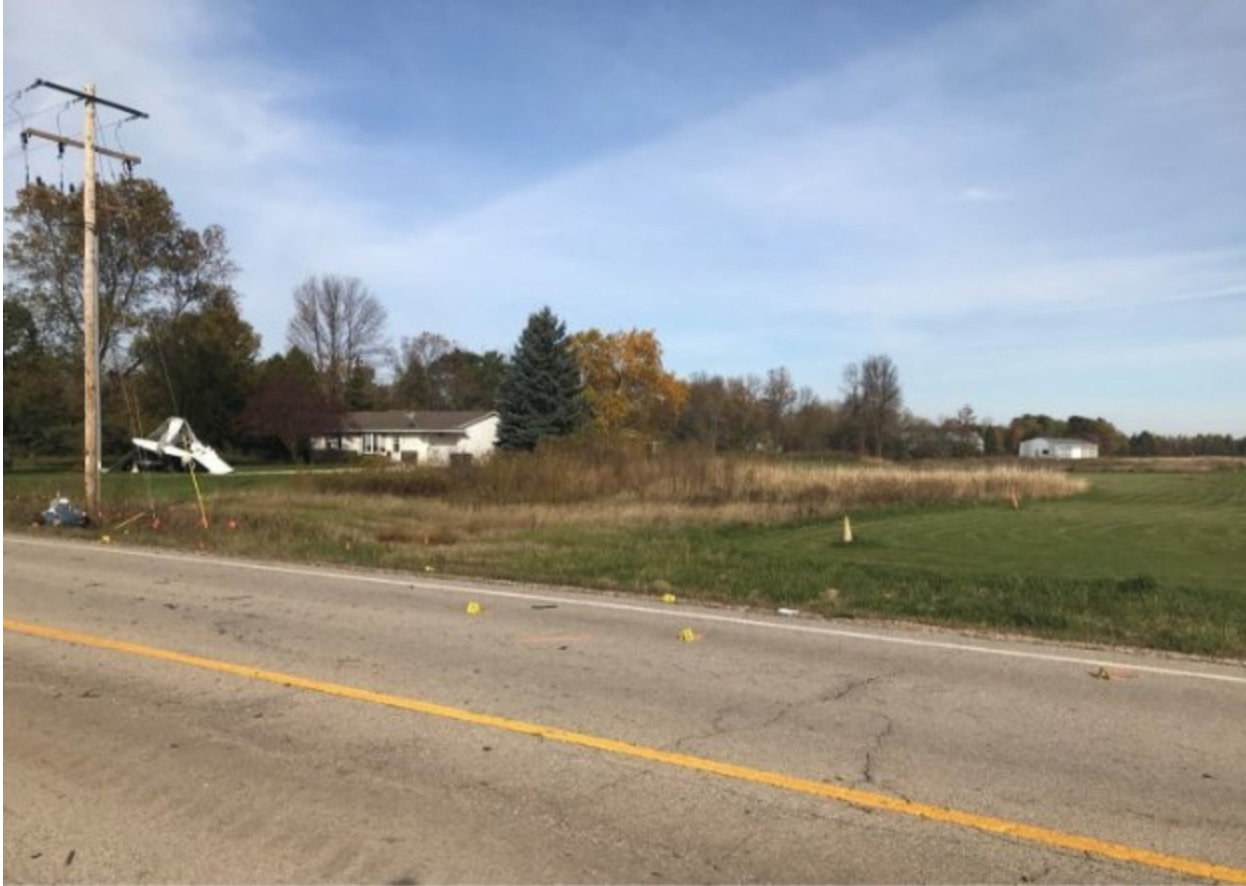
Figure 1. Accident site

According to witnesses in vehicles near the accident location and a vehicle dashboard camera, the airplane was flying north less than 5 ft over the county highway adjacent to the end of runway 1. The airplane impacted the front left side of a westbound truck. The airplane remained on top of the truck after the collision and they both continued off the right side of the road into a ditch, then came to rest in a front yard. Figure 1 shows the main wreckage on the left in front of the house, the grass runway on the far right, and the road in the foreground.

The main wreckage, which comprised the fuselage, wings, and empennage, came to rest on top of the truck, and they both came to rest upright in a front yard. The engine, propeller, engine mount, and cowling were separated from the airplane during the impact sequence and were located in a nearby ditch. The engine assembly came to rest adjacent to a powerline pole.
