Aviation Investigation Final Report

Location:	Angel Fire, New Mexico	Accident Number:	WPR20FA008
Date & Time:	October 20, 2019, 08:45 Local	Registration:	N7742P
Aircraft:	Piper PA 24	Aircraft Damage:	Substantial
Defining Event:	Collision during takeoff/land	Injuries:	2 Fatal
Flight Conducted Under:	Part 91: General aviation - Personal

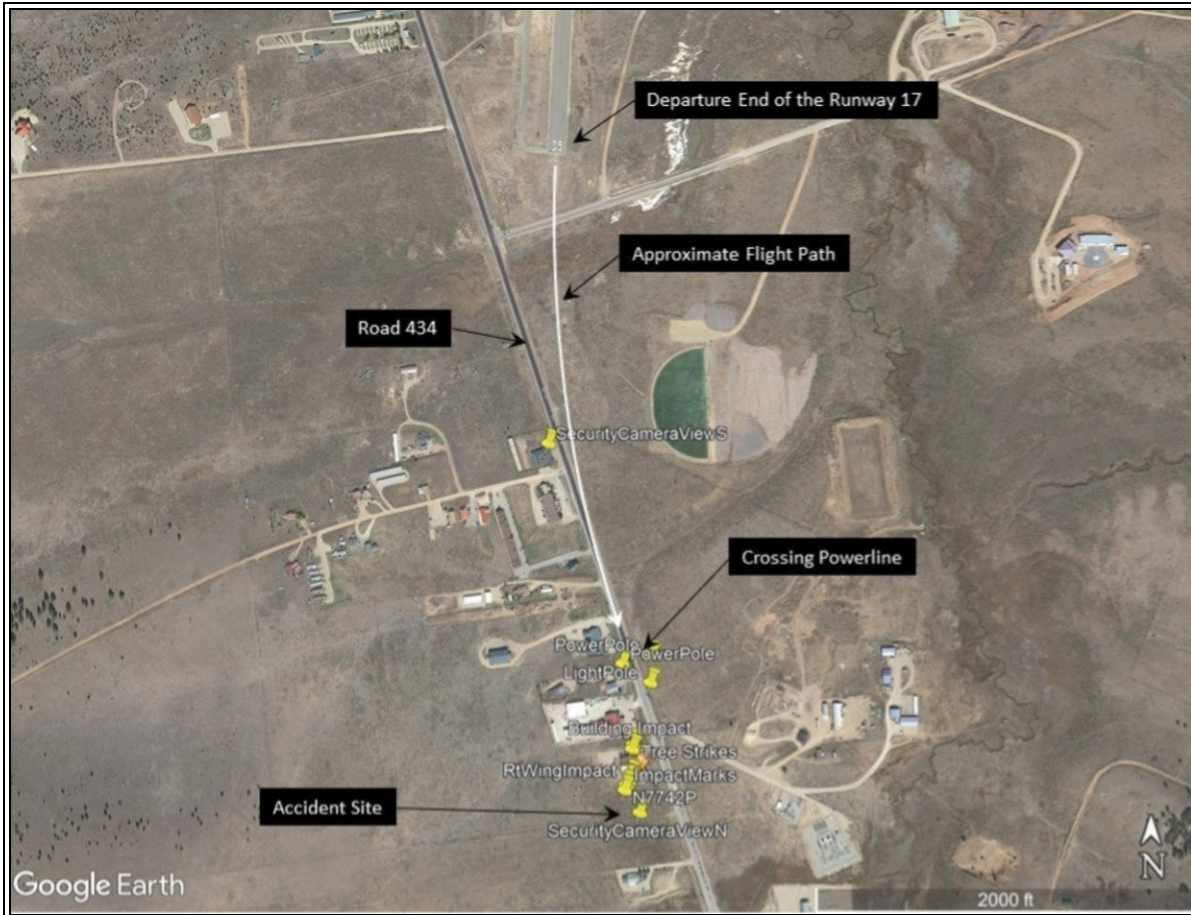
A security camera with a southward view, located at a business between the airport and the accident site, captured the airplane flying overhead about 50 ft above ground level, over the adjacent road. The airplane was flying wings level and the landing gear was extended. As the airplane approached the light poles and power lines in the background, the airplane banked right and traveled behind trees and buildings until it went out of view. Another security camera located near the accident site captured the airplane impacting trees and a building, before cartwheeling to the ground in a nose-down attitude. The airplane's engine was heard producing power in the video. The airplane came to rest in an inverted position and a postaccident fire ensued.

Figure 1-Aerial view of the accident site and approximate flight path.
