Aviation Investigation Final Report

| Location: | Atlanta, Georgia | Incident Number: | DCA201A014 |
| Date & Time: | November 6, 2019, 21:15 Local | Registration: | N117HQ |
| Aircraft: | Embraer ERJ170 | Aircraft Damage: | None |

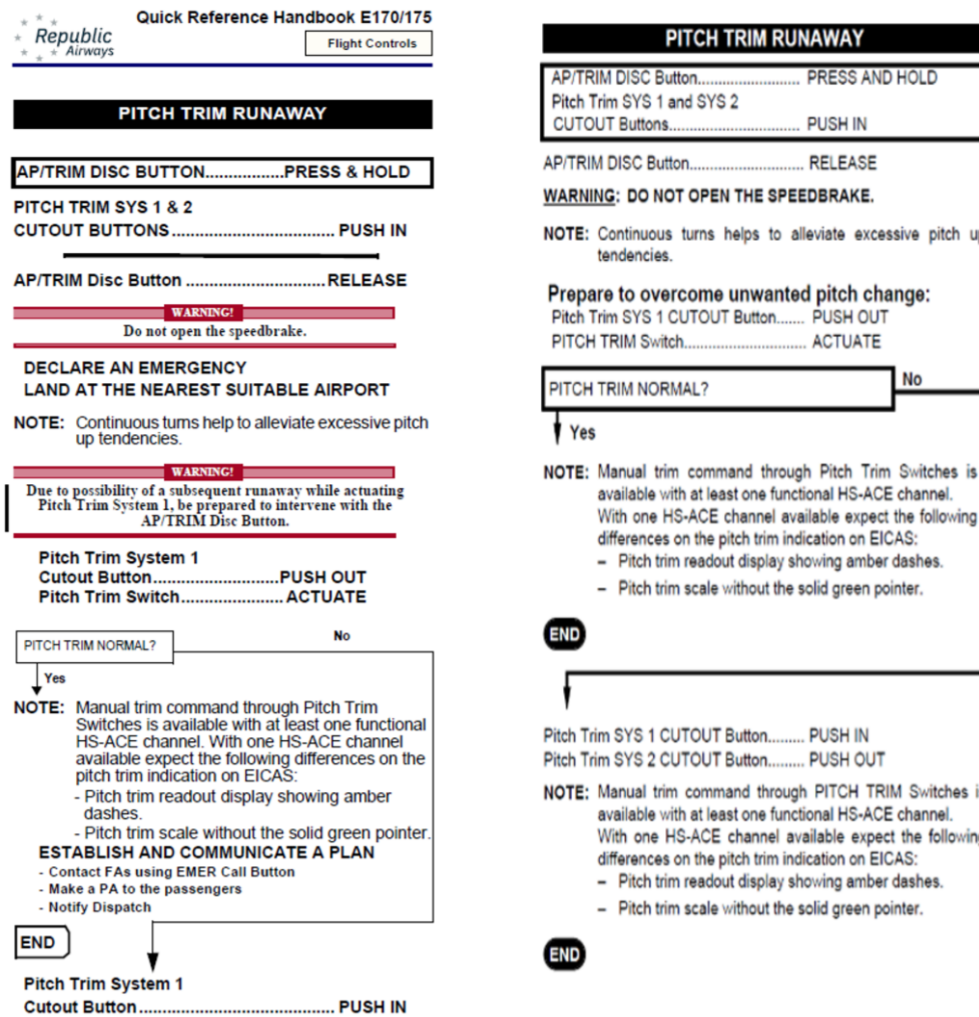
Republic Airways' quick reference handbook had one memory item for a pitch trim runaway: the autopilot/trim disconnect button was required to be pressed in and held. The Embraer 170/175 *Airplane Operations Manual* required two memory items; the autopilot/trim disconnect button

had to be pressed in and held, and both cutout buttons had to be pushed in. Figure 1 compares the two documents and shows other steps to address a pitch trim runaway.

Figure 1. Company and manufacturer pitch trim runaway procedures (Source: Republic Airways and Embraer).

In coordination with the Federal Aviation Administration, Embraer, and US operators, determine if changes to the Embraer EMB-170/175/190/195/Lineage 1000 series airplane Pitch Trim Runaway checklists are required to adequately address all potential trim system failures, and make such changes as necessary. (A-20-6, classified "Open—Acceptable Response" on September 2, 2020)

In coordination with the National Civil Aviation Agency of Brazil, Embraer, and US operators, determine if changes to the Embraer EMB-170/175/190/195/ Lineage 1000 series airplane Pitch Trim Runaway checklists are required to adequately address all potential trim system failures, and make such changes as necessary. (A-20-10, classified “Closed—Acceptable Action” on October 21, 2022)

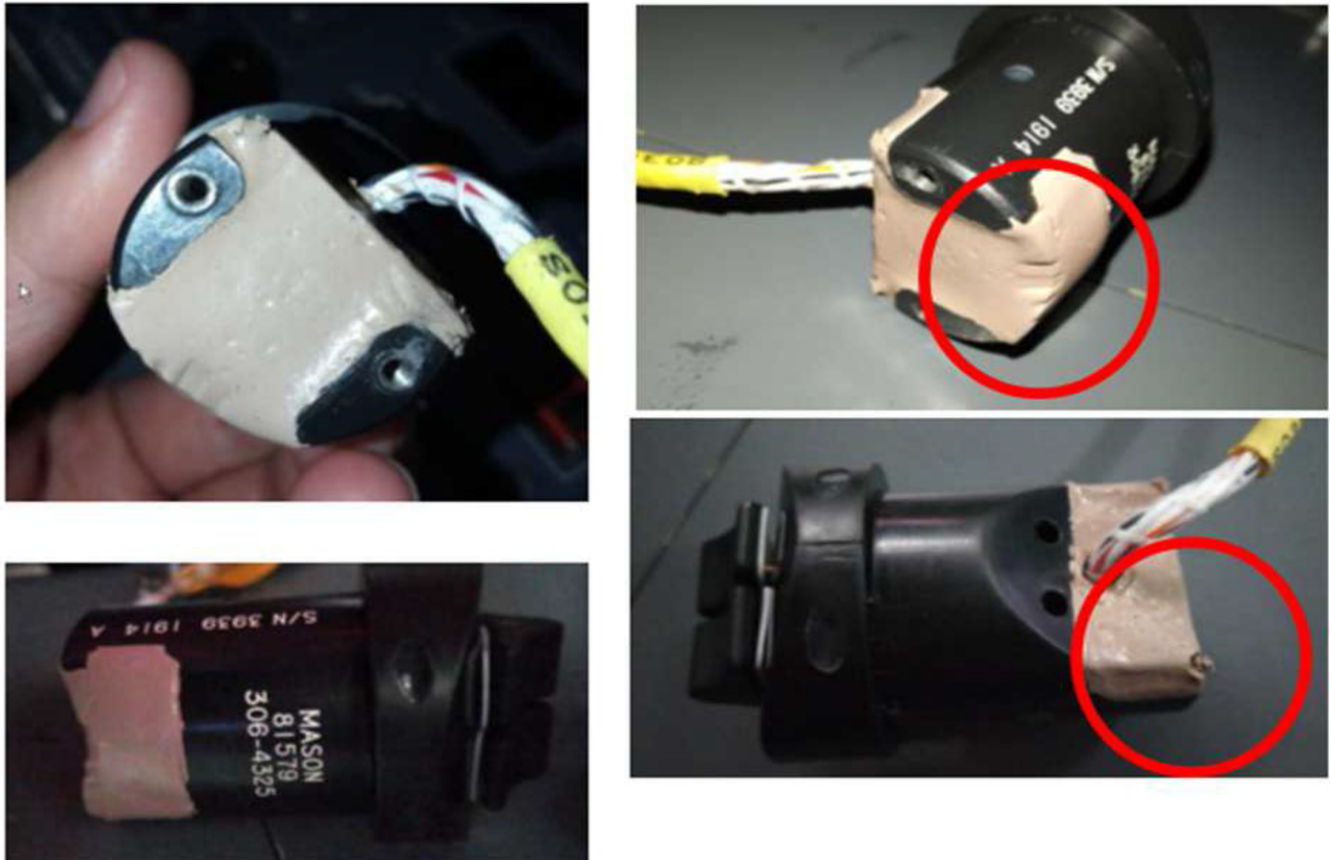
Postincident examination of the captain's pitch trim control switch identified imprint marks on the back of the switch, indicating that, at some point, the switch was installed in an inverted position. The most likely opportunity for this to occur would have been during maintenance after the first flight leg when the pitch trim switch was partially removed then reinstalled since the decision was made to defer maintenance. Since maintenance was deferred, the switch was not functionally tested.

Examination of the pitch trim control switch revealed an imprint mark in the silicone area on the back of the switch, as shown in figure 3. According to Embraer, this mark was caused by contact against a spring and was consistent with the switch being installed inverted at some point.

Figure 3. Captain-side pitch trim control switch after removal from the incident airplane (Source: Republic Airways).

Note: The red circles show the location of the imprint marks on the back of the control switch.

Embraer issued Service Bulletins (SBs) 170-27-0051, 190-27-0039, and 190LIN-27-0019 in February 2015 after reports about inverted pitch trim switches. The SBs recommended the installation of a support in the control yoke within the next 7,500 flight hours or 36 months after the SB's issuance (whichever occurred first). However, the SB 170-27-0051 had not been accomplished on the incident airplane. If the SB had been accomplished, the recommended support in the control yoke would have prevented the faulty installation.

Embraer released Service Bulletin (SB) 170-27- 0051 on February 27, 2015, to alert operators of the possibility that the pitch trim switch could be installed inverted. The SB recommended the installation of a support in the control yoke to prevent the incorrect installation of the switch. The SB compliance time was 7,500 hours or 36 months, whichever occurred first. This SB had not been performed on the airplane before the incident.
