# Aviation Investigation Final Report

<b>Location:</b>	Atlanta, Georgia	<b>Incident Number:</b>	DCA201A014
<b>Date &amp; Time:</b>	November 6, 2019, 21:15 Local	<b>Registration:</b>	N117HQ
<b>Aircraft:</b>	Embraer ERJ170	<b>Aircraft Damage:</b>	None
<b>Defining Event:</b>	Loss of control in flight	<b>Injuries:</b>	9 None
<b>Flight Conducted Under:</b>	Part 121: Air carrier - Scheduled

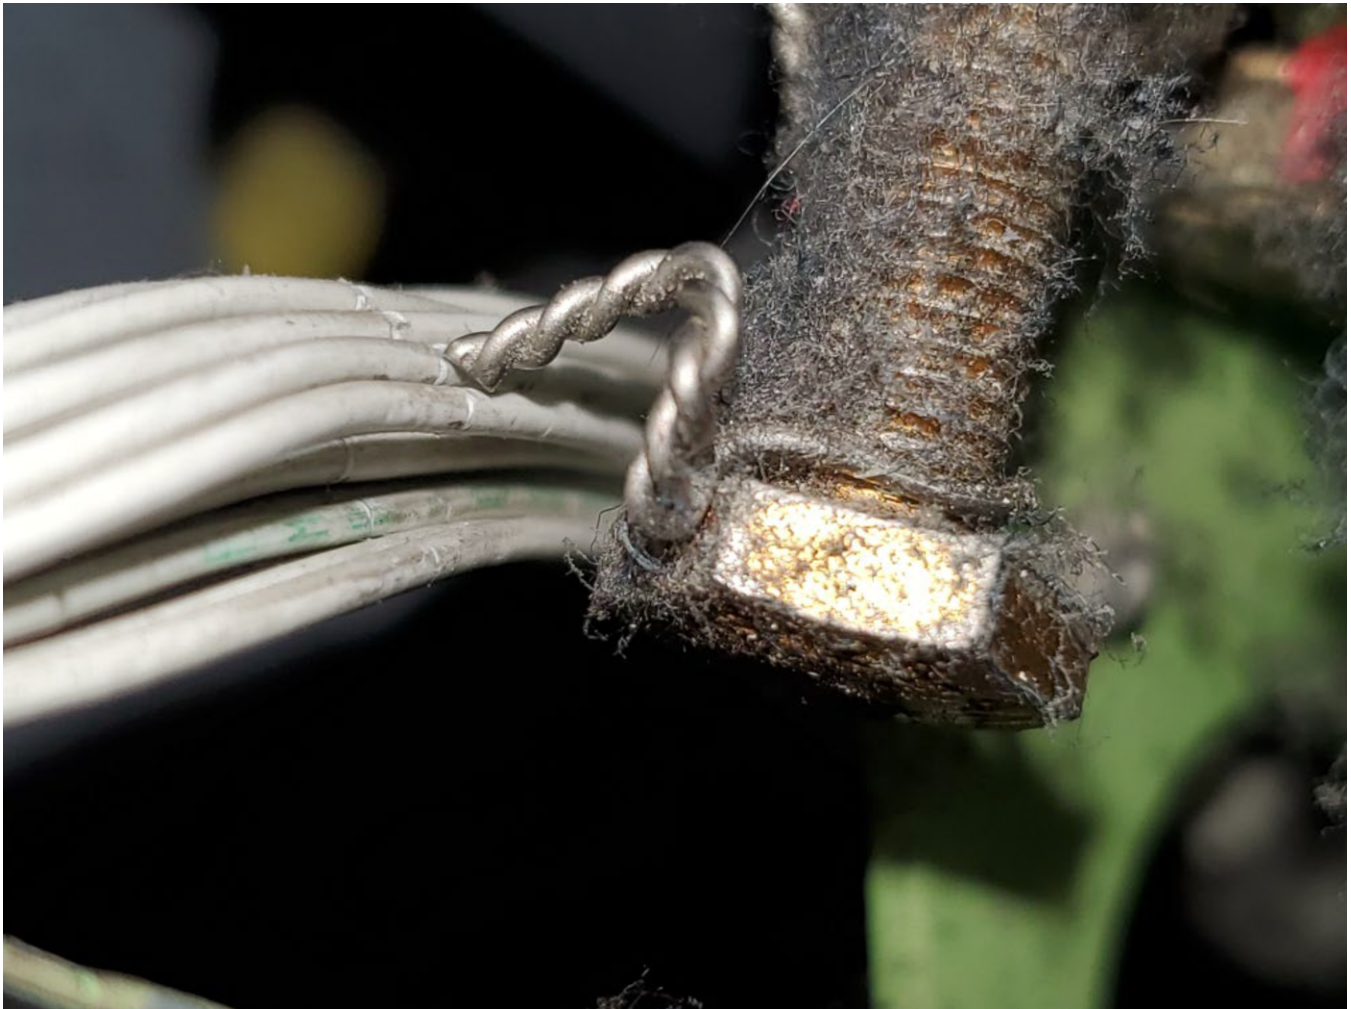
Although both wires enabling the captain's pitch trim switch trim-up command were damaged and chafed and were capable of allowing continuity to the untucked safety wire pigtail (which would result in a short to ground condition), it is unlikely that the pigtail would have made continuity to both wires at the same time. Both wires would need to short to ground simultaneously to allow the stabilizer trim to activate. If both wires shorted to ground, the

horizontal stabilizer control surface movement would automatically stop after three seconds, and if the condition persisted the aural alert "TRIM" would annunciate. This alert was not reported by the crew.

Postincident examination of the area near the captain's control column revealed wires with chafed insulation. These wires connected the horizontal stabilizer actuator control electronics to the captain's pitch trim switch and autopilot/trim disconnect button. The wires contacted an incorrectly tucked pigtail on the safety wire retaining the captain's control column forward mechanical stop bolt, as shown in in figure 2.

**Figure 2.** Bolt with pigtail contacting wires (Source: Republic Airways).

Subsequent laboratory testing revealed that the insulation for three wires (the captain's quick disconnect switch, the captain's nose-up trim switch A, and the captain's nose-up trim switch B) was damaged but that continuity to the internal wire strands could be achieved. Specifically, the quick disconnect switch wire insulation was damaged completely around the wire strands, and multiple exposed wire strands were severed. The nose-up trim switch A wire insulation was chafed, and a small section of exposed conducting wire showed signs of mechanical scraping. The nose-up trim switch B wire insulation was chafed and damaged, and the conducting wire strands were not visible. Continuity was achieved by using both a cotton swab soaked in soapy

water placed on the damage area as well as a sample piece of cut safety wire pressed lightly on the damaged area. No evidence of arcing was observed.

Require Embraer to develop instructions for operators of Embraer EMB-170/175/190/195/Lineage 1000 series airplanes to inspect the wiring in the captain’s and first officer’s control columns for damage, replace where needed, and ensure proper clearance from adjacent components, including the forward mechanical stop bolt and its safety wire. (A-20-1, classified “Closed—Acceptable Action” on September 2, 2020)

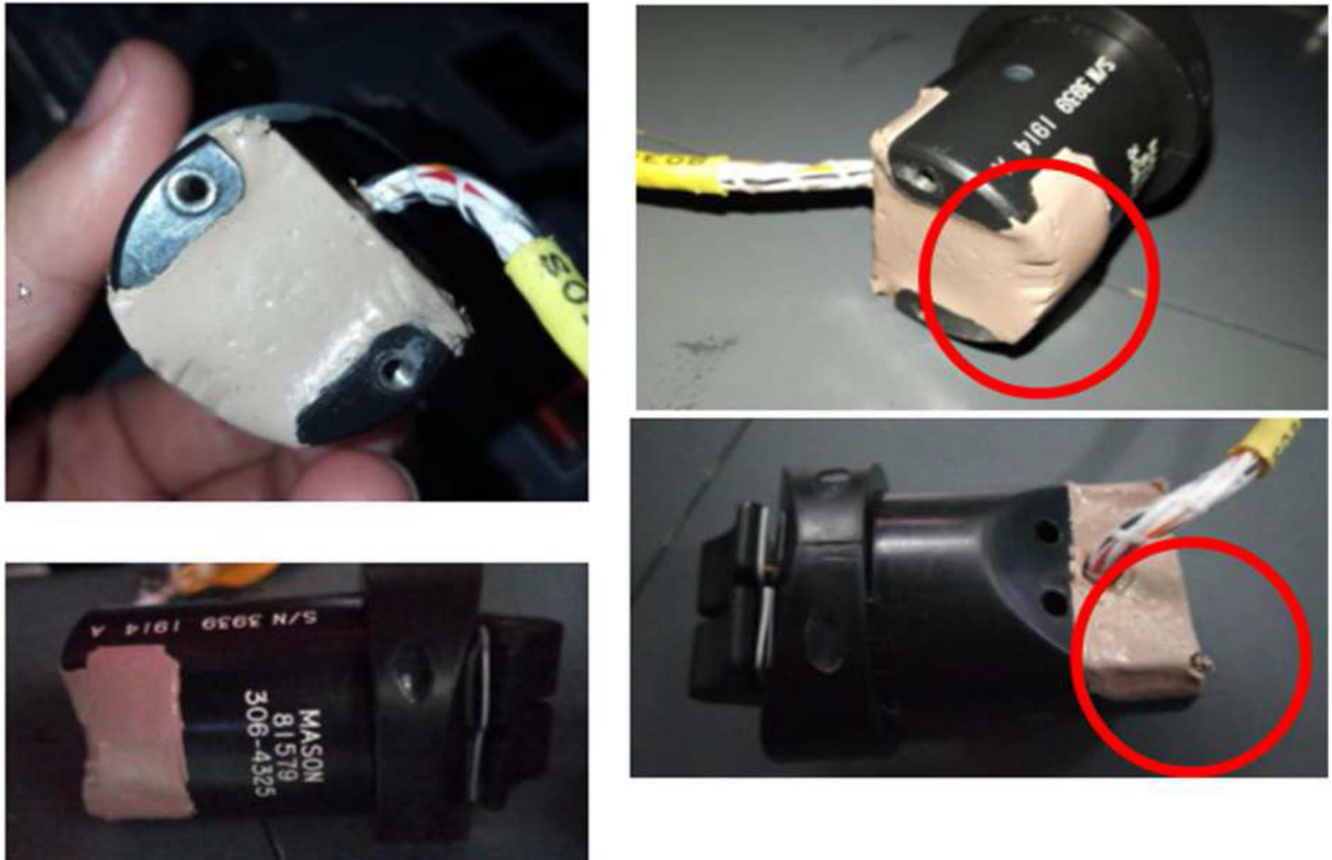
Postincident examination of the captain's pitch trim control switch identified imprint marks on the back of the switch, indicating that, at some point, the switch was installed in an inverted position. The most likely opportunity for this to occur would have been during maintenance after the first flight leg when the pitch trim switch was partially removed then reinstalled since the decision was made to defer maintenance. Since maintenance was deferred, the switch was not functionally tested.

Examination of the pitch trim control switch revealed an imprint mark in the silicone area on the back of the switch, as shown in figure 3. According to Embraer, this mark was caused by contact against a spring and was consistent with the switch being installed inverted at some point.

**Figure 3.** Captain-side pitch trim control switch after removal from the incident airplane (Source: Republic Airways).

Note: The red circles show the location of the imprint marks on the back of the control switch.

Embraer released Service Bulletin (SB) 170-27- 0051 on February 27, 2015, to alert operators of the possibility that the pitch trim switch could be installed inverted. The SB recommended the installation of a support in the control yoke to prevent the incorrect installation of the switch. The SB compliance time was 7,500 hours or 36 months, whichever occurred first. This SB had not been performed on the airplane before the incident.
