Aviation Investigation Final Report

| Location: | Chicago, Illinois | Accident Number: | DCA20LA013 |
| Date & Time: | November 11, 2019, 07:42 Local | Registration: | N619AE |
| Aircraft: | Embraer EMB145 | Aircraft Damage: | Substantial |

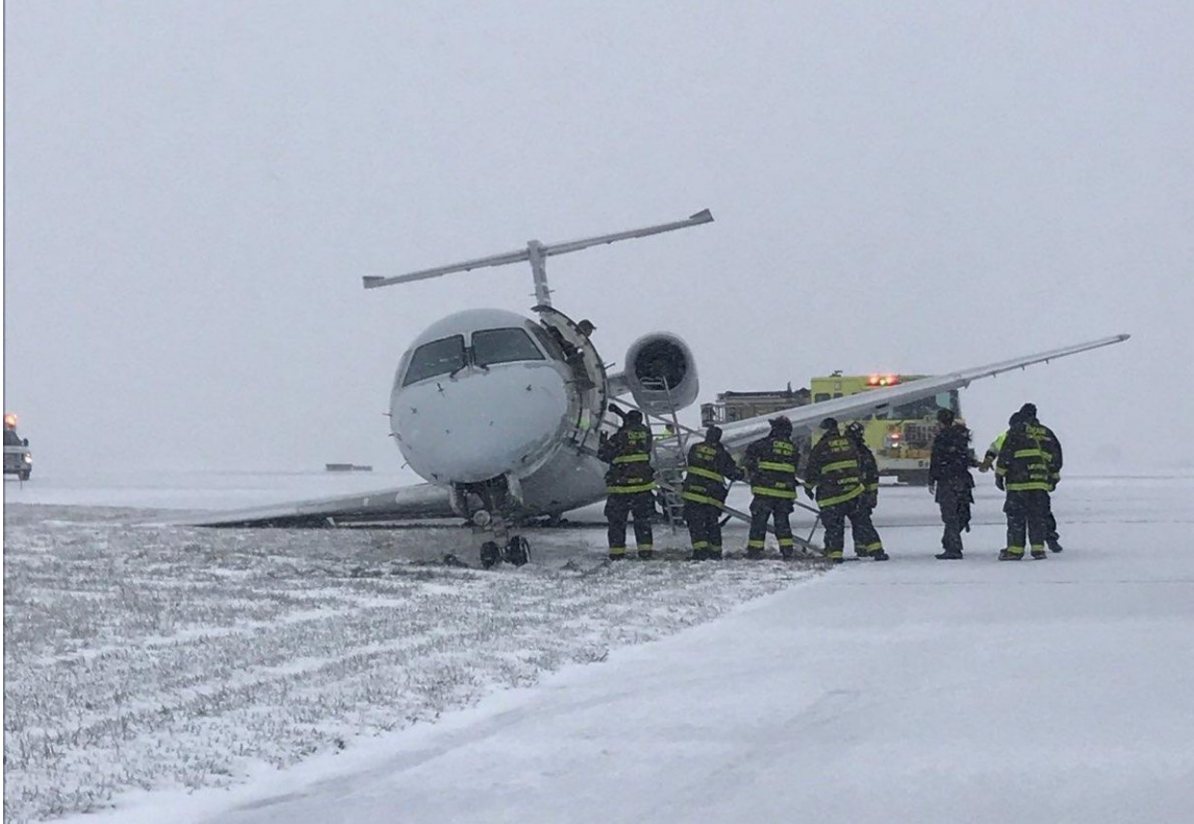
The airplane subsequently slid off the end of the runway and onto the grass on the left side of the runway, as shown in figure 1. The right main gear collapsed when the airplane departed the runway surface and entered the grass area.

Figure 1. Airplane's resting position after runway excursion (Source: Envoy Air).
