Aviation Investigation Final Report

Location:	Los Angeles, California	Incident Number:	DCA201A034
Date & Time:	December 4, 2019, 19:15 Local	Registration:	N71HD
Aircraft:	Airbus AS 350 B2	Aircraft Damage:	Minor
Defining Event:	Midair collision	Injuries:	3 None
Flight Conducted Under:	Part 91: General aviation - Aerial observation

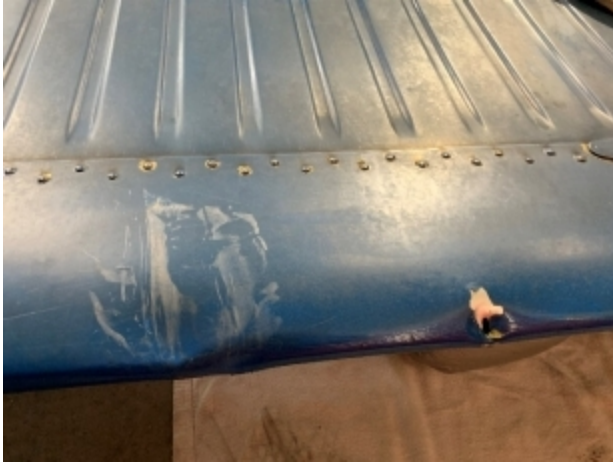
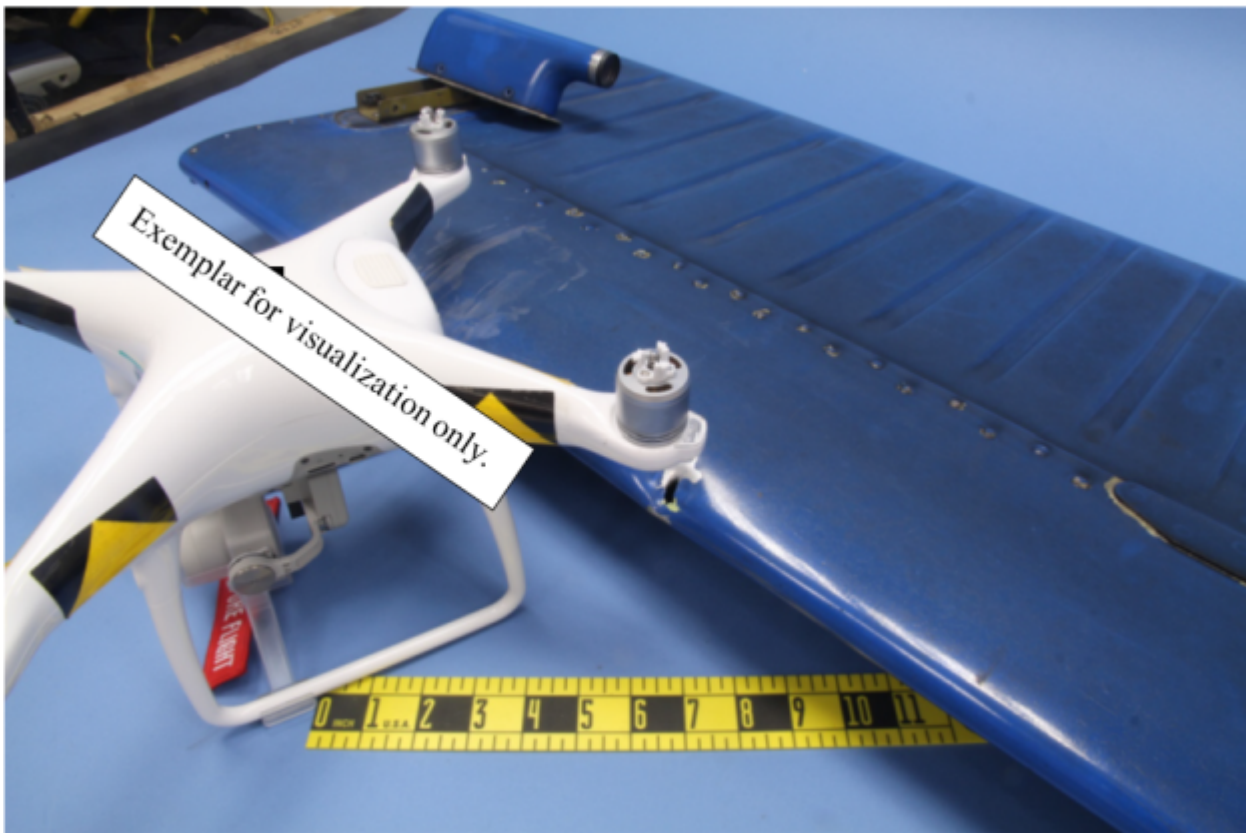
Laboratory examinations indicated that the shape and dimensions of the damage to the horizontal stabilizer were consistent with the configuration and dimensions of many popular small drones. A small mark inside the larger round dent was consistent with the propeller shaft diameter of common small drones.

Infrared examination revealed material transfer of polycarbonate polymer, which is a commonly used construction material of small drones. Although many items which could come in contact with the helicopter as ground FOD, are manufactured of polycarbonate (e.g. safety glasses, light lenses), the shape and configuration of the indentations and scuffs were very consistent with a small drone.

There was a small round dent which partially punctured the leading edge of the horizontal stabilizer. Further dents and scuff marks were approximately 6 to 8 inches outboard of the round dent on the leading edge and along the upper surface. One of the tail rotor blades exhibited a small gouge in the composite surface approximately mid-chord.

Figure 2 – Damage to helicopter

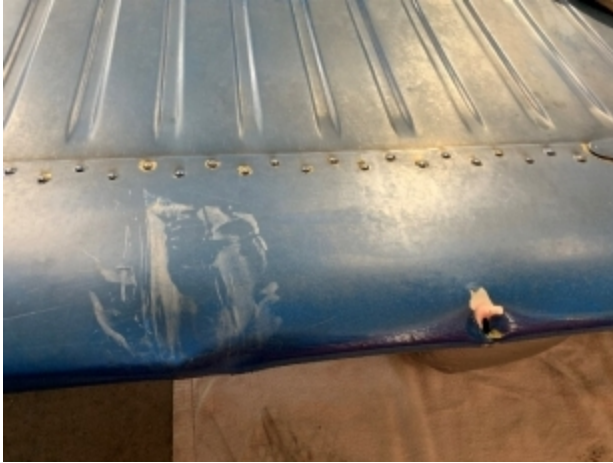
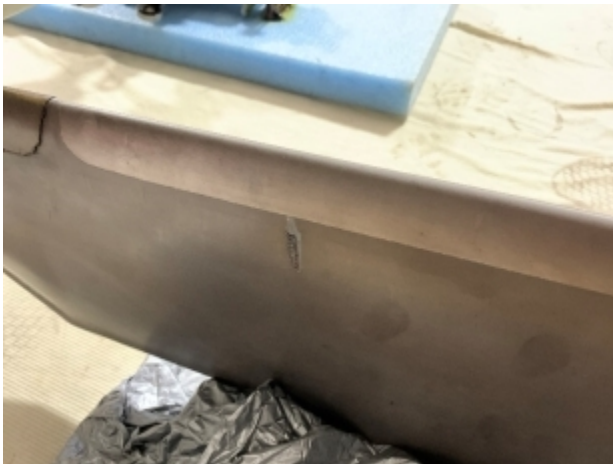
There was a small round dent which partially punctured the leading edge of the horizontal stabilizer. Further dents and scuff marks were approximately 6 to 8 inches outboard of the round dent on the leading edge and along the upper surface. One of the tail rotor blades exhibited a small gouge in the composite surface approximately mid-chord.

Figure 2 – Damage to helicopter

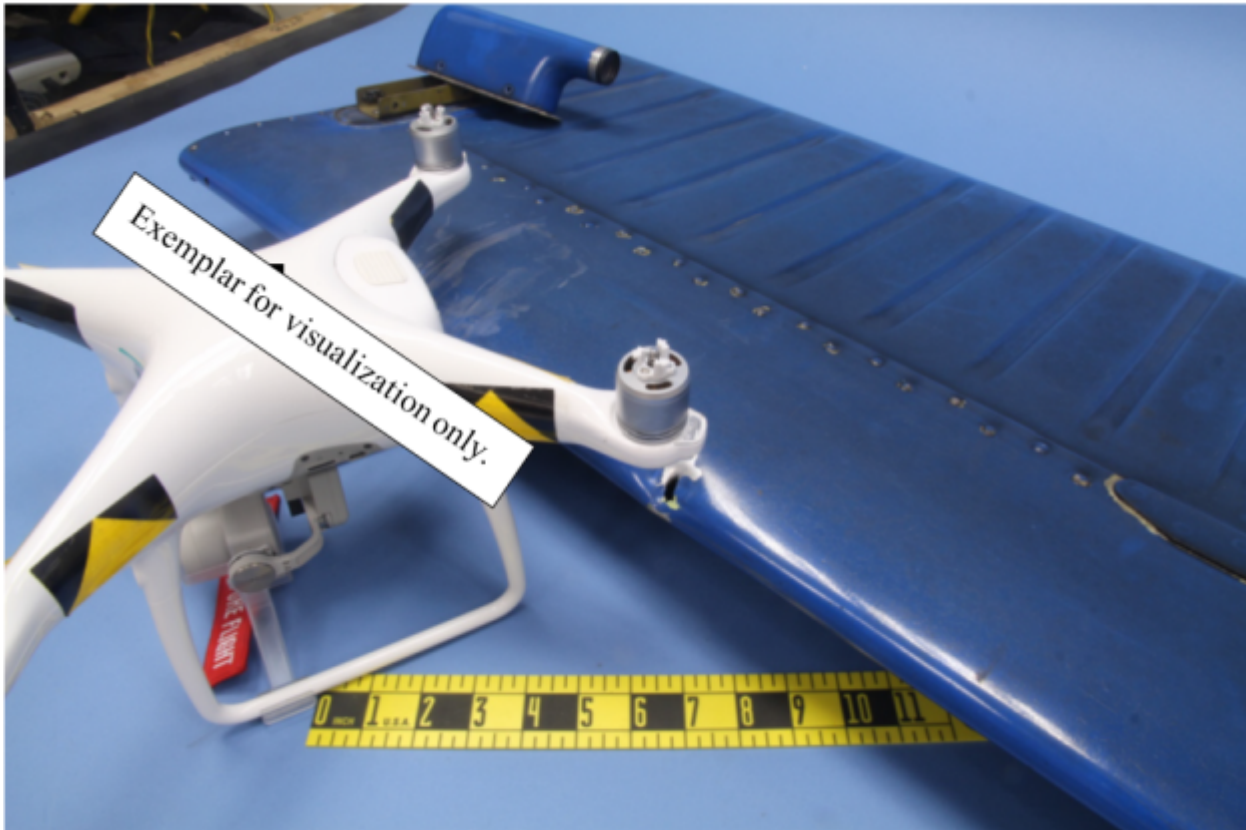
The horizontal stabilizer and tail rotor were sent to the NTSB Materials Laboratory for examination. Visual examination was consistent with an inflight hard-body impact. The dent and scuff marks were compared to the dimensions of common small drones and were consistent with the distance and orientation between the motor and center fuselage/battery compartment (Figure 3).

Figure 3 – Angled view comparing common drone to impact marks. The drone in the photo is an exemplar of a popular drone used to illustrate size comparison. Numerous manufacturers and models of drone fall into this size class. Does not necessarily depict the actual collision object.

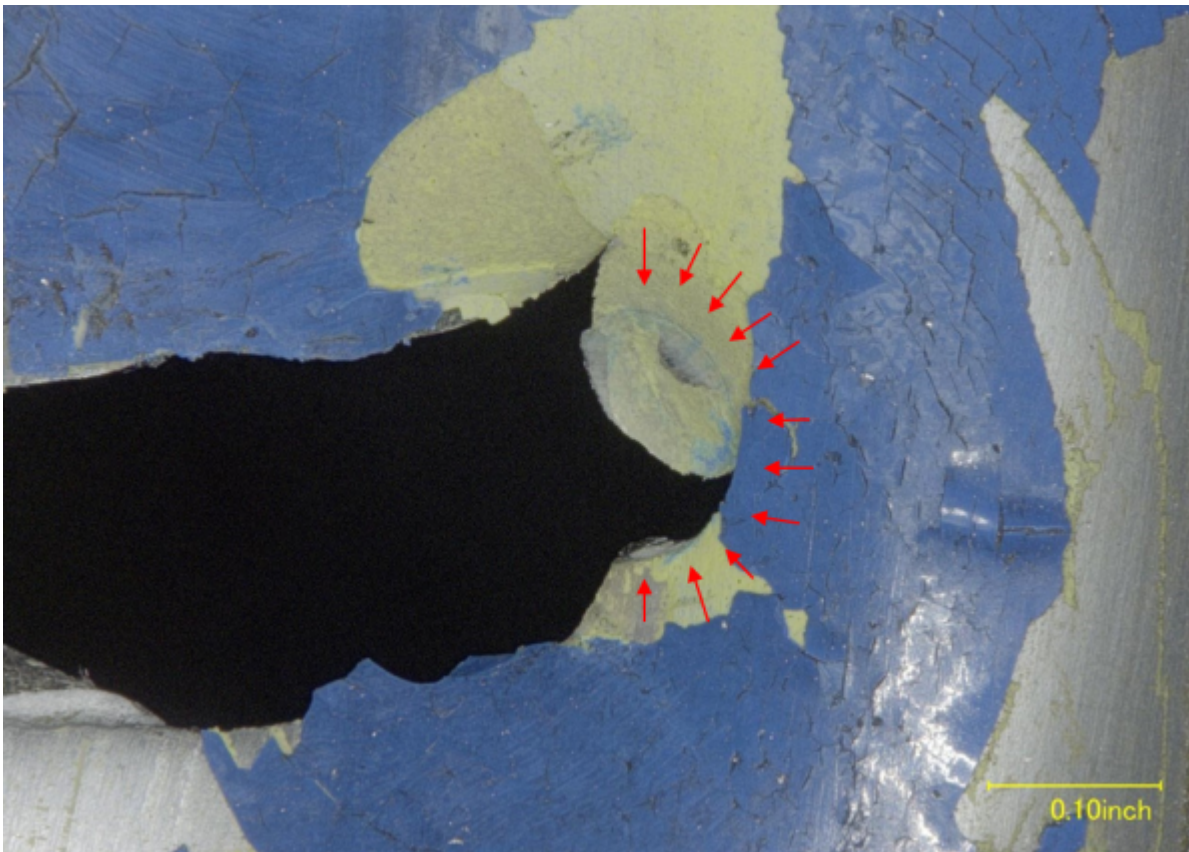
Under magnification, inside the round dent, a small circular indentation was noted of approximately 0.125 inches (~3 mm) in diameter, exhibiting tears and cracking around its circumference (Figure 4). These features were consistent with fore-to-aft impact with a hard, cylindrical object. The propeller shafts on many common small drones are approximately 3 mm in diameter.

Figure 4 – Small indentation inside larger dent
