Aviation Investigation Final Report

Location:	Victoria, Texas	Accident Number:	CEN20FA032
Date & Time:	December 9, 2019, 20:17 Local	Registration:	N4602B
Aircraft:	Cessna 208	Aircraft Damage:	Destroyed
Defining Event:	Loss of control in flight	Injuries:	1 Fatal
Flight Conducted Under:	Part 135: Air taxi & commuter - Non-scheduled

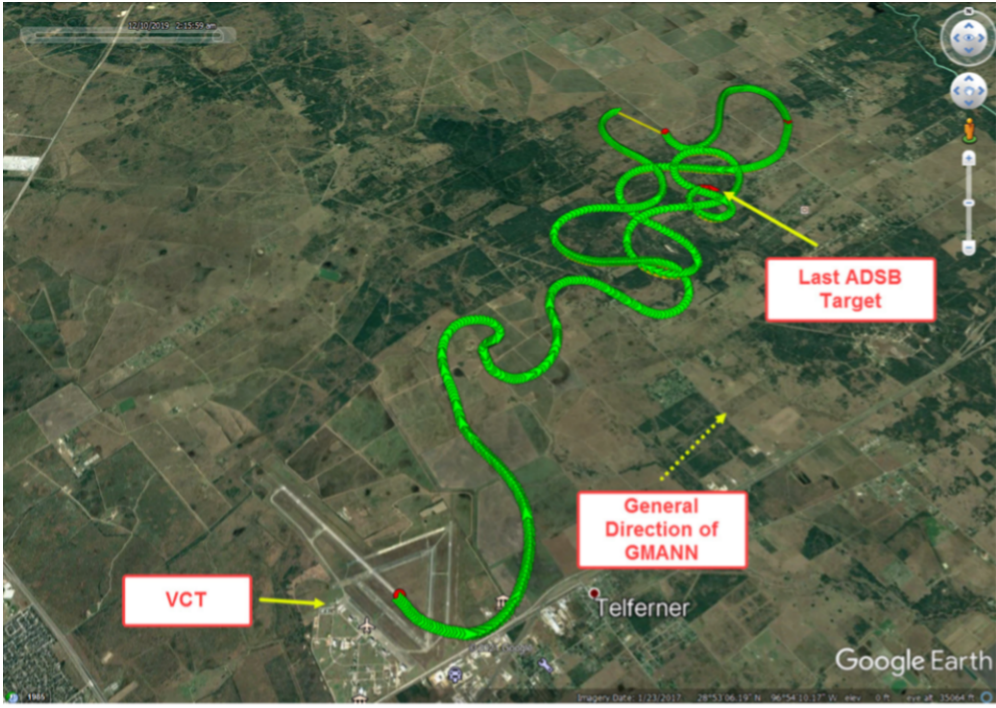
Figure 1. Flight Path of the Airplane

About 2004, the pilot departed VCT and was cleared to 3,000 ft mean sea level (msl). As the airplane climbed through 1,900 ft mean sea level (msl), air traffic control data showed the airplane make a series of fifteen course changes that continued for the remainder of the flight. The course changes alternated between left and right turns, and each involved a heading change of more than 90°. The controller queried the pilot several times concerning the airplane's erratic course changes and assigned the pilot a heading of 035° toward GMANN. The pilot continued to make large turns with erratic altitude and airspeed changes and the pilot often responded to the controller with unintelligible transmissions.

About 2011, the pilot stated that he had "some instrument problems." The controller suggested a return for landing at VCT and the pilot concurred. The pilot was initially cleared for a visual approach to VCT, but when another pilot reported "really hazy" conditions near the airport, the controller notified the pilot he would be given radar vectors and to maintain 3,000 ft msl. The pilot acknowledged these new instructions. The airplane continued to make large turns and subsequently entered a rapid descent, during which radar contact was lost.
