Aviation Investigation Final Report

Location:	Scotts Bluff, Nebraska	Accident Number:	CEN20LA041
Date & Time:	December 18, 2019, 09:00 Local	Registration:	CGOJG
Aircraft:	Cessna 525A	Aircraft Damage:	Substantial
Defining Event:	Part(s) separation from AC	Injuries:	5 None
Flight Conducted Under:	Non-U.S., non-commercial

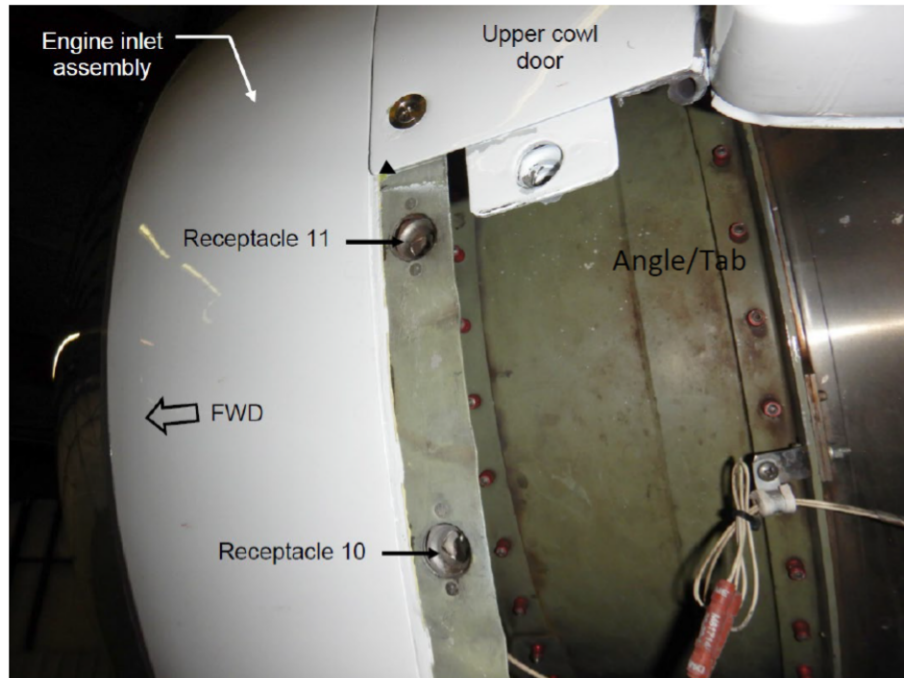
Postaccident examination of the airplane revealed the right engine lower cowl separated from the airplane, struck the right engine upper cowl, and damaged about a third of the outboard side of the right horizontal stabilizer and elevator, resulting in substantial damage. The cowl fastener assemblies were all quarter-turn fasteners. Two consecutive fasteners located at the forward inboard corner of the right engine lower cowl (labeled receptacles 10 and 11 in figure 1) were missing. A third fastener, which joined the right engine upper and lower cowls through an angle/tab, was missing (see figure 1). The receptacles associated with these fasteners did not display tearing or fractures. All the remaining right engine lower cowl fasteners were in place.

Figure 1: Missing fasteners at receptacles 10 and 11 and at the angle/tab on the right engine lower cowl.

The separated cowlings and missing fasteners were not located. The remaining fastener assemblies were removed by the repair facility that recovered the airplane and sent to the National Transportation Safety Board Materials Laboratory for examination.

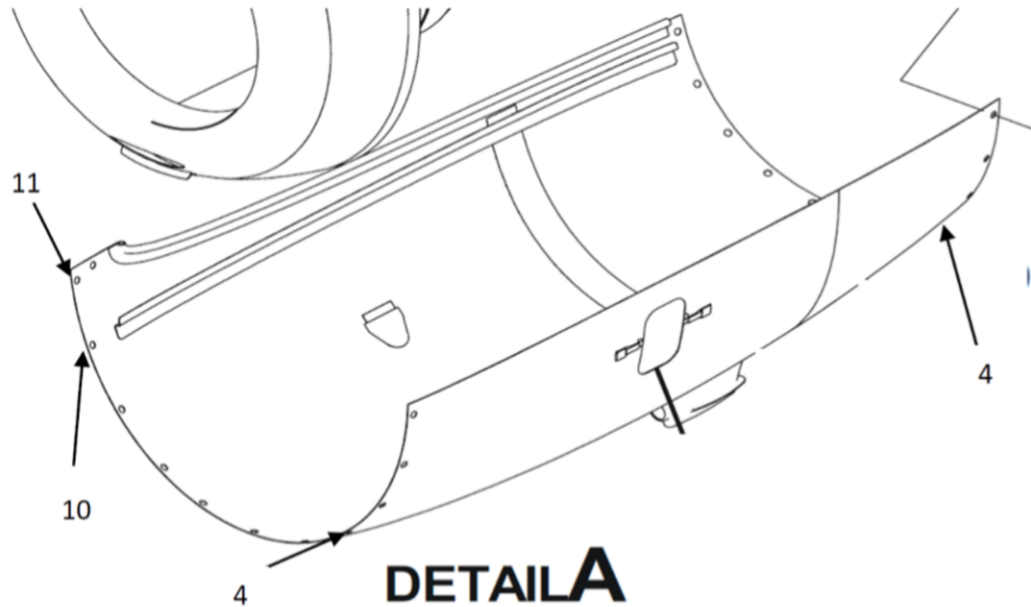
The fastener assemblies were examined for part numbers or other identifying marks. None were found on the receptacles. The stud heads were labelled with dash numbers and all studs were “-3” except for the studs at receptacle location 4 on both the forward and aft attachment flanges, which were “-4” studs (see figure 2).

Figure 2: Illustrated Parts Catalog detail of engine lower cowl and locations of number 4, 10, and 11 receptacles.

The Illustrated Parts Catalog (IPC) for the airplane listed the engine lower cowl fastener studs as part number S3412-103, which had a Phillips head and the same stud length as part number S4312-3, which had a straight-slot head. Each subsequent increase in dash number increased fastener length by about 0.03 inch. The IPC did not list any -4 studs for the upper or lower engine cowl. A -4 stud would correspond to part number S3412-104; no S3412-104 fasteners are specified on the Textron Aviation drawing for the lower cowling door.

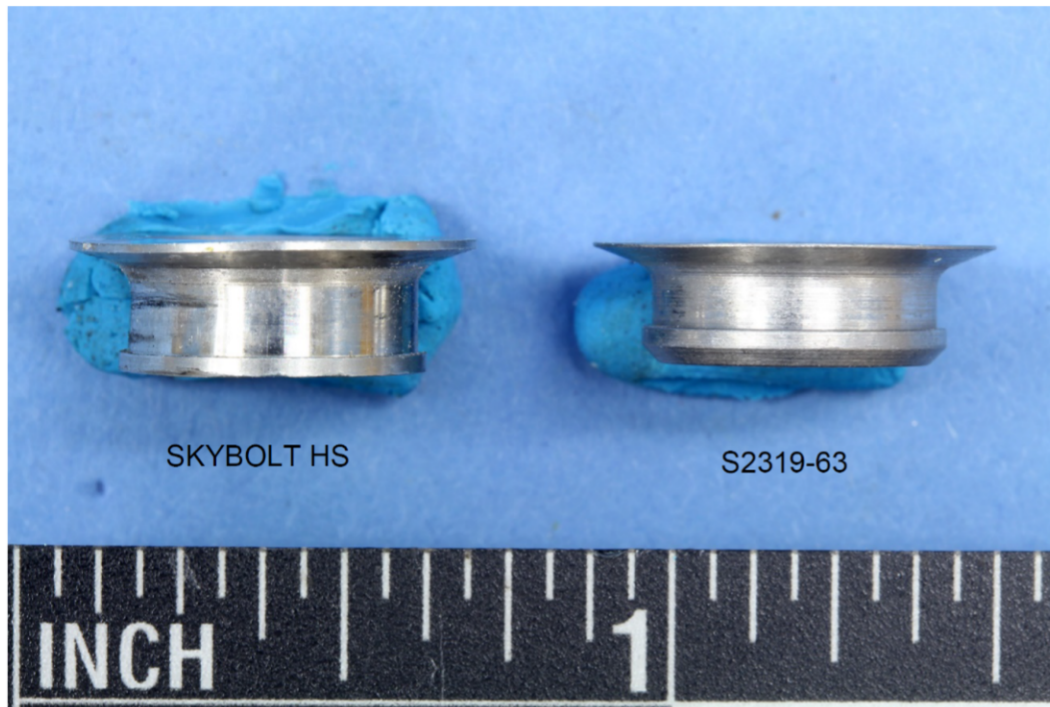
The fastener assembly grommets that were on the accident airplane right engine lower cowl were all labelled as “SKYBOLT HS.” According to Skybolt product information, HS-type grommets are nominally 0.197 inch in height. Measured with a micrometer, the height of one of the grommets from the accident airplane was 0.204 inch. Figure 3 shows a top-down view of an HS grommet from the accident airplane and a profile view, comparing the height with that of a S2319-63 (from the IPC). Skybolt was not an approved vendor for these assemblies per the Textron Aviation drawing and the IPC.

Figure 3: Profile view of the Skybolt HS grommet from the accident airplane and the grommet listed in the IPC (S2319-63) for the airplane.

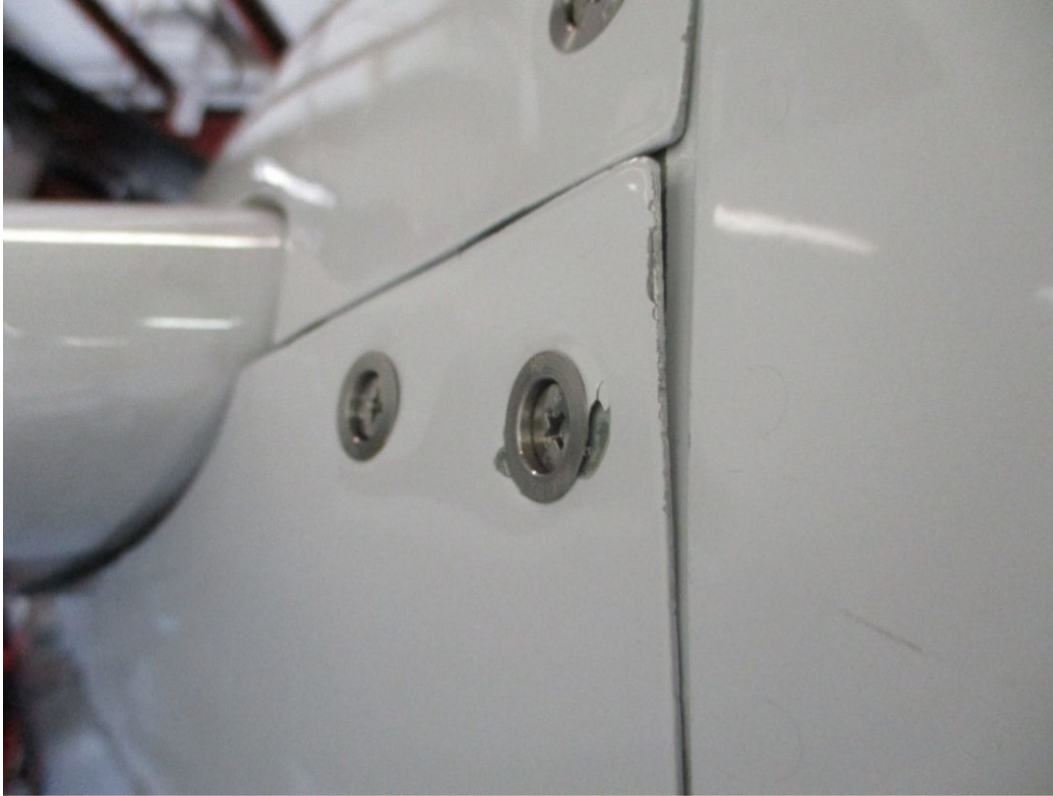
Postaccident photographs of the left engine lower cowl showed that it exhibited protrusion/mismatch (or misalignment) that exceeded aerodynamic smoothness requirements cited in the airplane structural repair manual. The left engine lower cowl had at least two -3 studs that were recessed below Skybolt grommets, which were located in the same area as that of the right engine lower cowl that had the three missing studs.

According to the repair facility that performed postaccident repairs to the airplane, the left engine lower cowl was intact and secure with all its fasteners. Photos provided by the repair facility showed several of the retained fastener heads were recessed and not flush with the cowl surface, as specified in the manufacturer structural repair manual. The repair facility reported that the fasteners that were not recessed were too long. Further, the cowl surface visibly protruded about an 1/8 inch and was not flush with the adjacent structure (see figure 4). The photos of the fasteners shown in figure 4, showed the grommet labelled as “SKYBOLT HS” and “-3” studs. The 1/8-inch protrusion exceeded aerodynamic smoothness requirements cited in the aircraft structural repair manual (SRM). The aircraft maintenance/service manual did not cite aerodynamic smoothness requirements.

Figure 4: Shows the left engine inboard lower cowl mismatch and screw heads recessed beneath their grommets at the same relative receptacle location numbers 10 and 11. The grommets were labeled “HS SKYBOLT” and the studs were labeled “-3.”

The postaccident repair of the airplane included replacement of fasteners with shorter fasteners in the left engine cowl, and through approval by a designated engineering representative, additional fastener(s) were installed in the engine cowlings.
