# Aviation Investigation Final Report

<b>Location:</b>	College Park, Maryland	<b>Accident Number:</b>	ERA20FA060
<b>Date &amp; Time:</b>	December 29, 2019, 14:48 Local	<b>Registration:</b>	N26455
<b>Aircraft:</b>	American Aviation AA5	<b>Aircraft Damage:</b>	Destroyed
<b>Defining Event:</b>	Loss of control in flight	<b>Injuries:</b>	1 Fatal
<b>Flight Conducted Under:</b>	Part 91: General aviation - Personal

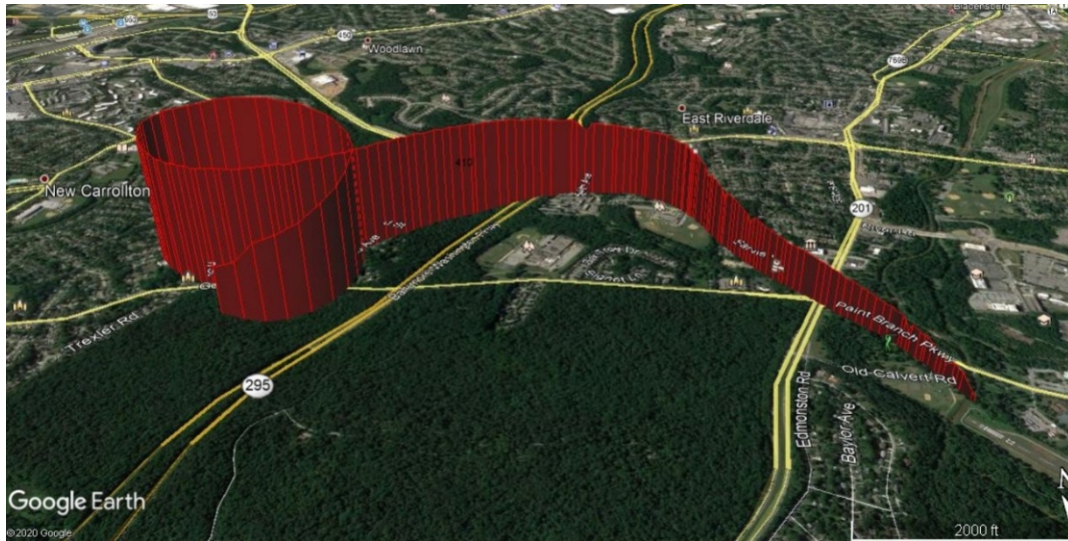
Figure 1. Map showing the airplane's radar track.

The airplane departed runway 15, maintained an approximate heading of between 140° and 150°, and climbed for about 1 mile as it tracked slightly right of the extended runway centerline. When the airplane reached an altitude of about 1,200 ft the pilot established communication with air traffic control and was instructed to climb to 5,000 ft and turn to a 310° heading once the airplane climbed above 1,700 ft. The airplane then entered a right turn and climbed to about 1,900 ft before entering a right spiraling descent. The controller issued a low-altitude alert as the airplane descended through 700 ft before radar and voice communications were lost. At 1447, the final radar target was near the accident site at an

altitude of 525 ft and 153 knots groundspeed. Figure 1 shows the airplane's radar-derived track plotted in red.
