Aviation Investigation Final Report

Location:	Kenansville, North Carolina	Accident Number:	ERA20LA064
Date & Time:	January 2, 2020, 10:25 Local	Registration:	N323SR
Aircraft:	Cirrus SR22	Aircraft Damage:	Substantial
Defining Event:	Loss of engine power (partial)	Injuries:	2 None
Flight Conducted Under:	Part 91: General aviation - Personal

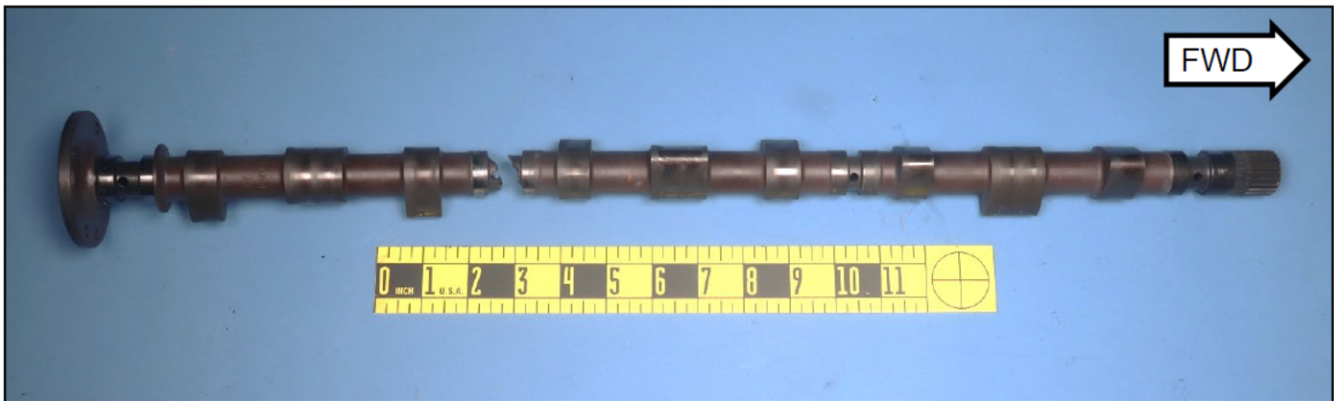
Postaccident examination of the engine revealed that the camshaft fractured at one of its four oil transfer holes. As a result, camshaft continuity was lost, and the engine was partially unable to produce power. Forensic examination of the fracture surface revealed that the fracture occurred due to fatigue that initiated from a burr at the corner of an oil transfer hole. The extent of fatigue crack growth through the cross-section suggested the overall torsion load on the camshaft was relatively low as the crack grew. However, a burr at the edge of a hole is a feature that is known to reduce component fatigue life. The burr was deformed and coated, consistent with forming during a peening operation and before the manganese phosphate coating had been applied. A similar burr was also observed on the adjacent oil transfer hole in the camshaft. The presence of a burr suggests the corner of the hole was not properly broken before the part was peened during manufacturing, leading to deformation of a sharp corner during the peening operation.

A fatigue failure of the camshaft due to a manufacturing defect, which resulted in a partial loss of engine power.

According to the NTSB Materials Laboratory factual report, the camshaft had fractured between lobes associated with the No. 2 and 3 cylinders, intersecting oil transfer holes as shown in figure 1. The fracture plane was angled relative to the transverse plane consistent with fatigue fracture under torsion loading.

Figure 1. Overall view of the submitted camshaft.

The fracture surface was further forensically examined, which revealed relatively smooth fracture features with curving crack arrest lines, features consistent with fatigue. Crack arrest lines emanated from origins at the corner of the oil transfer hole where it intersected the camshaft exterior surface. Fatigue features were observed around most of the fracture surface, intersecting the oil transfer hole at the opposite side of the camshaft. A portion of the fracture had post-fracture rub damage that obliterated the fracture features. The exterior surface of the camshaft had a dimpled appearance, consistent with a shot-peened surface treatment. The corner of the oil transfer hole was deformed inward, forming a burr. Dimple features were also observed on the surface of the burr consistent with peening deformation.
