Aviation Investigation Final Report

Location:	Kenansville, North Carolina	Accident Number:	ERA20LA064
Date & Time:	January 2, 2020, 10:25 Local	Registration:	N323SR
Aircraft:	Cirrus SR22	Aircraft Damage:	Substantial
Defining Event:	Loss of engine power (partial)	Injuries:	2 None
Flight Conducted Under:	Part 91: General aviation - Personal

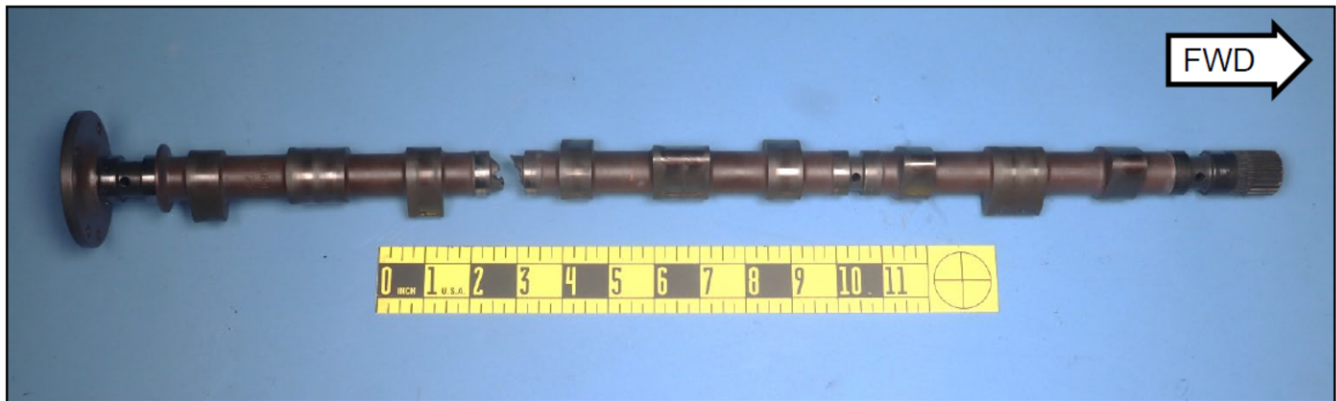
Figure 1. Overall view of the submitted camshaft.

Postaccident examination of the engine revealed that the camshaft fractured at one of its four oil transfer holes. As a result, camshaft continuity was lost, and the engine was partially unable to produce power. Forensic examination of the fracture surface revealed that the fracture occurred due to fatigue that initiated from a burr at the corner of an oil transfer hole. The extent of fatigue crack growth through the cross-section suggested the overall torsion load on the camshaft was relatively low as the crack grew. However, a burr at the edge of a hole is a feature that is known to reduce component fatigue life. The burr was deformed and coated, consistent with forming during a peening operation and before the manganese phosphate coating had been applied. A similar burr was also observed on the adjacent oil transfer hole in the camshaft. The presence of a burr suggests the corner of the hole was not properly broken before the part was peened during manufacturing, leading to deformation of a sharp corner during the peening operation.

A fatigue failure of the camshaft due to a manufacturing defect, which resulted in a partial loss of engine power.

According to the NTSB Materials Laboratory factual report, the camshaft had fractured between lobes associated with the No. 2 and 3 cylinders, intersecting oil transfer holes as shown in figure 1. The fracture plane was angled relative to the transverse plane consistent with fatigue fracture under torsion loading.

The fracture surface was further forensically examined, which revealed relatively smooth fracture features with curving crack arrest lines, features consistent with fatigue. Crack arrest lines emanated from origins at the corner of the oil transfer hole where it intersected the camshaft exterior surface. Fatigue features were observed around most of the fracture surface, intersecting the oil transfer hole at the opposite side of the camshaft. A portion of the fracture had post-fracture rub damage that obliterated the fracture features. The exterior surface of the camshaft had a dimpled appearance, consistent with a shot-peened surface treatment. The corner of the oil transfer hole was deformed inward, forming a burr. Dimple features were also observed on the surface of the burr consistent with peening deformation.

The oil transfer hole between lobes associated with the No. 4 and 5 cylinders also displayed a burr at the corner of the hole, but no crack was observed. Further forensic examination and cuts to the oil transfer hole found an elongated texture consistent with surface deformation associated with the burr formation.
