# Aviation Investigation Final Report

| <b>Location:</b> | Billings, Montana | <b>Accident Number:</b> | WPR20FA063 |
| <b>Date &amp; Time:</b> | January 11, 2020, 18:01 Local | <b>Registration:</b> | N736YU |
| <b>Aircraft:</b> | Cessna TR182 | <b>Aircraft Damage:</b> | Destroyed |

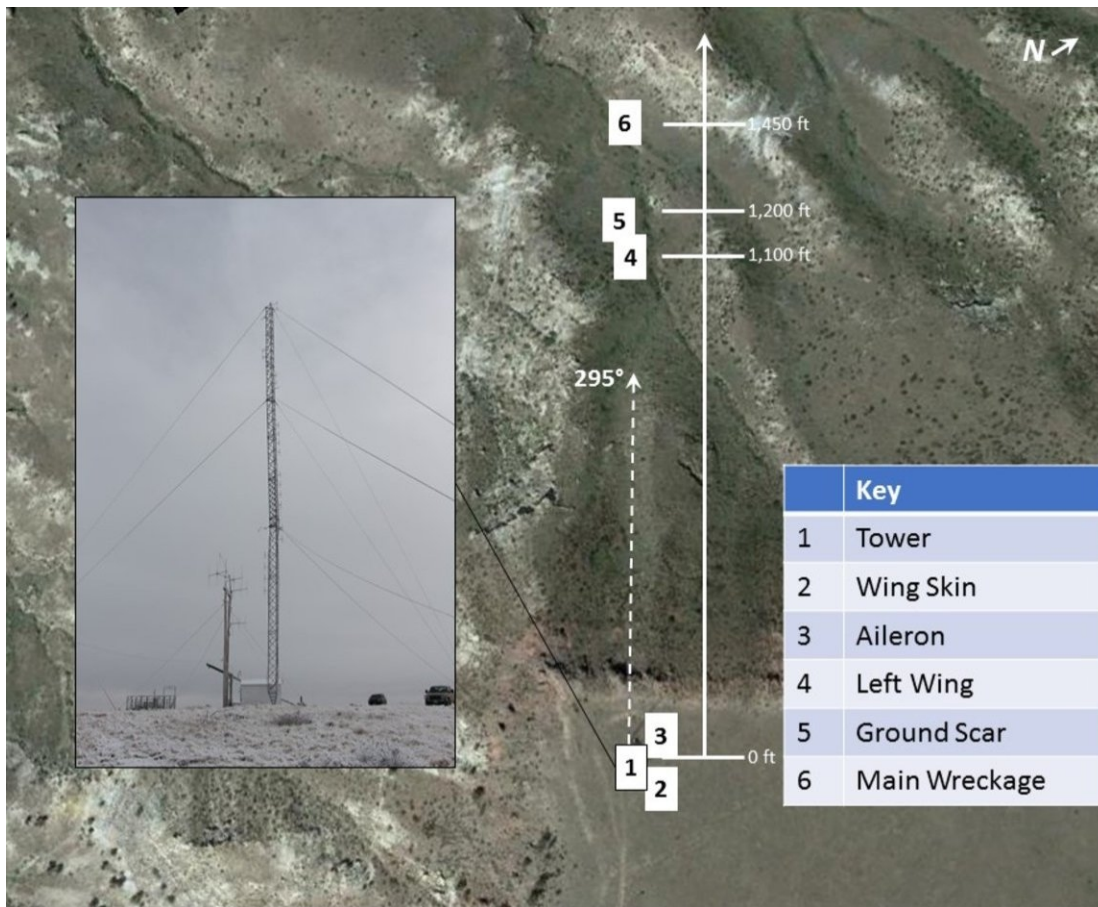
The airplane wreckage was located in mountainous terrain at an elevation of about 4,252 ft msl. All major sections of the airplane were accounted for at the accident site. The initial impact point was marked by several bent cross members and a broken guy wire about 65 ft high (4,809 ft msl) on an about 185-ft-tall radio tower, which was located on a peak with a field elevation of about 4,744 ft msl. Several sections of the outboard left wing (not shown in figure 1) were located about 100 ft north of the tower, and two pieces displayed longitudinal signatures consistent with impacting a wire. The remaining section of the left wing was found in the debris path about 350 ft from the main wreckage. Several airframe and engine fragments were distributed along the energy path, which was oriented on a heading of about 295°. The main wreckage was found about 1,450 ft northwest of the initial impact point in a coulee and included the right wing, fuselage, empennage, and engine. A 5-ft intermediate ground scar was located about 250 ft beyond the main wreckage.

*Figure 1: Wreckage diagram and photograph of impacted tower*
