# Aviation Investigation Final Report

<b>Location:</b>	Roy, Utah	<b>Accident Number:</b>	WPR20FA065
<b>Date &amp; Time:</b>	January 15, 2020, 15:11 Local	<b>Registration:</b>	N5805M
<b>Aircraft:</b>	Cessna T310	<b>Aircraft Damage:</b>	Substantial
<b>Defining Event:</b>	Fuel related	<b>Injuries:</b>	1 Fatal
<b>Flight Conducted Under:</b>	Part 91: General aviation - Personal

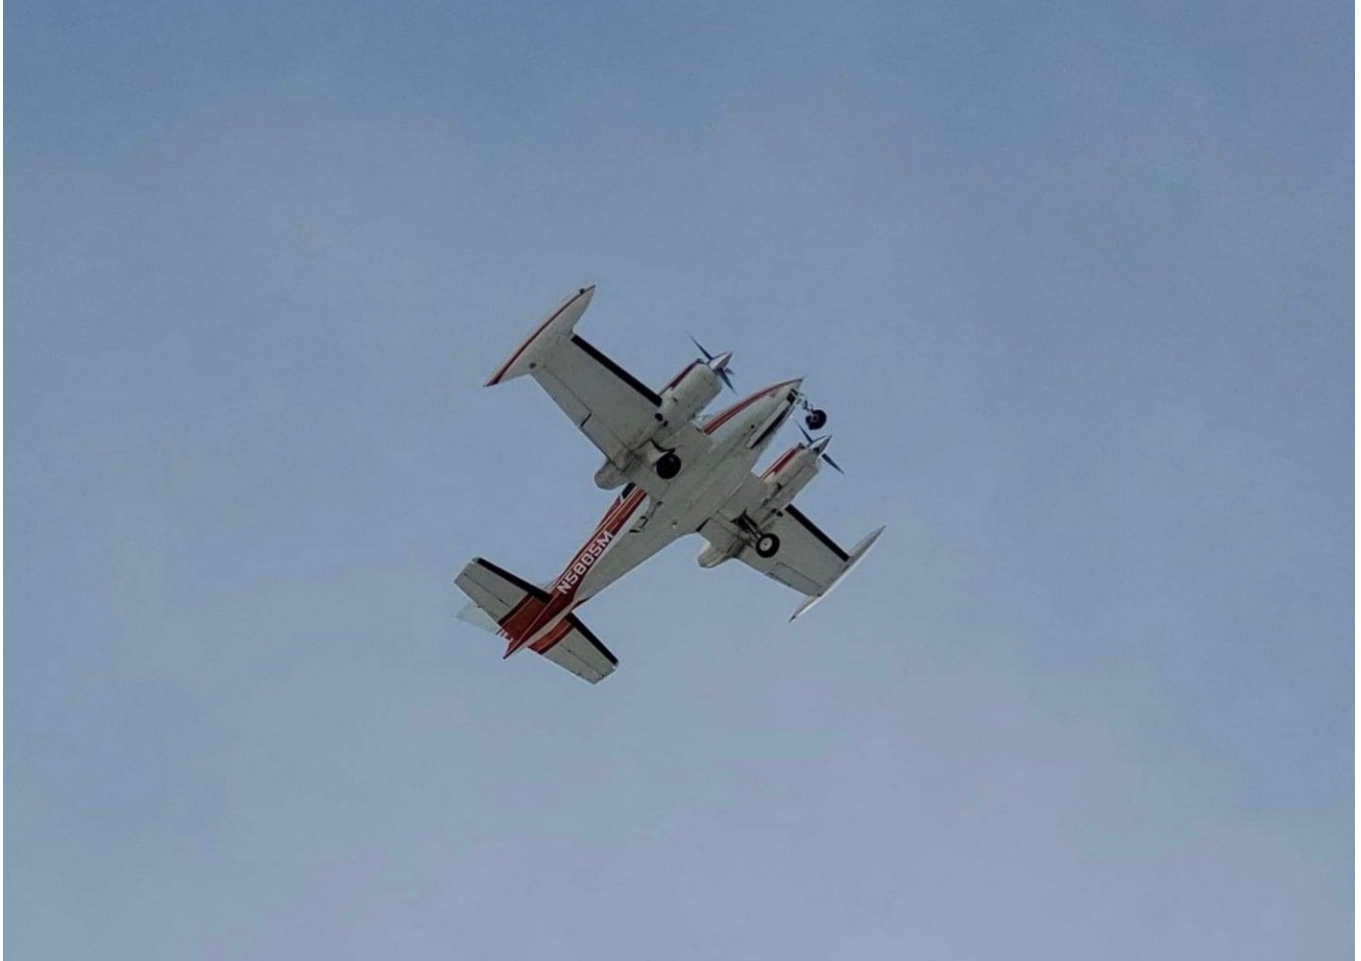
Several witnesses reported that they saw the airplane and noticed how slow it seemed to be when it was flying northbound, parallel, over the interstate highway I-15. An eyewitness who was in a store adjacent to the interstate, and about 1-1/2 miles south of OGD, heard the airplane while inside the store and went outside to get a better view. The witness described the sound as “popping,” and he thought that one of the engines was trying to be restarted. The witness reported that the airplane was flying northbound above the interstate at about 150 ft to 200 ft above the ground, and that the landing gear and the flaps were extended. A second eyewitness at the same location took a photo as the airplane flew overhead. (See figure 1.) As the first eyewitness watched the airplane continue to fly north and away from his location, he saw that the airplane was “crabbing” to the left and that it seemed to be struggling to stay airborne. While it was crabbing, he could see the left side of the airplane’s fuselage and noticed that the tail section seemed to be lower than normal. Subsequently, the airplane’s left wing dropped, the airplane momentarily stabilized, and the left wing dropped again, banking the airplane further to the left. The airplane crossed to the other side of the interstate, where the nose dropped, and where he soon lost sight of it.

*Figure 1-Eyewitness photograph of the accident airplane.*
