Aviation Investigation Final Report

Location:	Roy, Utah	Accident Number:	WPR20FA065
Date & Time:	January 15, 2020, 15:11 Local	Registration:	N5805M
Aircraft:	Cessna T310	Aircraft Damage:	Substantial
Defining Event:	Fuel related	Injuries:	1 Fatal
Flight Conducted Under:	Part 91: General aviation - Personal

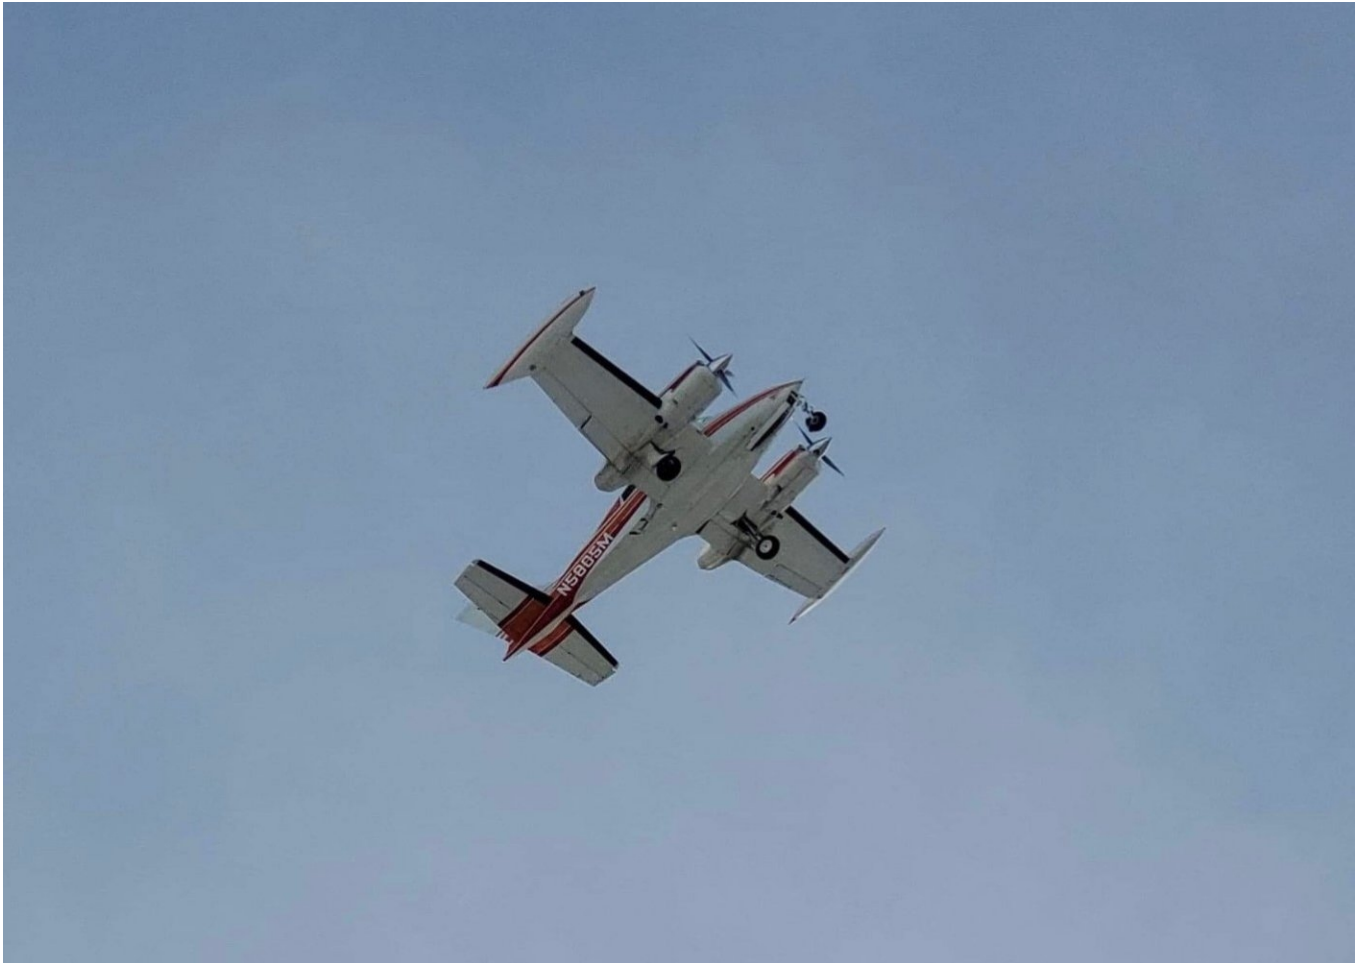
Several witnesses reported that they saw the airplane and noticed how slow it seemed to be when it was flying northbound, parallel, over the interstate highway I-15. An eyewitness who was in a store adjacent to the interstate, and about 1-1/2 miles south of OGD, heard the airplane while inside the store and went outside to get a better view. The witness described the sound as “popping,” and he thought that one of the engines was trying to be restarted. The witness reported that the airplane was flying northbound above the interstate at about 150 ft to 200 ft above the ground, and that the landing gear and the flaps were extended. A second eyewitness at the same location took a photo as the airplane flew overhead. (See figure 1.) As the first eyewitness watched the airplane continue to fly north and away from his location, he saw that the airplane was “crabbing” to the left and that it seemed to be struggling to stay airborne. While it was crabbing, he could see the left side of the airplane’s fuselage and noticed that the tail section seemed to be lower than normal. Subsequently, the airplane’s left wing dropped, the airplane momentarily stabilized, and the left wing dropped again, banking the airplane further to the left. The airplane crossed to the other side of the interstate, where the nose dropped, and where he soon lost sight of it.

Figure 1-Eyewitness photograph of the accident airplane.
