Aviation Investigation Final Report

Location:	Tuntutuliak, Alaska	Accident Number:	ANC20FA017
Date & Time:	February 6, 2020, 11:10 Local	Registration:	N7632C
Aircraft:	Piper PA32R	Aircraft Damage:	Substantial
Defining Event:	Controlled flight into terr/obj (CFIT)	Injuries:	5 Fatal
Flight Conducted Under:	Part 135: Air taxi & commuter - Scheduled

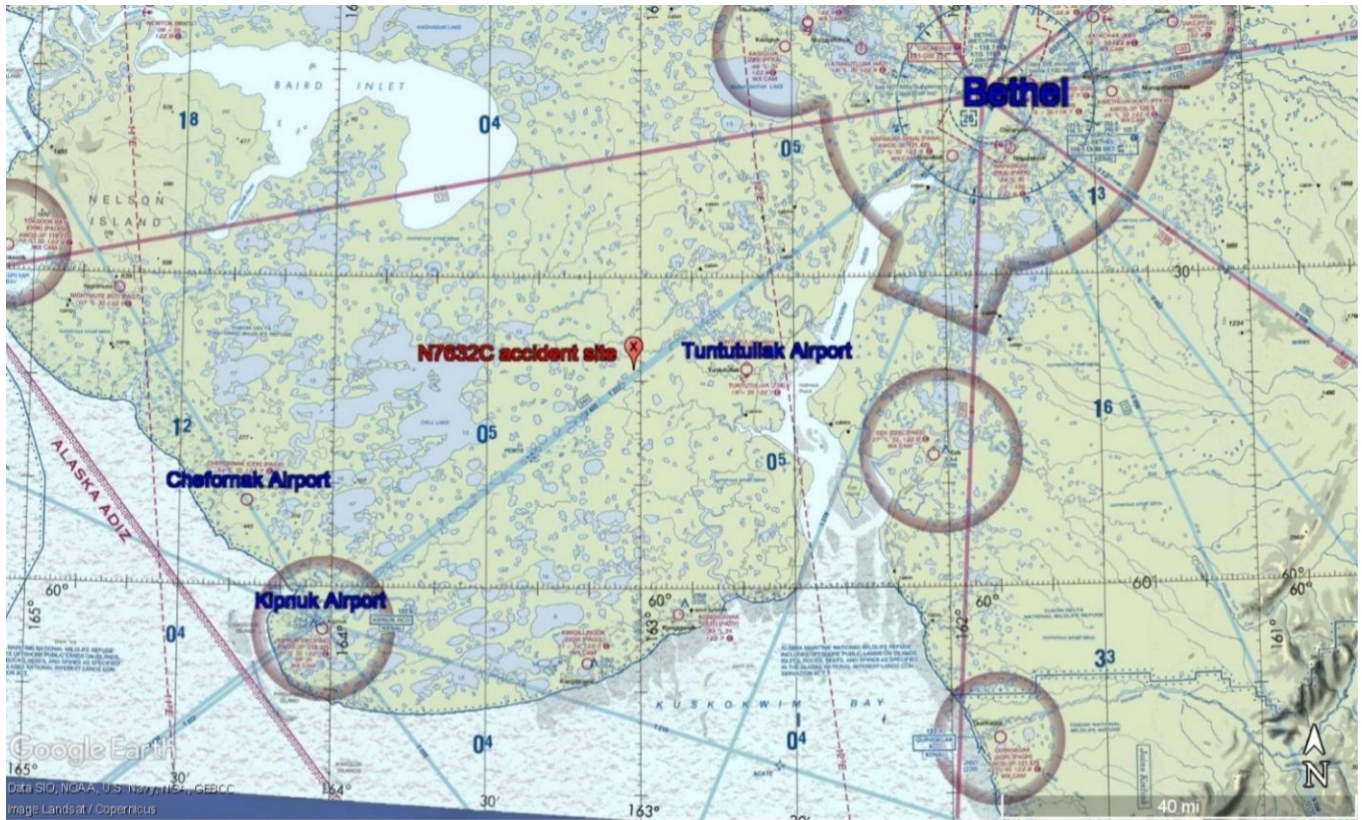
Figure 1. The accident site and route airports
