Aviation Investigation Final Report

| Location: | Fairmount, Georgia | Accident Number: | ERA20FA096 |
| Date & Time: | February 8, 2020, 10:13 Local | Registration: | N501RG |
| Aircraft: | Cessna 501 | Aircraft Damage: | Substantial |

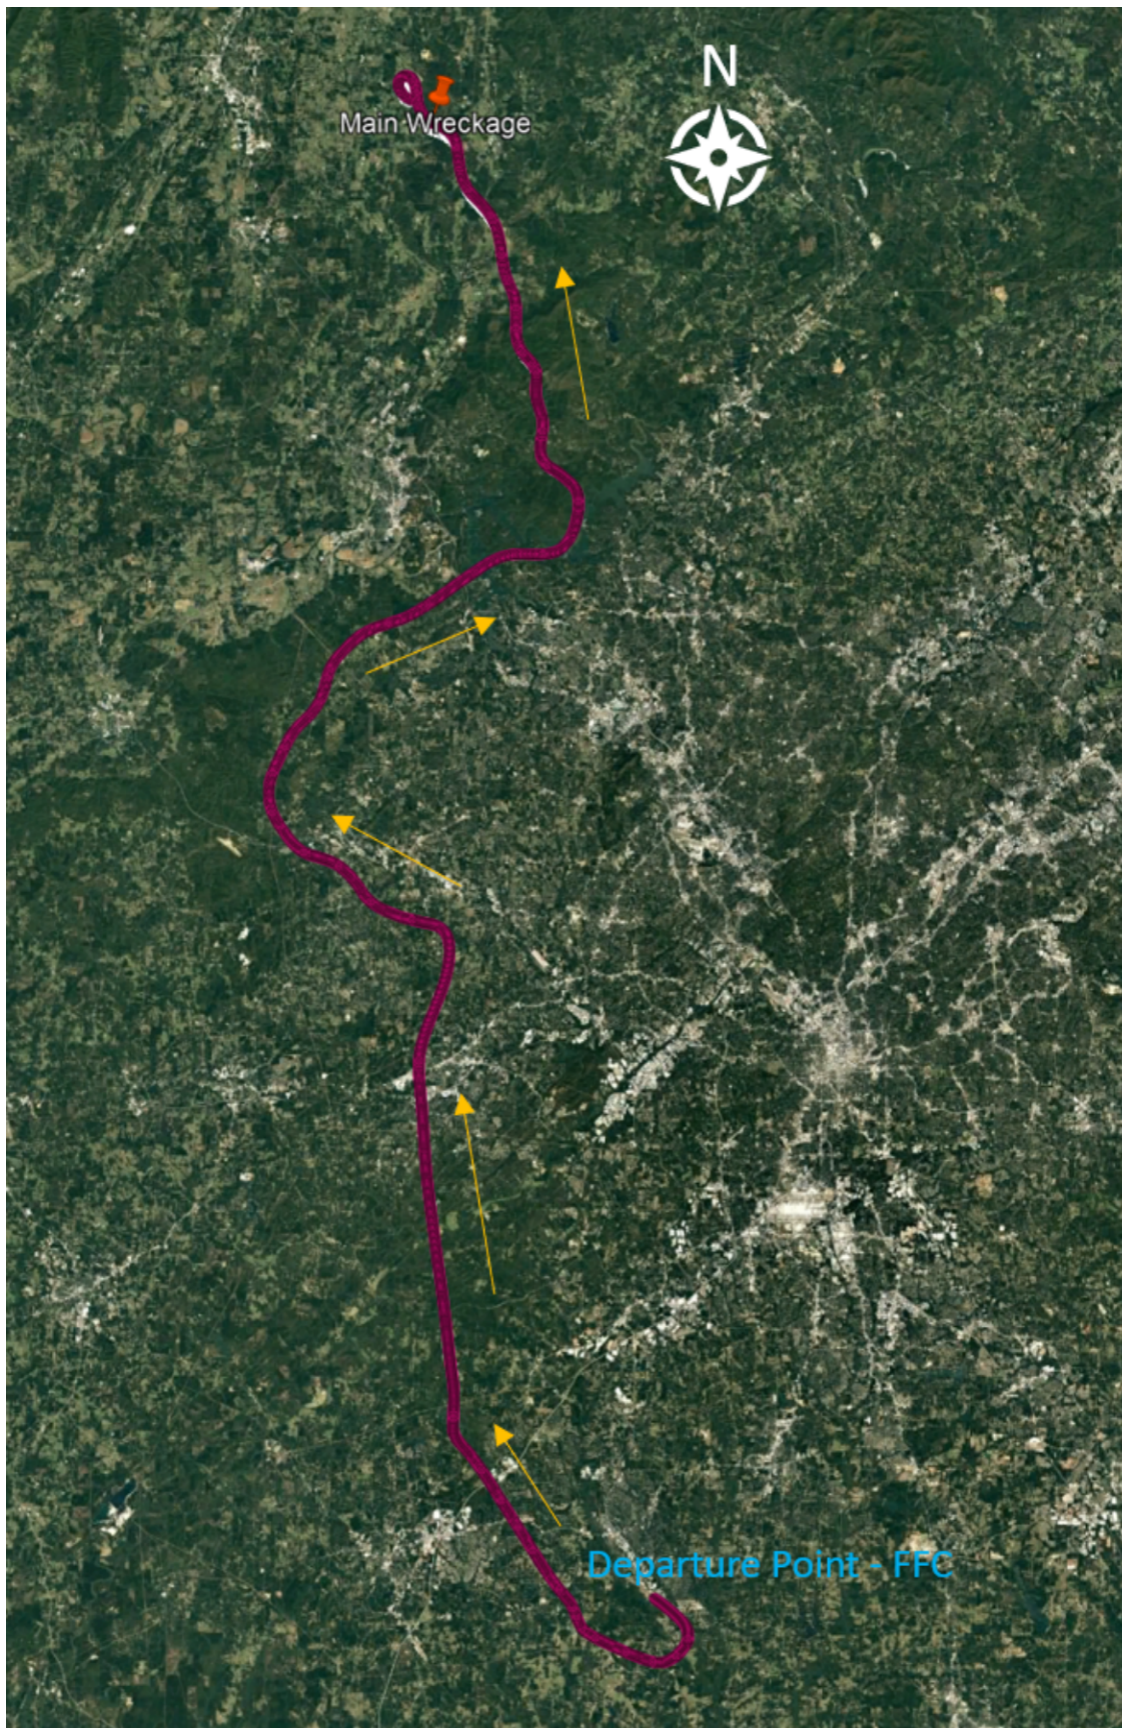
A review of air traffic control communications and radar data revealed that the flight departed FFC at 0949 (see figure 1). A controller issued local weather information and instructed the flight to climb to 7,000 ft mean sea level (msl). The controller provided a PIREP for trace to light rime icing between 9,000 ft and 11,000 ft, and one of the pilots acknowledged. The controller then instructed the flight to climb to 10,000 ft and to turn right to 020°.

Figure 1 -Overview of flight track data. Magenta line depicts the airplane's flight track for the accident flight and orange arrows indicate the direction of flight.
