Aviation Investigation Final Report

| Location: | Johnson Valley, California | Incident Number: | DCA201A081 |
| Date & Time: | February 6, 2020, 12:00 Local | Registration: | N611TC (A1); FA37NAYXP9 (A2) |
| Defining Event: | Midair collision | Injuries: | 2 None (A1); 1 None (A2) |

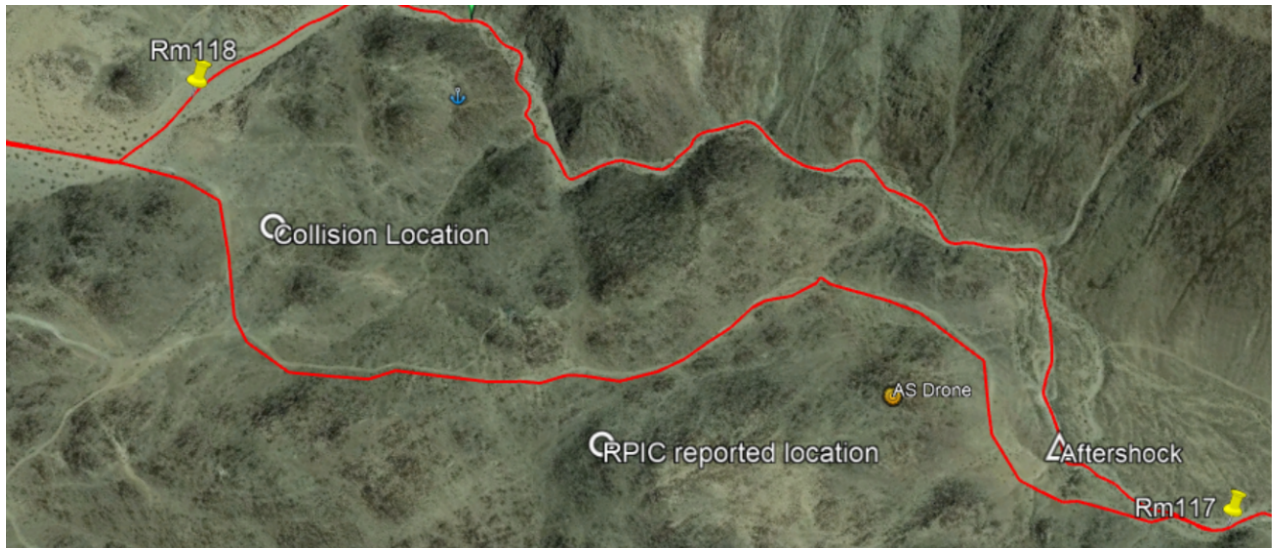
Figure 1 – Reported area of collision and location of drone RPIC. “AS (AfterShock) Drone” indicated intended position of operator according to race-organizer provided map.

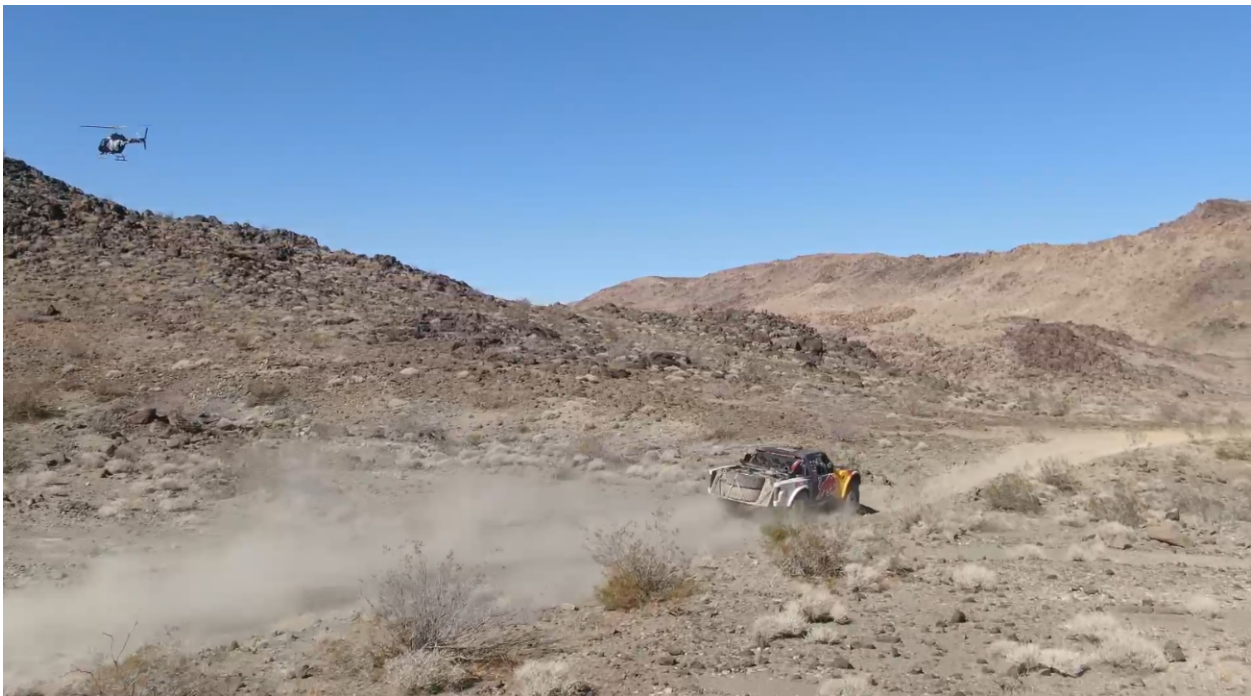
Figure 2 – Snapshot from video 10 seconds prior to collision. Collision occurred on far side of small rise in center frame.

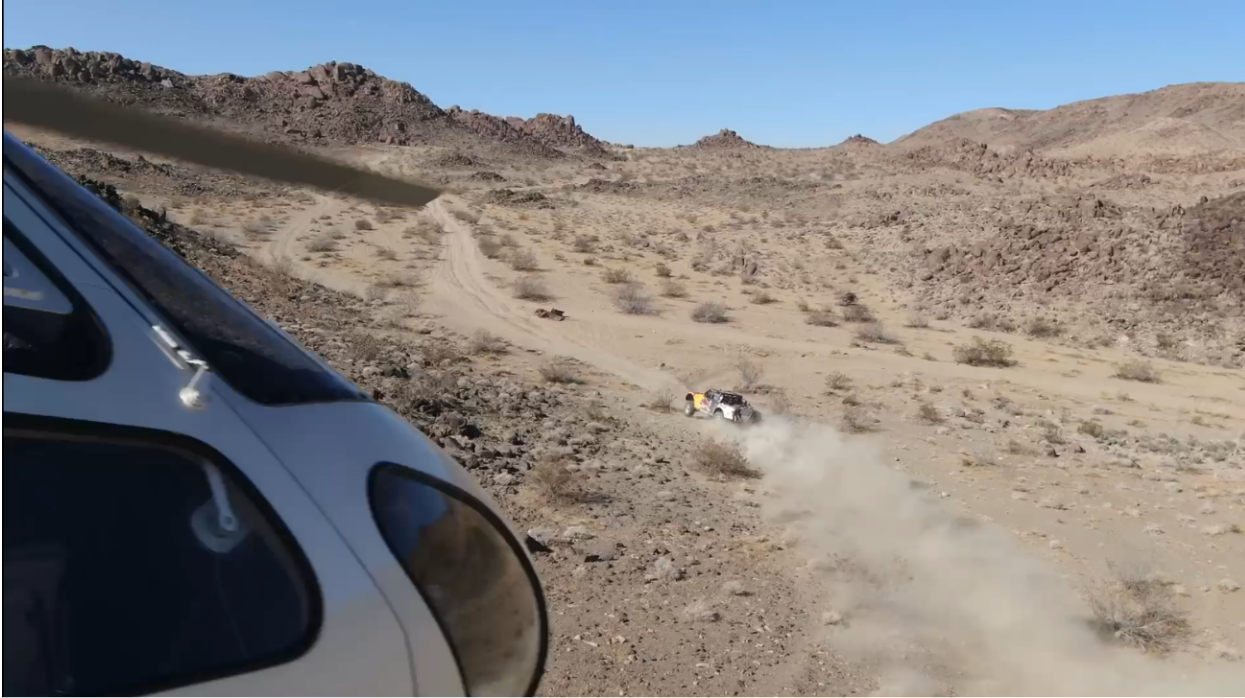
The helicopter pilot avoided the sUAS, and assumed he was far enough away, when he returned to the racecourse. The sUAS, continuing to follow the racecourse, struck the helicopter on the right side of the windscreen.

Figure 3 – Snapshot from video just prior to collision.
