Aviation Investigation Final Report

Location:	Johnson Valley, California	Incident Number:	DCA20IA081
Date & Time:	February 6, 2020, 12:00 Local	Registration:	N611TC (A1); FA37NAYXP9 (A2)
Aircraft:	Aerospatiale AS350BA (A1); DJI Mavic (A2)	Aircraft Damage:	Minor (A1); Substantial (A2)
Defining Event:	Midair collision	Injuries:	2 None (A1); 1 None (A2)
Flight Conducted Under:	Part 91: General aviation - Aerial observation (A1); Part 107: Small UAS (A2)

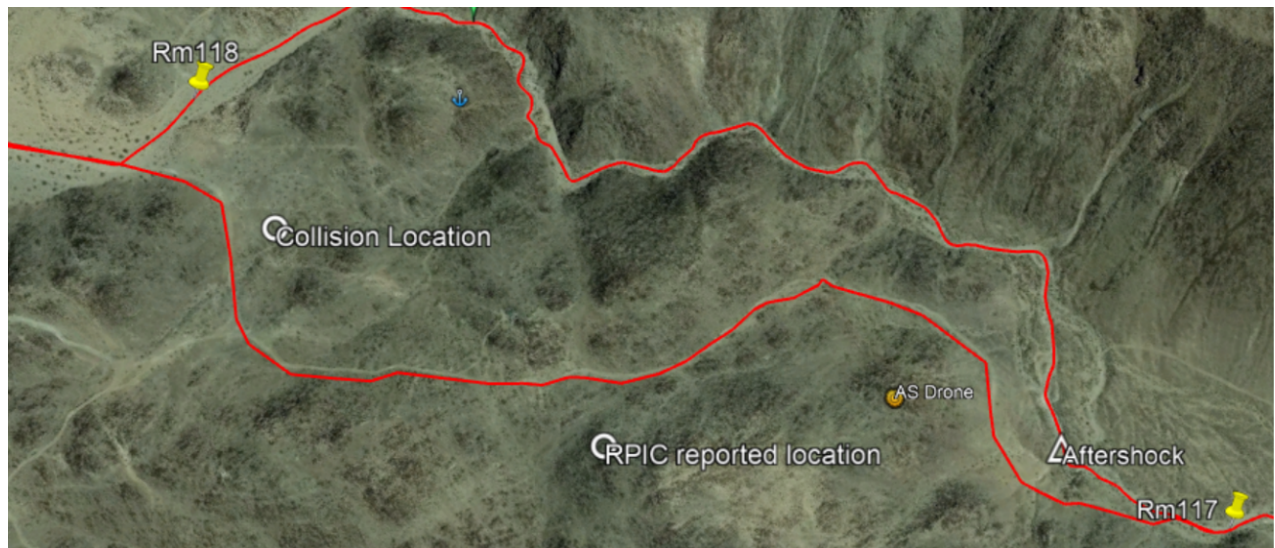
Figure 1 – Reported area of collision and location of drone RPIC. “AS (AfterShock) Drone” indicated intended position of operator according to race-organizer provided map.

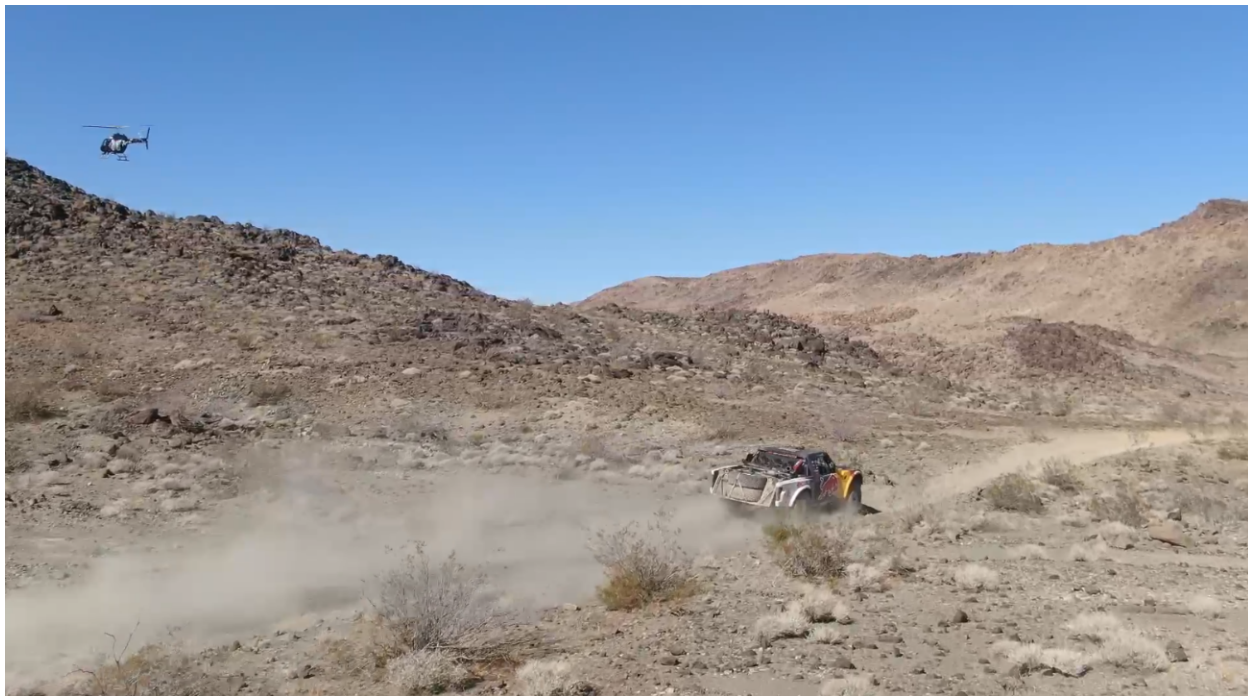
Figure 2 – Snapshot from video 10 seconds prior to collision. Collision occurred on far side of small rise in center frame.

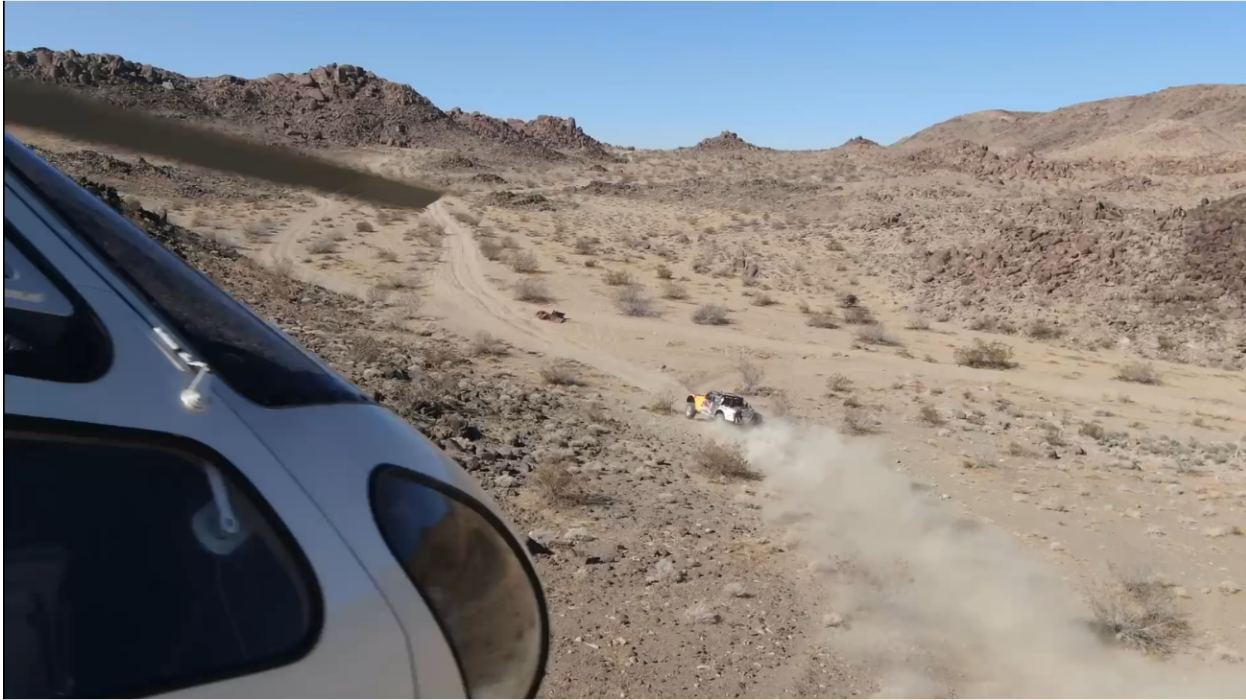
The helicopter pilot avoided the sUAS, and assumed he was far enough away, when he returned to the racecourse. The sUAS, continuing to follow the racecourse, struck the helicopter on the right side of the windscreen.

Figure 3 – Snapshot from video just prior to collision.
