Aviation Investigation Final Report

| Location: | Rogers, Minnesota | Accident Number: | CEN20FA096 |
| Date & Time: | February 22, 2020, 11:11 Local | Registration: | N3266Q |
| Aircraft: | Beech A36 | Aircraft Damage: | Destroyed |

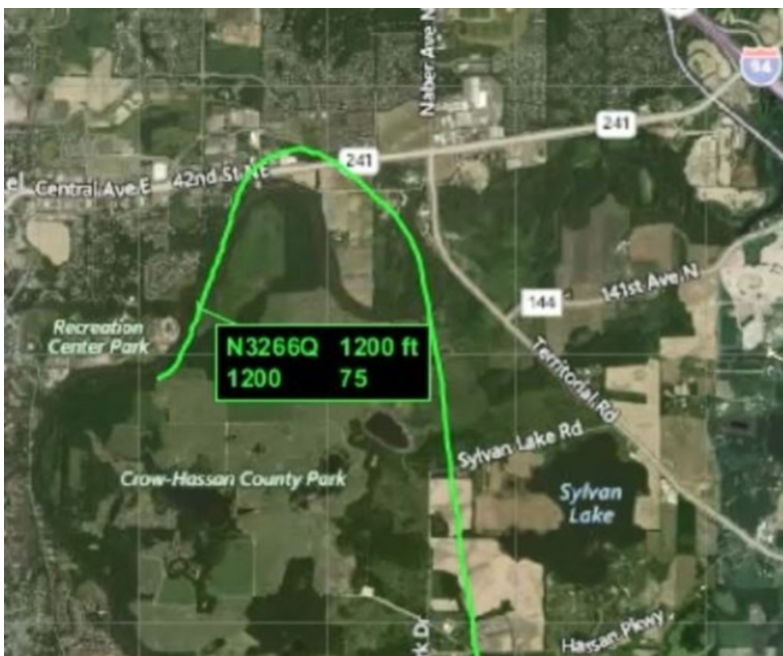
Figure 1 – Flight Path of Accident Airplane

Radar data indicate that the airplane was in cruise flight about 1,000 ft above ground level (agl) when it climbed about 300 ft and decelerated from about 170 to 110 knots groundspeed. The airplane subsequently turned away from populated areas and descended at 70 to 75 knots groundspeed with a steady vertical speed. About 100 ft agl, the airplane turned right and impacted forested terrain, which resulted in a postcrash fire. The flight profile was consistent with a power loss, followed by a forced landing attempt.

While in cruise flight, the airplane climbed from 2,000 to 2,300 ft msl and decelerated from about 170 to 110 knots groundspeed. The airplane subsequently turned left away from populated areas and descended with a steady vertical speed at 70 to 75 knots groundspeed. At 1,100 ft msl (200 ft agl), the airplane turned right and the last ATC data recorded was 1,000 ft msl (100 ft agl), 72 knots groundspeed, and 243°.
