# Aviation Investigation Final Report

<b>Location:</b>	Rogers, Minnesota	<b>Accident Number:</b>	CEN20FA096
<b>Date &amp; Time:</b>	February 22, 2020, 11:11 Local	<b>Registration:</b>	N3266Q
<b>Aircraft:</b>	Beech A36	<b>Aircraft Damage:</b>	Destroyed
<b>Defining Event:</b>	Loss of engine power (total)	<b>Injuries:</b>	1 Fatal
<b>Flight Conducted Under:</b>	Part 91: General aviation - Personal

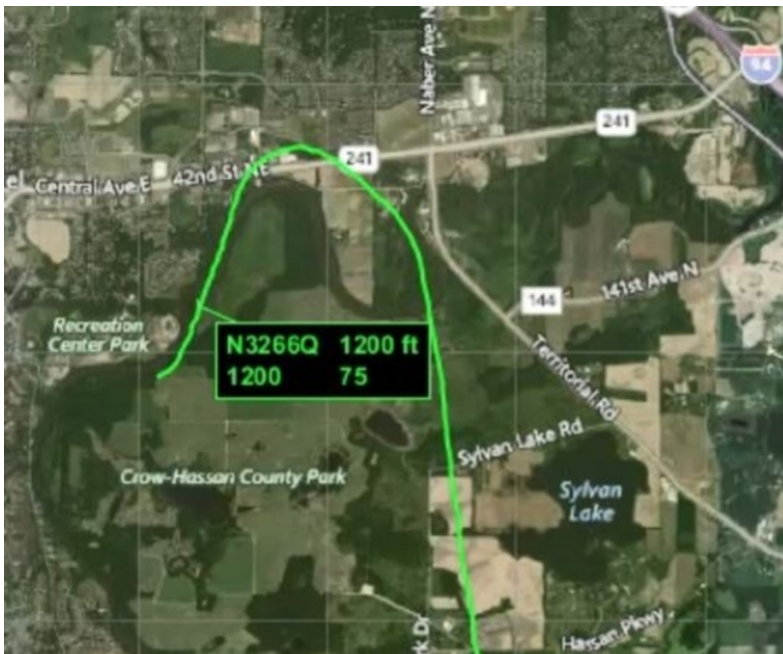
## Figure 1 – Flight Path of Accident Airplane

While in cruise flight, the airplane climbed from 2,000 to 2,300 ft msl and decelerated from about 170 to 110 knots groundspeed. The airplane subsequently turned left away from populated areas and descended with a steady vertical speed at 70 to 75 knots groundspeed. At 1,100 ft msl (200 ft agl), the airplane turned right and the last ATC data recorded was 1,000 ft msl (100 ft agl), 72 knots groundspeed, and 243°.

A witness observed the airplane flying at low altitude toward the southwest and subsequently noted that the airplane’s bank angle increased, followed by a rapid descent. The airplane impacted forested terrain and a post-crash fire occurred.
