Aviation Investigation Final Report

Location:	Mokuleia, Hawaii	Accident Number:	ANC20FA024
Date & Time:	February 22, 2020, 09:20 Local	Registration:	N65070
Aircraft:	Cessna 305	Aircraft Damage:	Substantial
Defining Event:	Loss of control in flight	Injuries:	2 Fatal
Flight Conducted Under:	Part 91: General aviation - Instructional

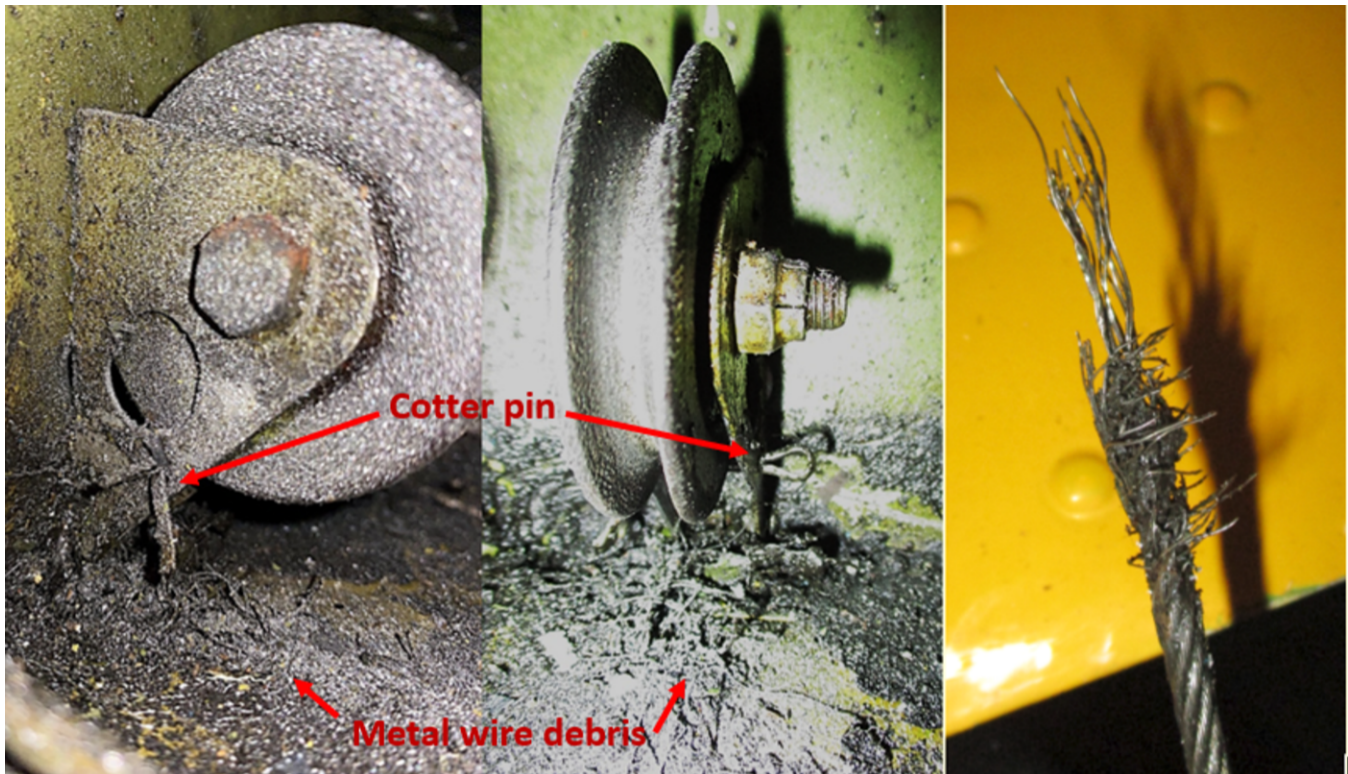
Examination of the engine revealed no anomalies that would have precluded normal operation. Examination of the airframe revealed that the left rudder cable was separated at the rudder pulley area behind the rear seat floor and displayed a combination of severely frayed and fractured strands with tension overload signatures. There was evidence of cable abrasions and rubbing in the area of the pulley bracket. A detailed examination of the cable fractures revealed that only 16 of the 133 total wires that comprised the cable were intact before they failed in overload, resulting in cable separation. The remainder of the cable strand wires were either degraded, shortened, or bent, indicative of abnormal cable contact and abrasion. Although the aileron and elevator control cables were continuous or displayed indications of overload separation due to impact, all of the cables exhibited areas of fraying and extensive wear.

Based on witness statements and examination of the wreckage, the pilots experienced a loss of yaw control after takeoff due to an overload separation of the left rudder cable and were unable to regain adequate control to land safely. Although when the separation occurred could not be determined, it is possible that the hard landing just before the accident takeoff may have caused the already degraded rudder cable to be displaced and encounter excessive stress loads in the pulley area.

A separation of the left rudder cable due to inadequate maintenance, which resulted in an in-flight loss of control and impact with terrain.

The flight controls in the cockpit could not be moved due to crush damage of the fuselage floor. The elevator control cables were continuous and connected. The aileron controls were continuous from the control stick to the wing roots, where the left wing root cables exhibited clean cuts and the right wing cable exhibited broomstraw signatures at the separation, consistent with overload separation. The left rudder cable was separated at the rudder pulley area behind the rear seat floor and exhibited a combination of severely frayed and fractured strands with tension overload signatures. A cotter pin extended out of the pulley bracket with metal shavings evident in the thick, grease-like debris around the pulley (see figure 2).

Figure 2. Photographs of the left and right side of left rudder cable pulley and the fractured left rudder cable forward end.

A detailed examination of the left rudder pulley assembly and rudder cable fractures was conducted at the National Transportation Safety Board materials laboratory. The cable was constructed of 7 strands (one core strand surrounded by six outer strands), each strand containing 19 wires. On the forward cable, 17 of the 19 core strand wires extended about 1/2 to 1 inch beyond the surrounding wires, which were bent back and frayed. On the aft cable section, 16 core strand wires extended beyond the rest of the wires. Examination under a scanning electron microscope revealed that of the extended core wires, 9 were thinned to less than half the wire diameter and 17 exhibited necking deformation at the ends, consistent with ductile overstress. Most of the wires on the outer strands that were bent back and frayed were worn to a chisel-like tip and were shorter than the extended wires, indicating abnormal wear.

The left rudder pulley bracket was partly covered in black grease deposits. The areas around the through-hole at the forward side of the bracket and near the cotter pin at the lower aft side of the bracket displayed missing paint and reflective textured appearance consistent with abrasion from contact with the cable. A cable wire was lodged in the hole for the cotter pin in the lower aft side of the bracket. The pulley cable guide groove exhibited one area in which the groove was deeper, consistent with the pulley not rotating while in contact with the moving control cable. The pulley rotated smoothly when removed and operated by hand.

FAA Advisory Circular 43.13-1B Section 8, paragraph 7-149, Cable System Inspection, states that at each annual or 100-hour inspection, all control cables must be inspected for broken wire strands. Any cable assembly that has one broken wire strand located in a critical fatigue area must be replaced. A critical fatigue area is defined as the working length of a cable where the cable runs over, under, or around a pulley, sleeve, or through a fair lead.

Close inspection in these critical fatigue areas must be made by passing a cloth over the area to snag on broken wires.
