# Aviation Investigation Final Report

<b>Location:</b>	Conway, South Carolina	<b>Accident Number:</b>	ERA20LA129
<b>Date &amp; Time:</b>	March 17, 2020, 15:50 Local	<b>Registration:</b>	N150X
<b>Aircraft:</b>	Cirrus SR22	<b>Aircraft Damage:</b>	Substantial
<b>Defining Event:</b>	Loss of control in flight	<b>Injuries:</b>	1 None
<b>Flight Conducted Under:</b>	Part 91: General aviation - Personal

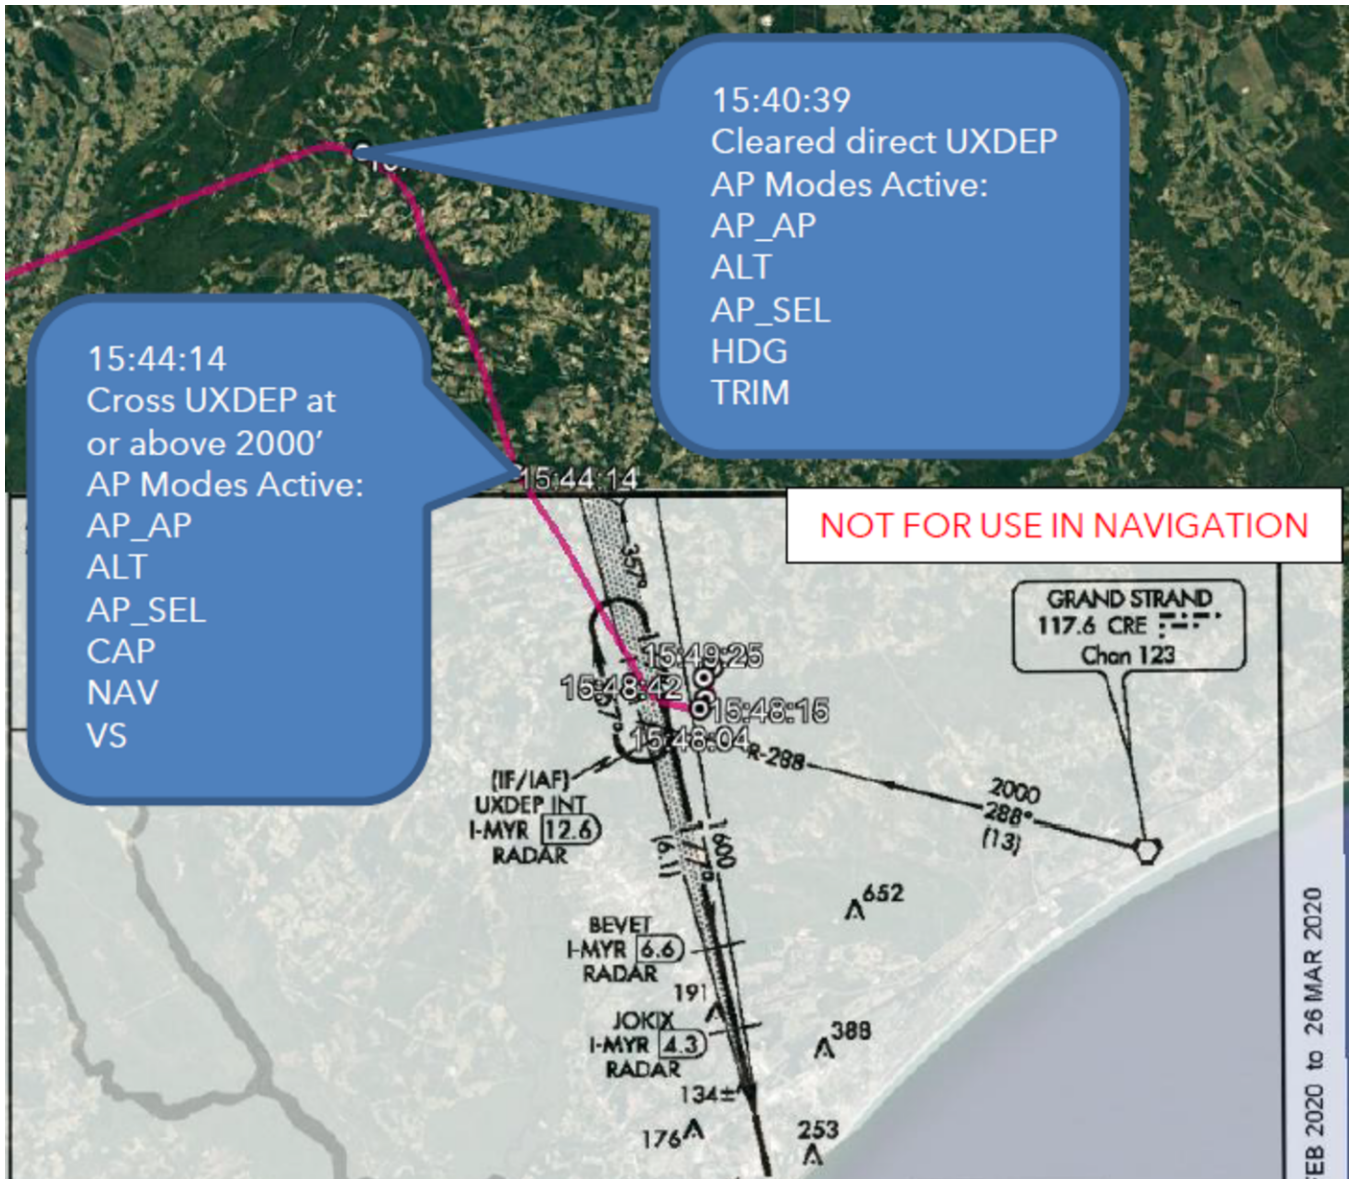
The downloaded data indicated that at 1544:07, autopilot course capture occurred. About 7 seconds later, the airplane was about 4,500 ft PA and 8 nautical miles northwest of UXDEP, when the controller instructed the pilot to cross UXDEP at or above 2,000 ft msl and cleared the flight for the ILS runway 18 approach (see figure 1).

Figure 1 – Flight track plot (purple) with selected moments overlaid on the MYR runway 18 ILS instrument approach procedure.

The flight continued towards UXDEP and continued to descend until about 1546 when it leveled off about 3,000 ft PA. At 1547:15, when the flight was about 1.4 nautical miles north-northwest of UXDEP on a south-southeasterly heading at about 3,000 ft PA, autopilot course captured occurred again, followed 1 second later by a turn to the left. It could not be determined from the available evidence what autopilot course was selected; the recorded data showed that the approach mode of the autopilot was never engaged and that autopilot failure did not occur.

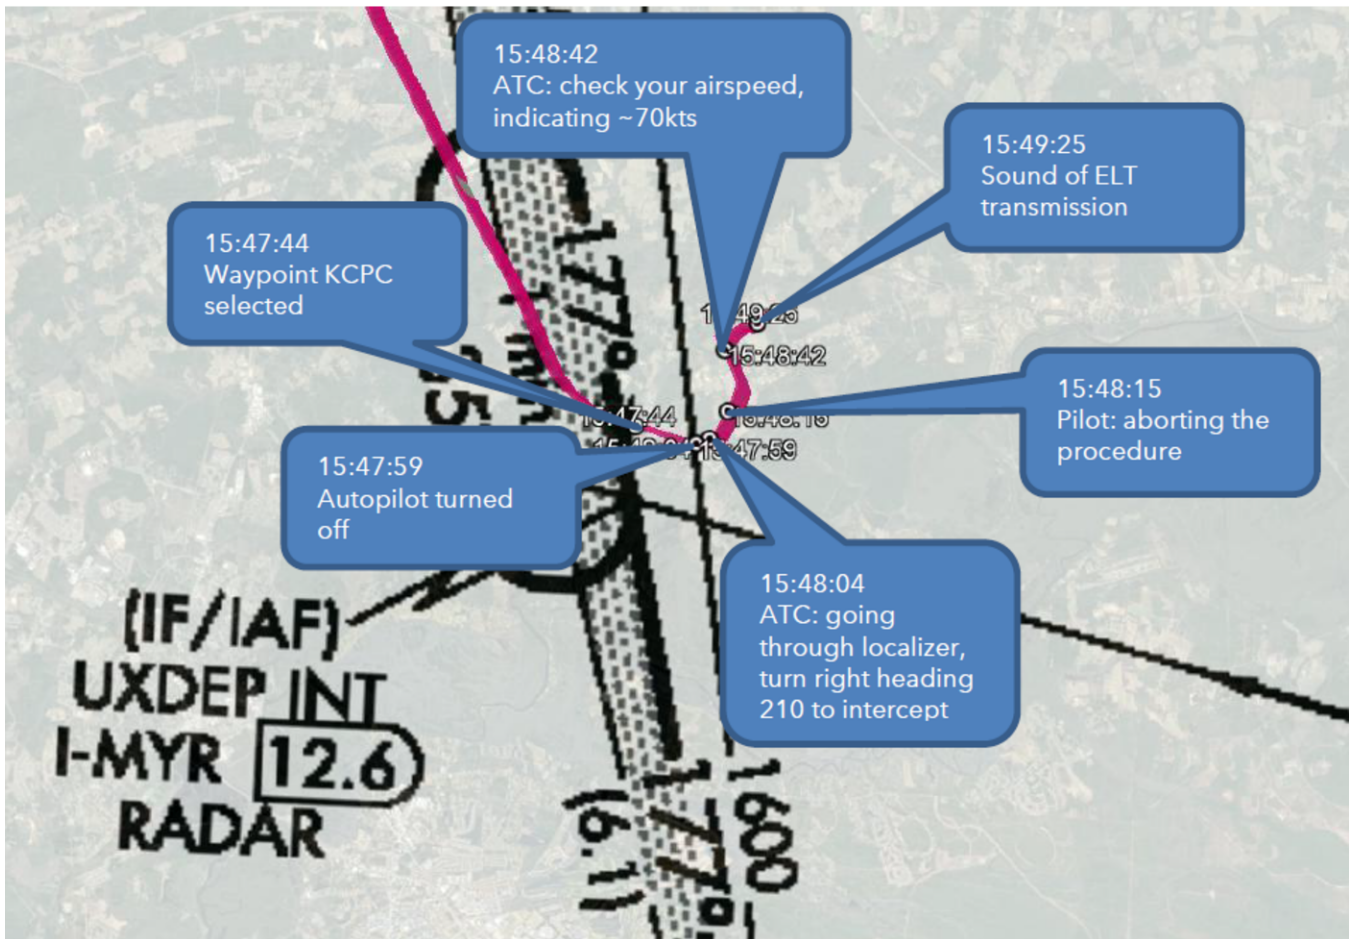
Between 1547:45 and 1547:59, with the autopilot vertical speed mode engaged, multiple short duration pitch trim-in-motion engagements occurred resulting in the airplane climbing. At 1547:59, as the flight passed outside of the outer edge of the localizer, the autopilot turned off (see figure 2). The pilot could not recall turning the autopilot off, and the reason for the autopilot turning off could not be determined from the available evidence.

Figure 2 - Flight track plot with selected events annotated.

Beginning at 1548:00 and lasting about 1 minute, a series of altitude excursions occurred during which the airplane repeatedly climbed and descended. At 1548:04, the controller advised the pilot that he was going through the localizer, and 11 seconds later, the pilot advised the controller that he was aborting the procedure and would “climb out.”
