# Aviation Investigation Final Report

<b>Location:</b>	Angostura, New Mexico	<b>Accident Number:</b>	WPR20LA121
<b>Date &amp; Time:</b>	April 10, 2020, 13:32 Local	<b>Registration:</b>	N2112A
<b>Aircraft:</b>	Piper PA-32RT-300T	<b>Aircraft Damage:</b>	Substantial
<b>Defining Event:</b>	Off-field or emergency landing	<b>Injuries:</b>	1 Minor
<b>Flight Conducted Under:</b>	Part 91: General aviation - Personal

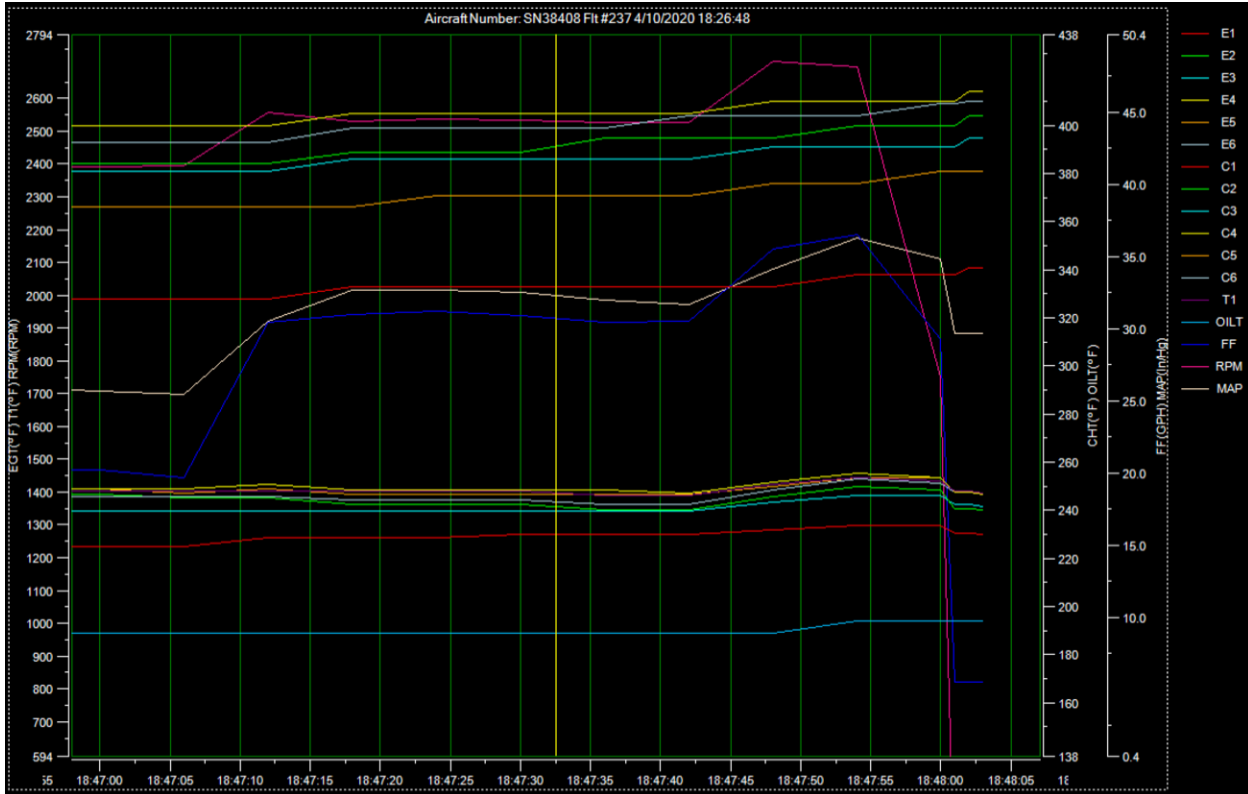
Figure 1: Portion of recorded engine data (last 1 minute, 5 seconds)

Postaccident examination of the recovered airframe and engine revealed no evidence of any preimpact mechanical malfunctions or failures that would have precluded normal operation. Engine data showed the engine operated normally throughout the flight and there were no anomalies prior to the data ending that would indicate the engine “sputtered” as reported by the pilot.

Recorded engine data captured the accident flight. The data showed that all recorded parameters were consistent with normal operation throughout the flight until about a unit time of 1847:06, fuel flow, manifold pressure, and engine RPM increased from about 20 gallons per hour (GPH), 25.6 inches, and 2,393 rpm, to about 31 GPH, 32.7 inches, and 2,531 rpm respectively. At a unit time of 1847:54, fuel flow, manifold pressure, and engine RPM further increased to 36.5 GPH, 36.3 inches, and 2,696 rpm, followed by a decrease that is consistent with the engine losing power or shut down normally, as seen in figure 1.
