Aviation Investigation Final Report

Location:	Camp Dwyer, Other Foreign	Accident Number:	DCA20LA100
Date & Time:	April 20, 2020, 08:00 Local	Registration:	N908CH
Aircraft:	Sikorsky S61	Aircraft Damage:	Substantial
Defining Event:	Flight control sys malf/fail	Injuries:	3 Serious
Flight Conducted Under:	Part 135: Air taxi & commuter - Non-scheduled

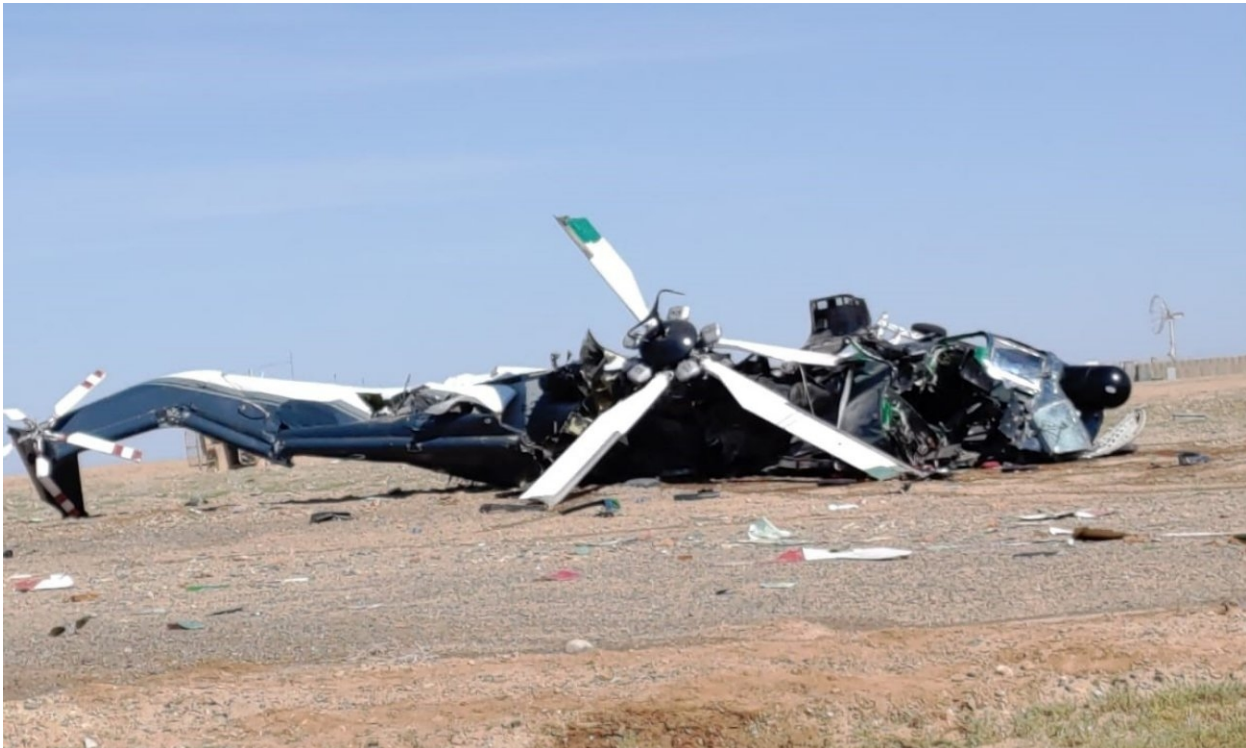
The helicopter came to rest on its right side on a magnetic heading of about 74°. The main fuselage had partially collapsed from impact, and the tailboom was twisted farther to the right than the main fuselage. The main rotor gearbox remained attached to the airframe, and the main rotor head remained installed. All five main rotor blade cuffs remained attached to the

Figure 2. Accident helicopter (Image courtesy of CHI Aviation)

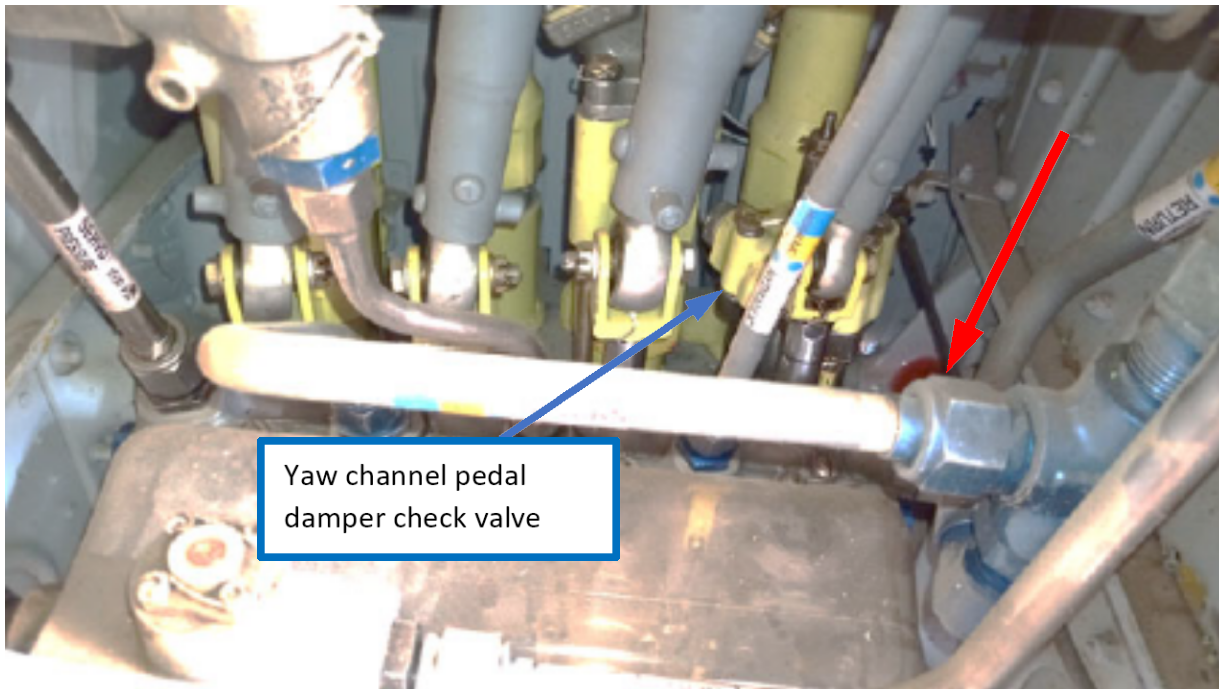
The auxiliary servo cylinder remained installed, and its surrounding structure had partially collapsed to the right. The input control tubes to the auxiliary servo cylinder remained connected at their rod ends, and the tubes were fractured at various locations. The output control tubes from the auxiliary servo cylinder remained connected at their rod ends, and there was no evidence of a disconnection of the control tubes leading up to the position of the mixing unit. The hydraulic lines to the auxiliary servo cylinder remained attached, and the plastic shield was intact. A small pool of hydraulic fluid was observed on the airframe to the right of the auxiliary servo cylinder.

Figure 3. Red arrow denotes small pool of hydraulic fluid visible to the right of the auxiliary servo cylinder. (Image courtesy of CHI Aviation)

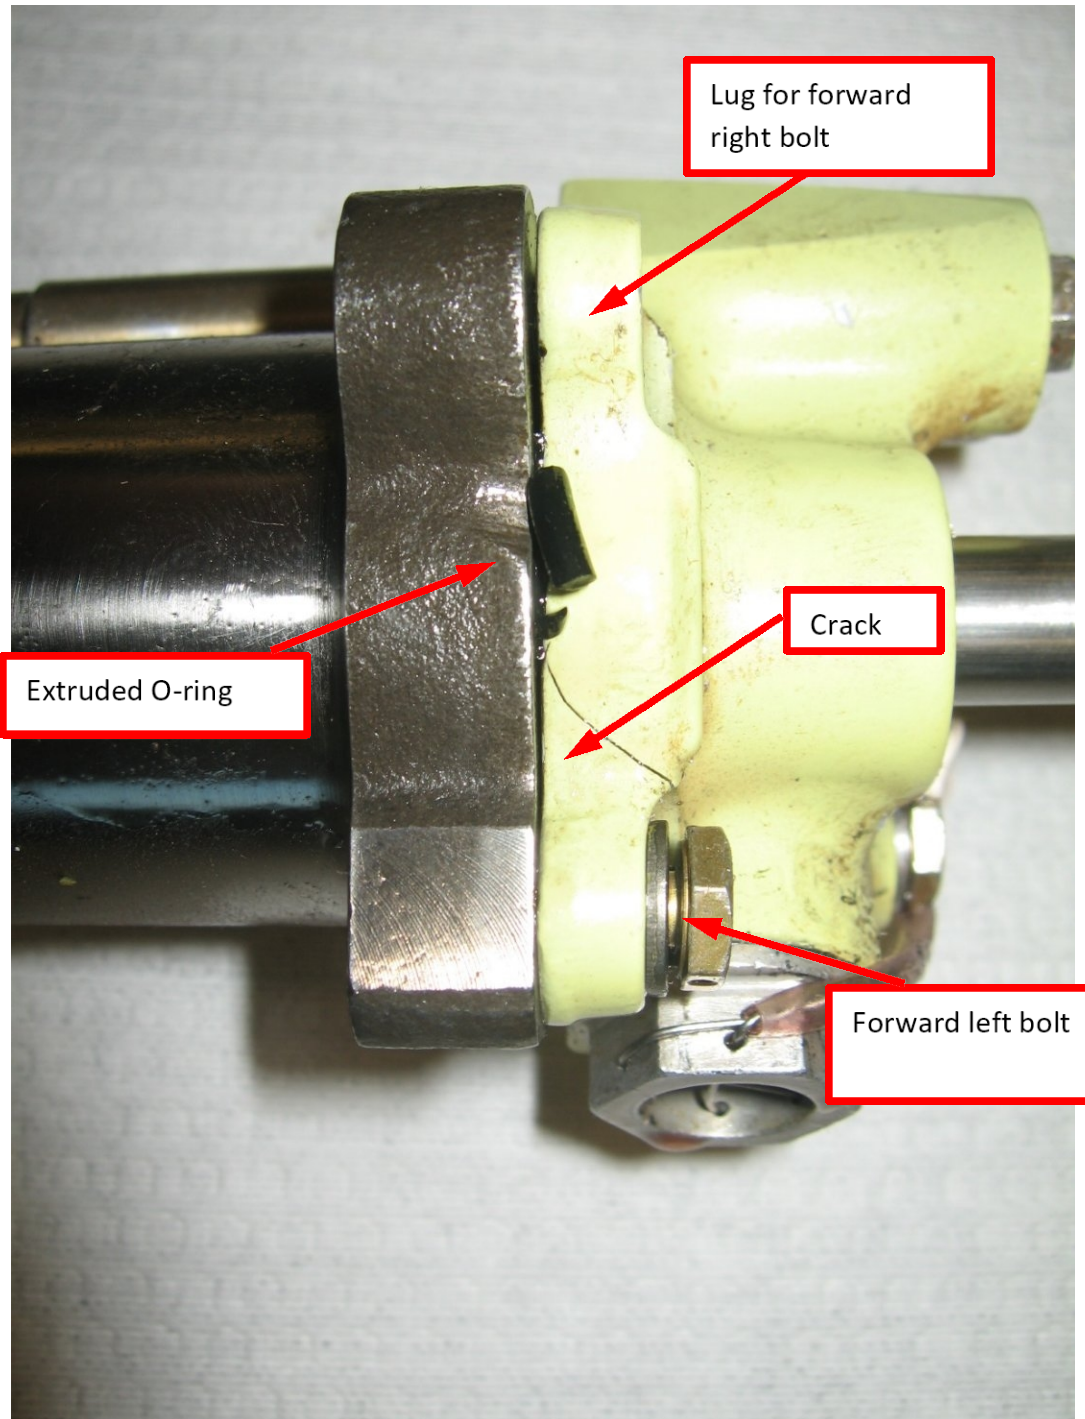
Further examination of the auxiliary servo cylinder assembly found that, on the yaw channel pedal damper check valve housing, the forward right bolt was fractured, but its bolt head remained attached to the safety wiring, which remained attached to the forward left bolt on the pedal damper check valve housing. An extruded piece of an O-ring near the fractured bolt was found at the interface between the pedal damper check valve and the pedal damper body. A crack was visible on the pedal damper check valve housing near the forward left bolt.

Figure 4. Pedal damper check valve housing installed on the pedal damper. (image courtesy of Sikorsky)

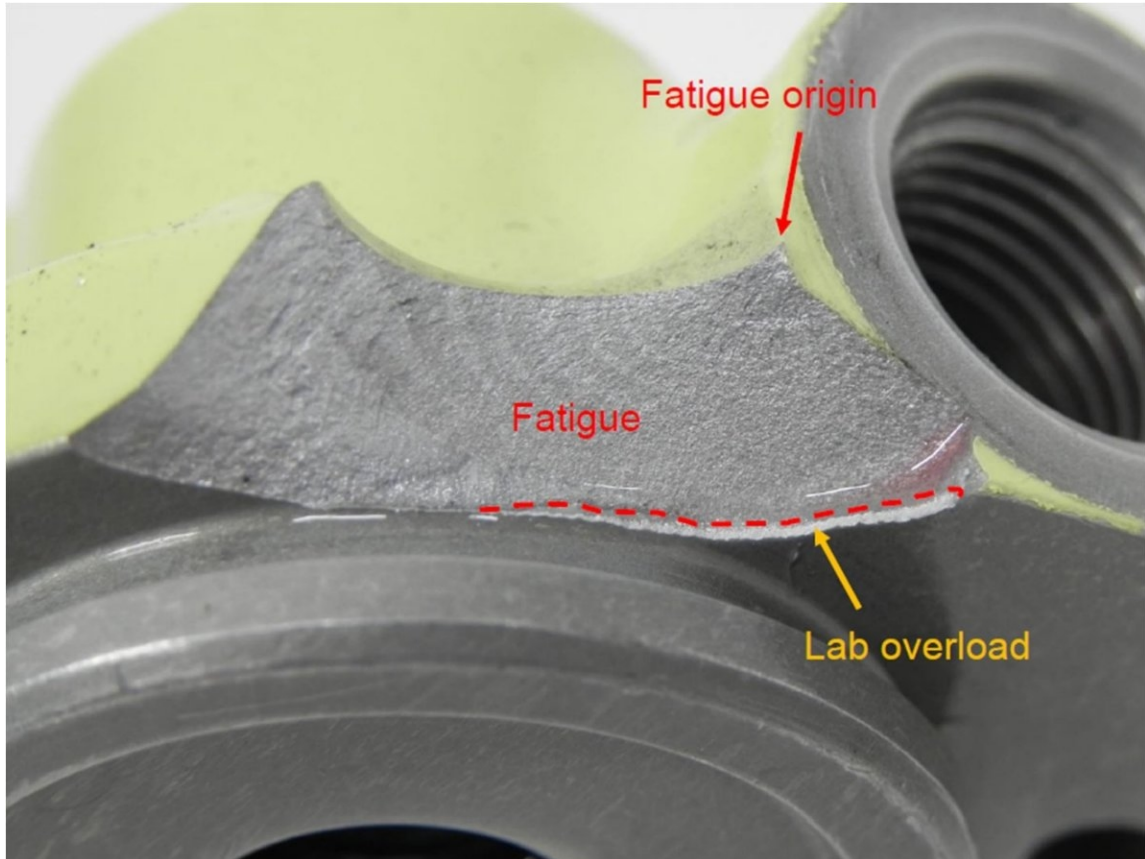
The pedal damper check valve conformed to drawing requirements except that the edge where the fatigue crack initiated, which had a radius of about 0.003 inches, did not conform to the drawing requirement for all sharp edges to have a radius between 0.005 and 0.015 inches. The nonconforming edge break was likely a factor in the initiation of the fatigue crack on the pedal damper check valve housing bolt lug. However, given the large area of stable fatigue crack growth on the pedal damper check valve housing, the loads on the pedal damper check valve housing bolt lug were likely low. Thus, the nonconforming edge break was likely not the only factor that led to the initiation of the fatigue crack.

The check valve housing crack fracture surface exhibited fatigue on most of the surface. The fatigue fracture surface showed no evidence of damage or contact wear. A red-colored oil consistent with hydraulic fluid was present within the crack. The fatigue origin was located near the radius of the forward left lug. The radius was measured to be about 0.003 inches, which did not conform with drawing requirements for all sharp edges to be from 0.005 to 0.015 inches. (Such edge breaks can be used to reduce stress concentrations, which could otherwise lead to fatigue cracks.) The material composition and hardness conformed to drawing requirements, and the microstructure appeared typical for the material.

Figure 5. Areas of fatigue cracking identified on the forward-left lug of the pedal damper check valve housing. (Image courtesy of Sikorsky)

On October 17, 2022, Sikorsky released an alert service bulletin that addressed the inspection of the auxiliary servo cylinder pedal damper check valve housing. In addition, Sikorsky implemented a daily inspection of the check valve housing and a 30,000-hour life limit for the check valve housing
