# Aviation Investigation Final Report

<b>Location:</b>	Camp Dwyer, Afghanistan	<b>Accident Number:</b>	DCA20LA100
<b>Date &amp; Time:</b>	April 20, 2020, 08:00 Local	<b>Registration:</b>	N908CH
<b>Aircraft:</b>	Sikorsky S61	<b>Aircraft Damage:</b>	Substantial
<b>Defining Event:</b>	Flight control sys malf/fail	<b>Injuries:</b>	3 Serious
<b>Flight Conducted Under:</b>	Part 135: Air taxi & commuter - Non-scheduled

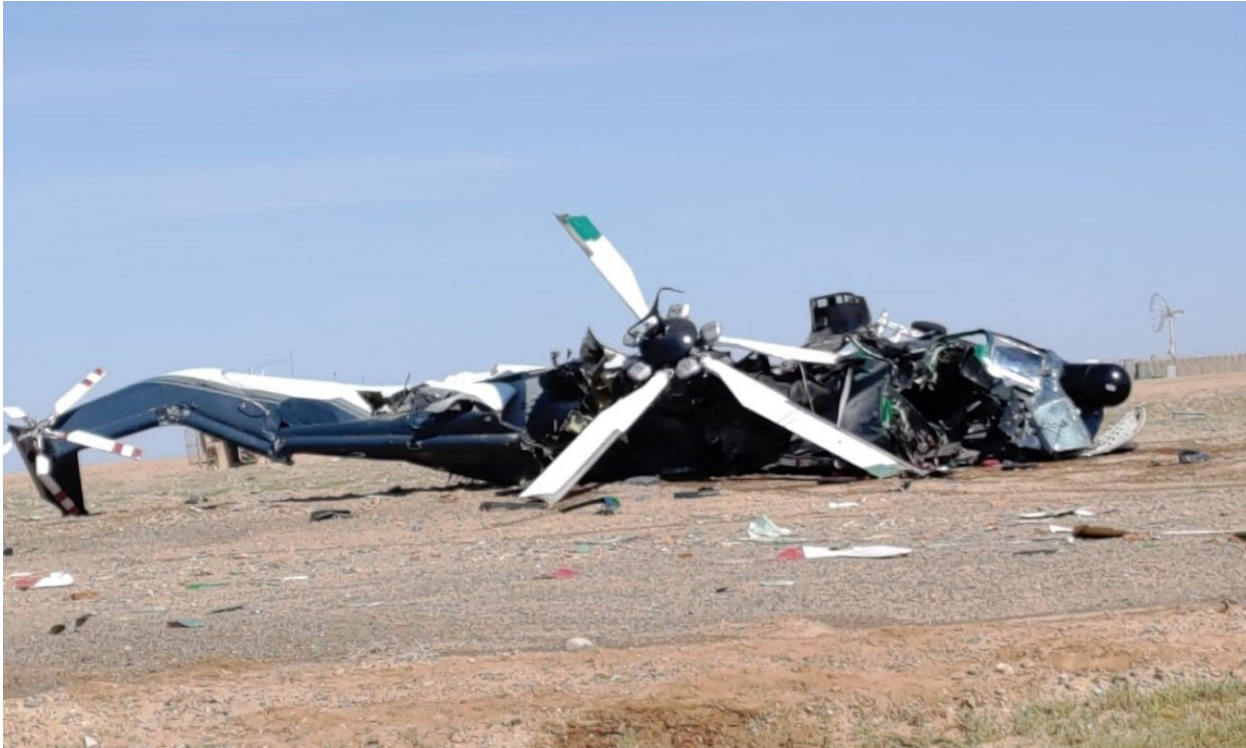
The helicopter came to rest on its right side on a magnetic heading of about 74°. The main fuselage had partially collapsed from impact, and the tailboom was twisted farther to the right than the main fuselage. The main rotor gearbox remained attached to the airframe, and the main rotor head remained installed. All five main rotor blade cuffs remained attached to the main rotor head. The inboard sections of four main rotor blades remained attached to their respective cuffs, and the outboard sections of the blades were found near the main wreckage.

Figure 2. Accident helicopter (Image courtesy of CHI Aviation)

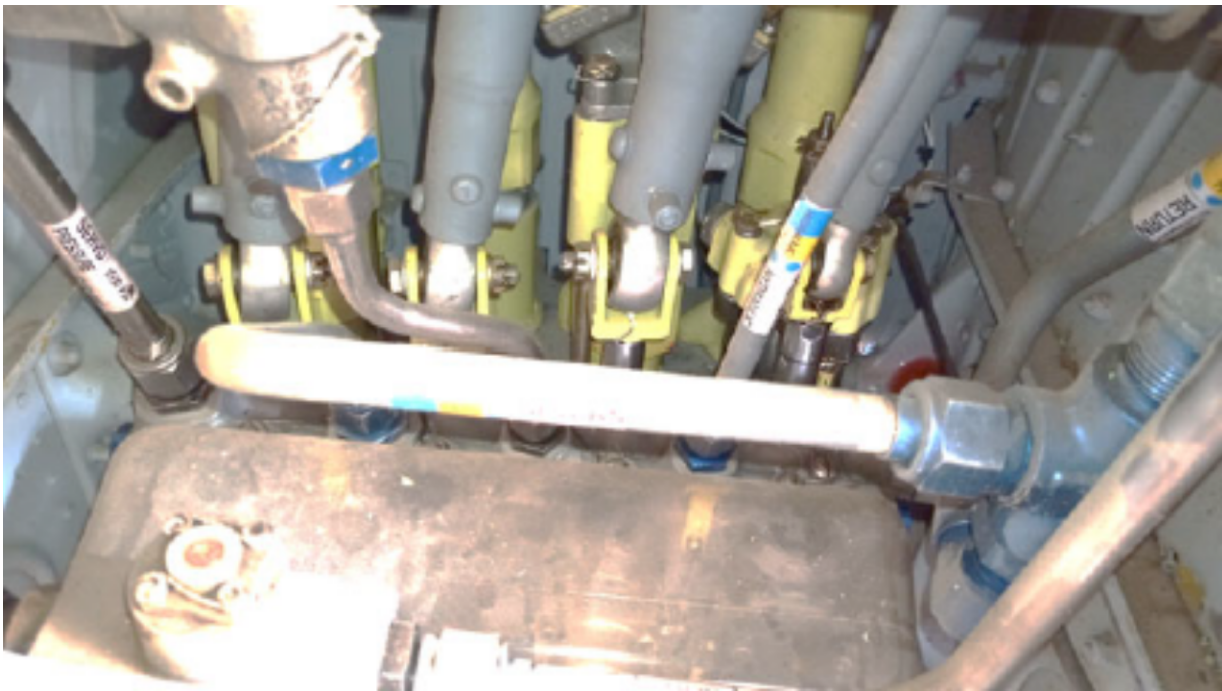
The auxiliary servo cylinder remained installed, and its surrounding structure had partially collapsed to the right. The input control tubes to the auxiliary servo cylinder remained connected at their rod ends, and the tubes were fractured at various locations. The output control tubes from the auxiliary servo cylinder remained connected at their rod ends, and there was no evidence of a disconnection of the control tubes leading up to the position of the mixing unit. The hydraulic lines to the auxiliary servo cylinder remained attached, and the plastic shield was intact. A small pool of hydraulic fluid was observed on the airframe to the right of the auxiliary servo cylinder.

Figure 3. Red arrow denotes small pool of hydraulic fluid visible to the right of the auxiliary servo cylinder. (Image courtesy of CHI Aviation)

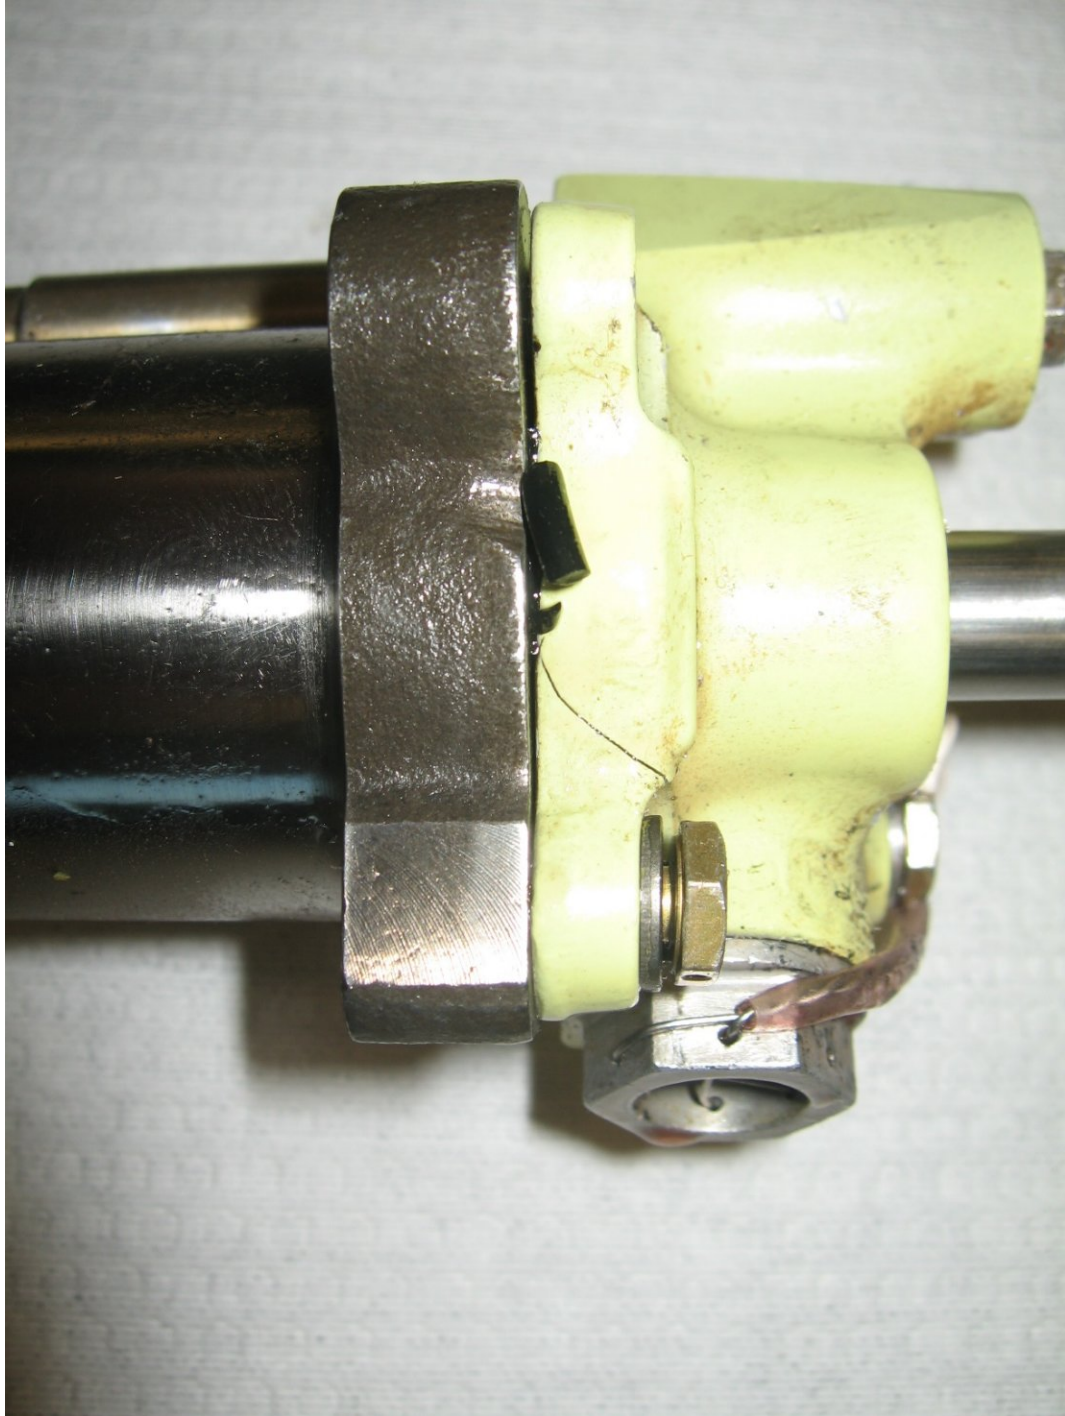
Further examination of the auxiliary servo cylinder assembly found that, on the yaw channel pedal damper check valve housing, the forward right bolt was fractured, but its bolt head remained attached to the safety wiring, which remained attached to the forward left bolt on the pedal damper check valve housing. An extruded piece of an O-ring near the fractured bolt was found at the interface between the pedal damper check valve and the pedal damper body. A crack was visible on the pedal damper check valve housing near the forward left bolt.

Figure 4. Pedal damper check valve housing installed on the pedal damper. (image courtesy of Sikorsky)

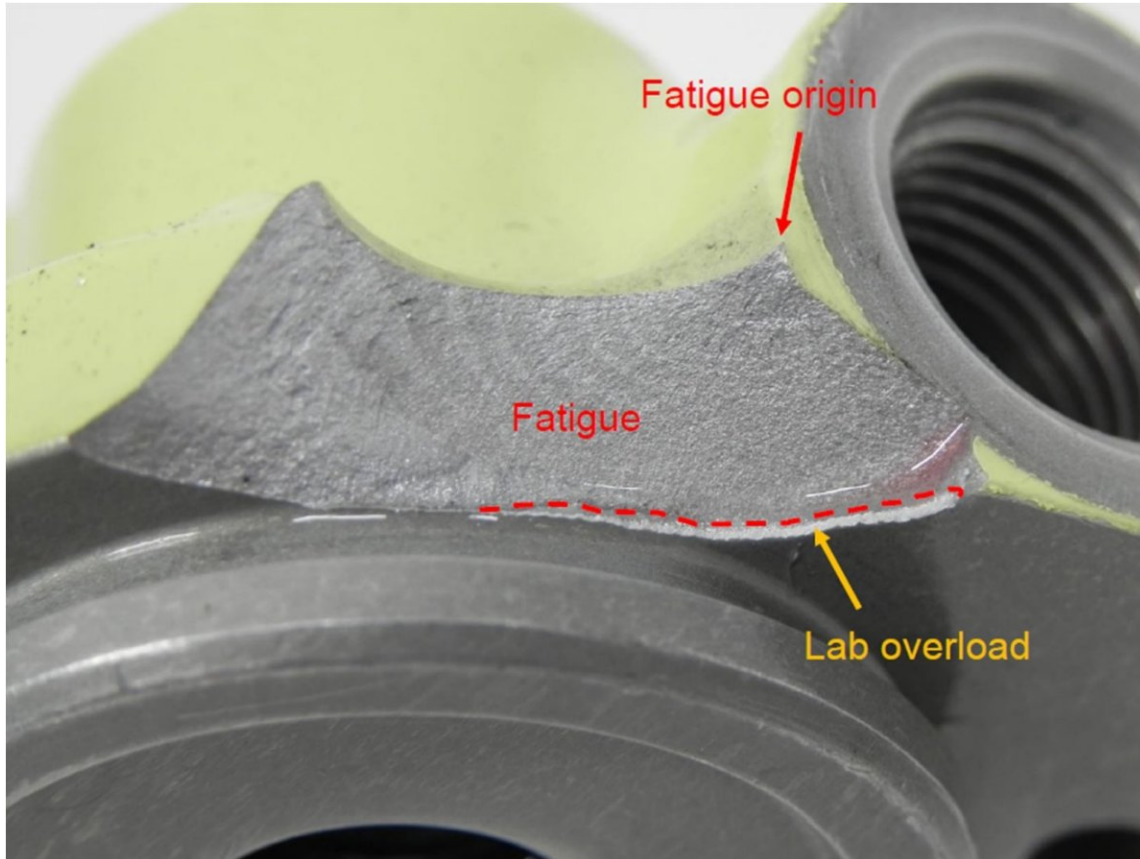
The pedal damper check valve conformed to drawing requirements except that the edge where the fatigue crack initiated, which had a radius of about 0.003 inches, did not conform to the drawing requirement for all sharp edges to have a radius between 0.005 and 0.015 inches. The nonconforming edge break was likely a factor in the initiation of the fatigue crack on the pedal damper check valve housing bolt lug. However, given the large area of stable fatigue crack growth on the pedal damper check valve housing, the loads on the pedal damper check valve housing bolt lug were likely low. Thus, the nonconforming edge break was likely not the only factor that led to the initiation of the fatigue crack.

The check valve housing crack fracture surface exhibited fatigue on most of the surface. The fatigue fracture surface showed no evidence of damage or contact wear. A red-colored oil consistent with hydraulic fluid was present within the crack. The fatigue origin was located near the radius of the forward left lug. The radius was measured to be about 0.003 inches, which did not conform with drawing requirements for all sharp edges to be from 0.005 to 0.015 inches. (Such edge breaks can be used to reduce stress concentrations, which could otherwise lead to fatigue cracks.) The material composition and hardness conformed to drawing requirements, and the microstructure appeared typical for the material.

Figure 5. Areas of fatigue cracking identified on the forward-left lug of the pedal damper check valve housing. (Image courtesy of Sikorsky)

On October 17, 2022, Sikorsky released an alert service bulletin that addressed the inspection of the auxiliary servo cylinder pedal damper check valve housing. In addition, Sikorsky implemented a daily inspection of the check valve housing and a 30,000-hour life limit for the check valve housing
