Aviation Investigation Final Report

Location:	Camp Dwyer, Other Foreign	Accident Number:	DCA20LA100
Date & Time:	April 20, 2020, 08:00 Local	Registration:	N908CH
Aircraft:	Sikorsky S61	Aircraft Damage:	Substantial
Defining Event:	Flight control sys malf/fail	Injuries:	3 Serious
Flight Conducted Under:	Part 135: Air taxi & commuter - Non-scheduled

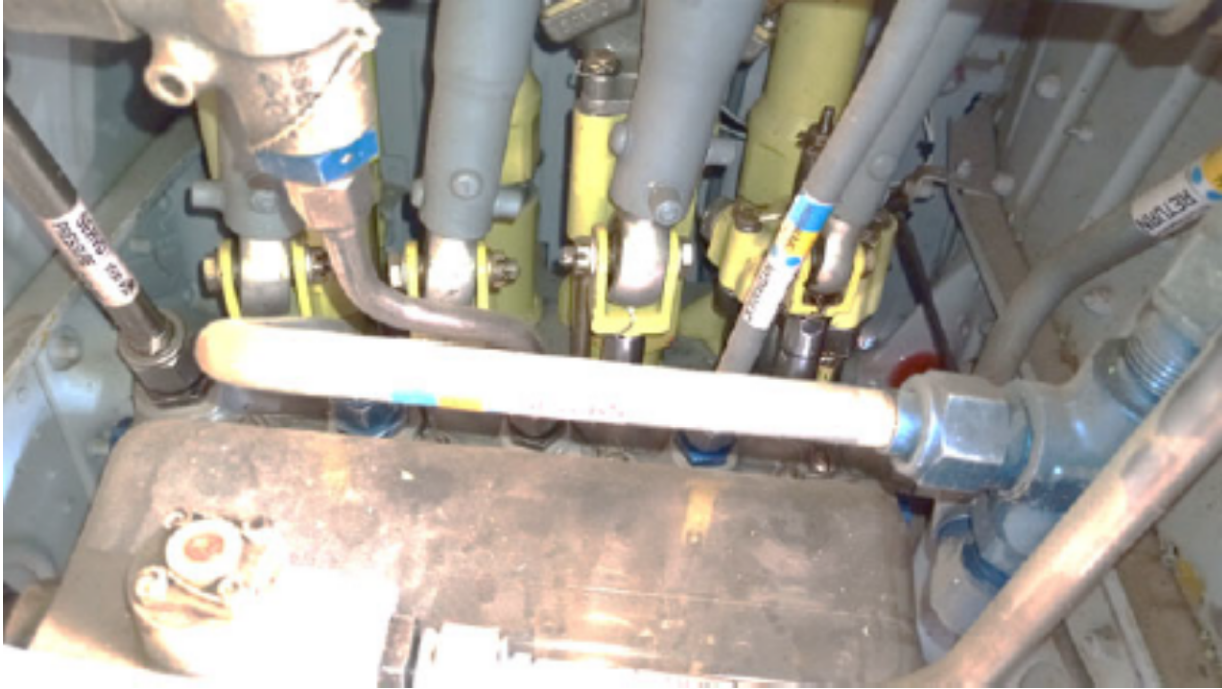
The auxiliary servo cylinder remained installed, and its surrounding structure had partially collapsed to the right. The input control tubes to the auxiliary servo cylinder remained connected at their rod ends, and the tubes were fractured at various locations. The output control tubes from the auxiliary servo cylinder remained connected at their rod ends, and there was no evidence of a disconnection of the control tubes leading up to the position of the mixing unit. The hydraulic lines to the auxiliary servo cylinder remained attached, and the plastic shield was intact. A small pool of hydraulic fluid was observed on the airframe to the right of the auxiliary servo cylinder.

Figure 3. Red arrow denotes small pool of hydraulic fluid visible to the right of the auxiliary servo cylinder. (Image courtesy of CHI Aviation)

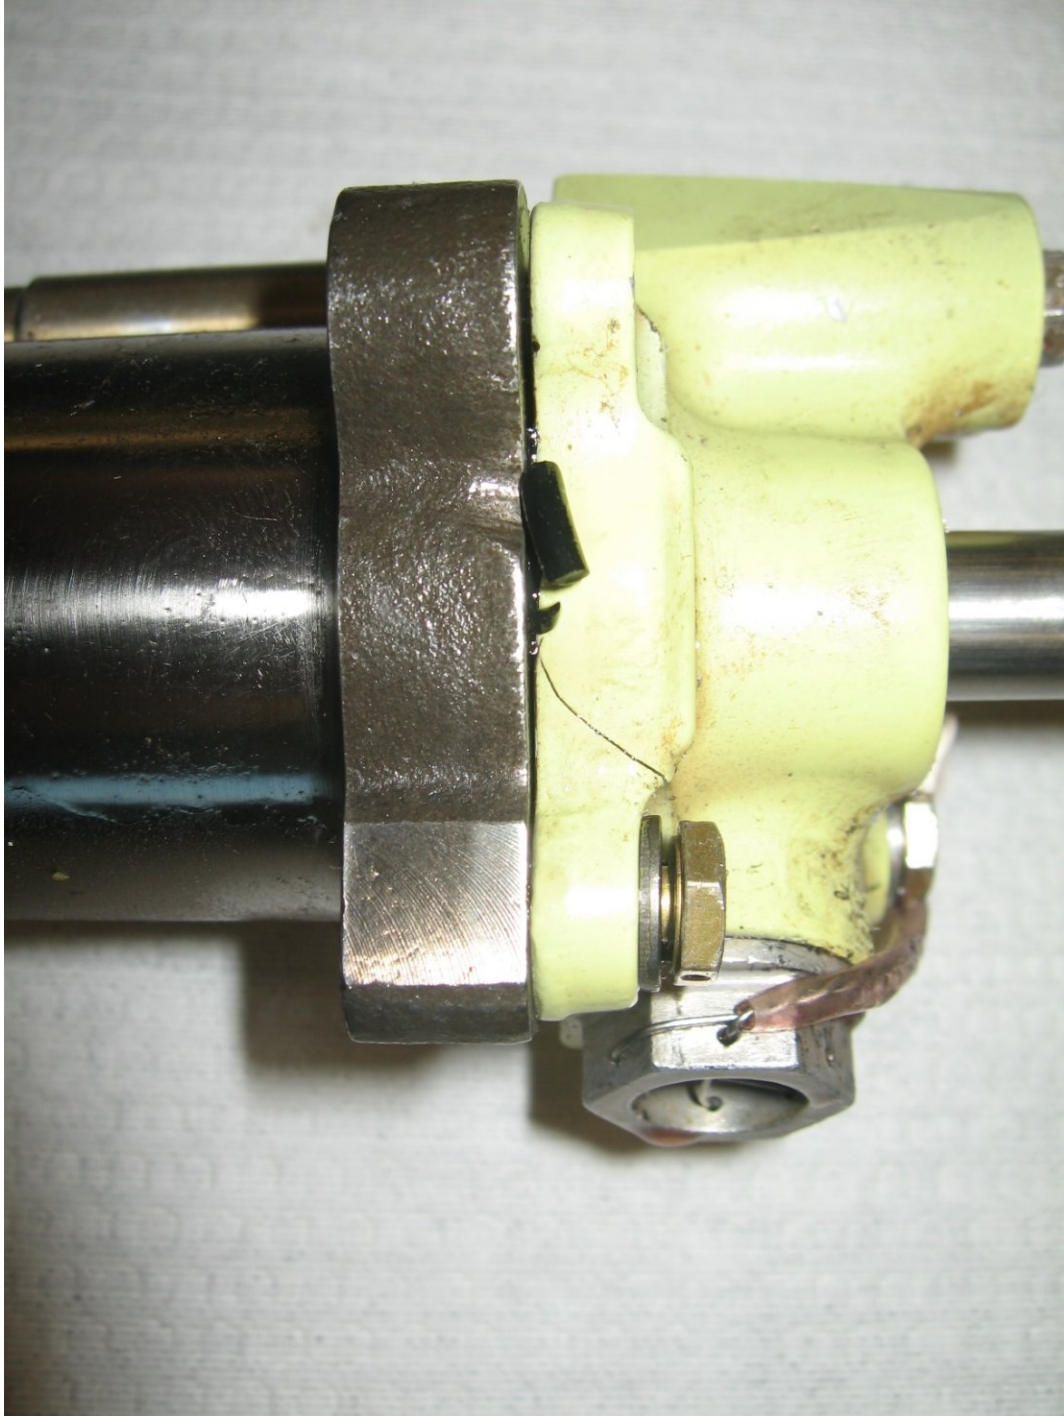
Further examination of the auxiliary servo cylinder assembly found that, on the yaw channel pedal damper check valve housing, the forward right bolt was fractured, but its bolt head remained attached to the safety wiring, which remained attached to the forward left bolt on the pedal damper check valve housing. An extruded piece of an O-ring near the fractured bolt was found at the interface between the pedal damper check valve and the pedal damper body. A crack was visible on the pedal damper check valve housing near the forward left bolt.

Figure 4. Pedal damper check valve housing installed on the pedal damper. (image courtesy of Sikorsky)

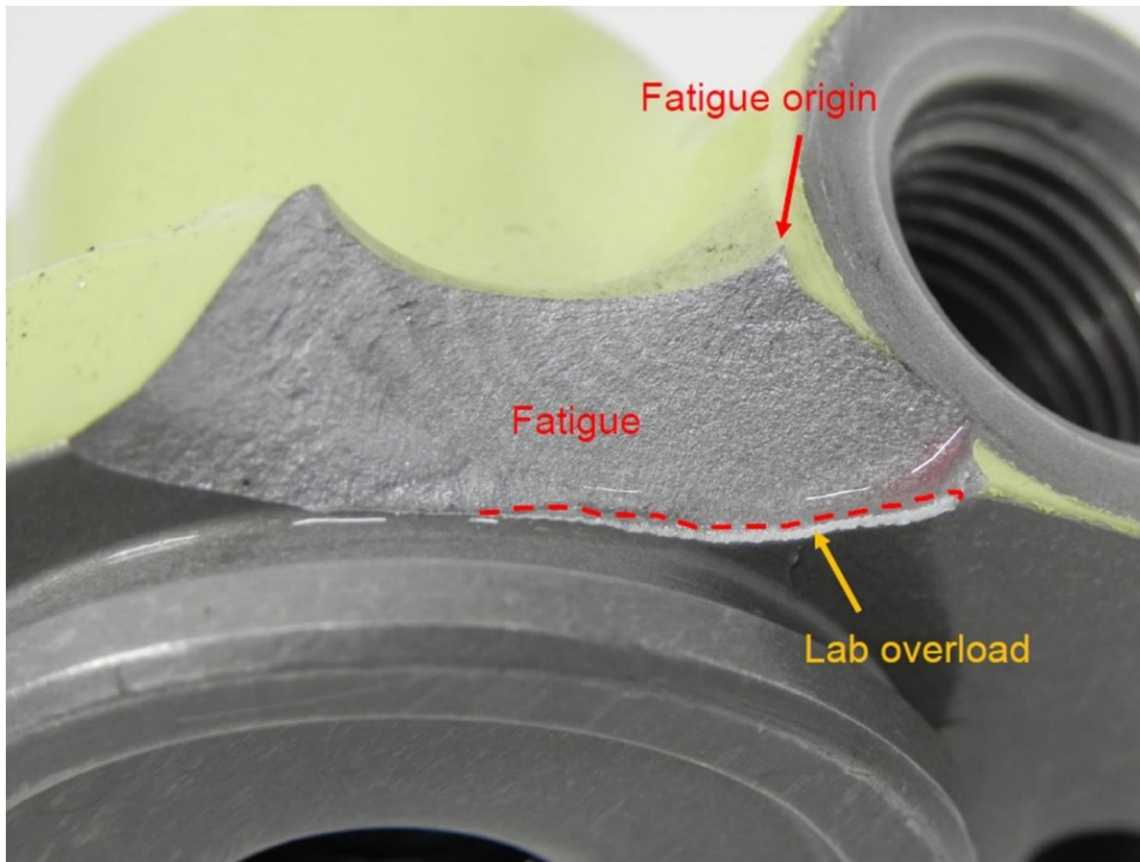
The pedal damper check valve conformed to drawing requirements except that the edge where the fatigue crack initiated, which had a radius of about 0.003 inches, did not conform to the drawing requirement for all sharp edges to have a radius between 0.005 and 0.015 inches. The nonconforming edge break was likely a factor in the initiation of the fatigue crack on the pedal damper check valve housing bolt lug. However, given the large area of stable fatigue crack growth on the pedal damper check valve housing, the loads on the pedal damper check valve housing bolt lug were likely low. Thus, the nonconforming edge break was likely not the only factor that led to the initiation of the fatigue crack.

The check valve housing crack fracture surface exhibited fatigue on most of the surface. The fatigue fracture surface showed no evidence of damage or contact wear. A red-colored oil consistent with hydraulic fluid was present within the crack. The fatigue origin was located near the radius of the forward left lug. The radius was measured to be about 0.003 inches, which did not conform with drawing requirements for all sharp edges to be from 0.005 to 0.015 inches. (Such edge breaks can be used to reduce stress concentrations, which could otherwise lead to fatigue cracks.) The material composition and hardness conformed to drawing requirements, and the microstructure appeared typical for the material.

Figure 5. Areas of fatigue cracking identified on the forward-left lug of the pedal damper check valve housing. (Image courtesy of Sikorsky)

On October 17, 2022, Sikorsky released an alert service bulletin that addressed the inspection of the auxiliary servo cylinder pedal damper check valve housing. In addition, Sikorsky implemented a daily inspection of the check valve housing and a 30,000-hour life limit for the check valve housing
