Aviation Investigation Final Report

Location:	Camp Dwyer, Other Foreign	Accident Number:	DCA20LA100
Date & Time:	April 20, 2020, 08:00 Local	Registration:	N908CH
Aircraft:	Sikorsky S61	Aircraft Damage:	Substantial
Defining Event:	Flight control sys malf/fail	Injuries:	3 Serious
Flight Conducted Under:	Part 135: Air taxi & commuter - Non-scheduled

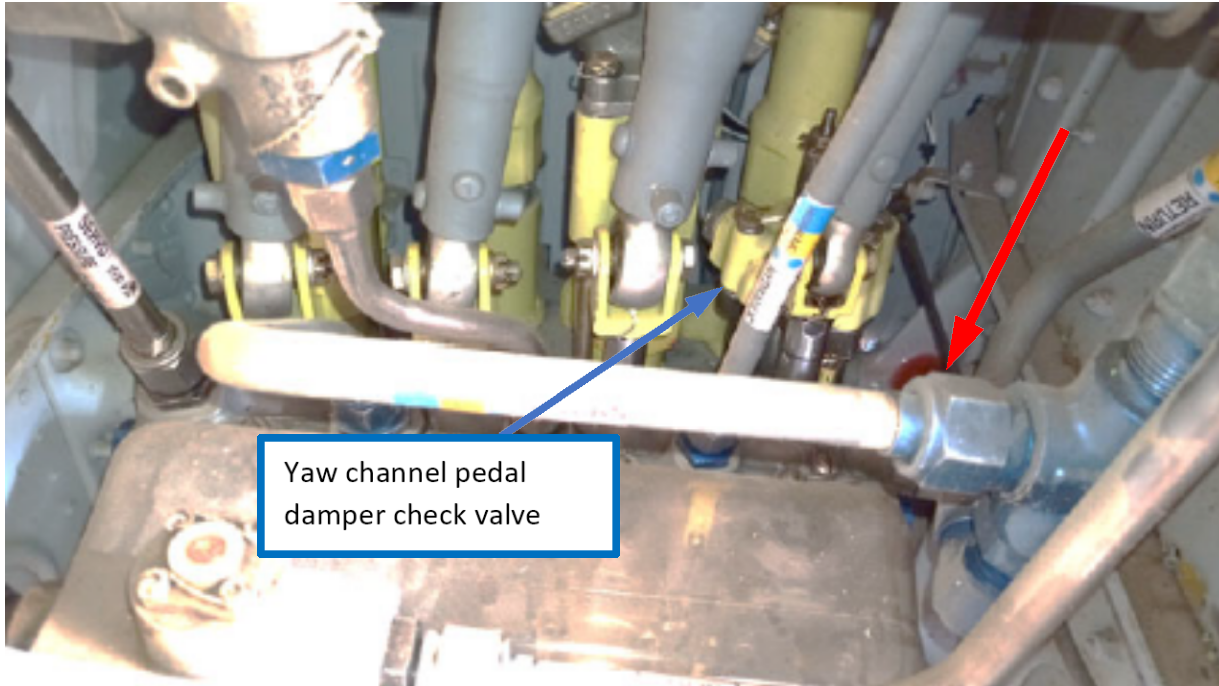
The auxiliary servo cylinder remained installed, and its surrounding structure had partially collapsed to the right. The input control tubes to the auxiliary servo cylinder remained connected at their rod ends, and the tubes were fractured at various locations. The output control tubes from the auxiliary servo cylinder remained connected at their rod ends, and there was no evidence of a disconnection of the control tubes leading up to the position of the mixing unit. The hydraulic lines to the auxiliary servo cylinder remained attached, and the plastic shield was intact. A small pool of hydraulic fluid was observed on the airframe to the right of the auxiliary servo cylinder.

Figure 3. Red arrow denotes small pool of hydraulic fluid visible to the right of the auxiliary servo cylinder. (Image courtesy of CHI Aviation)
