# Aviation Investigation Final Report

<b>Location:</b>	Pylesville, Maryland	<b>Accident Number:</b>	ERA20LA160
<b>Date &amp; Time:</b>	April 25, 2020, 12:40 Local	<b>Registration:</b>	N9159F
<b>Aircraft:</b>	Hughes 369	<b>Aircraft Damage:</b>	Substantial
<b>Defining Event:</b>	Fuel starvation	<b>Injuries:</b>	1 None
<b>Flight Conducted Under:</b>	Part 133: Rotorcraft ext. load

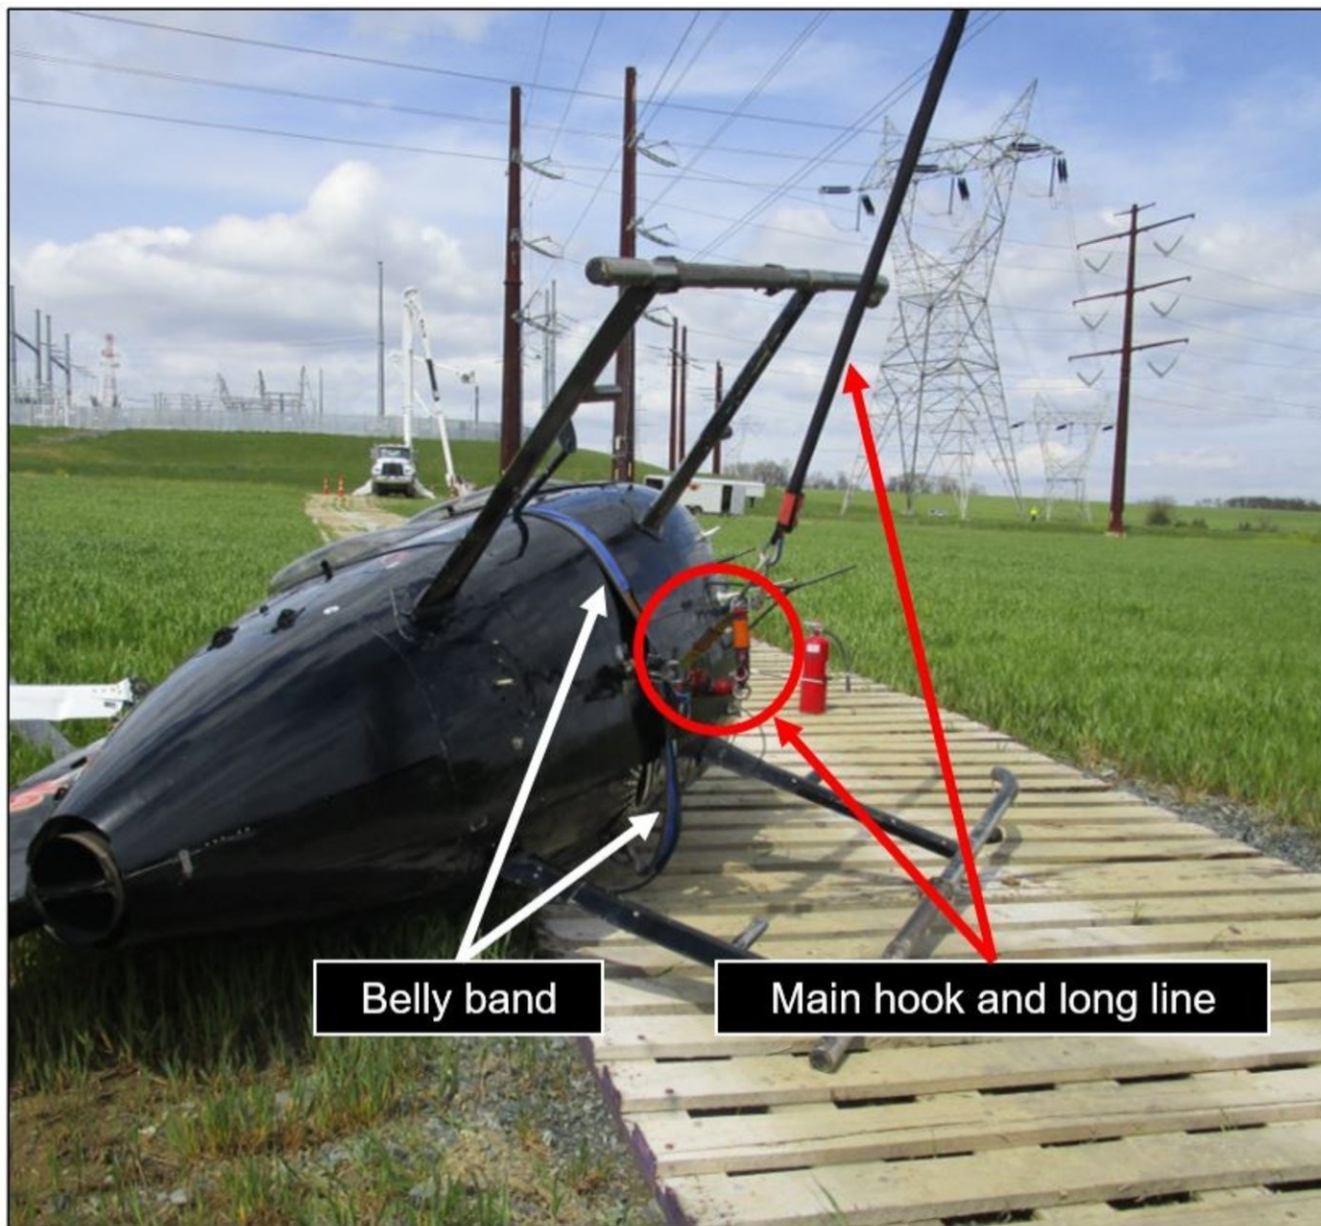
As the helicopter entered the flare, the pilot pulled the collective up to complete the autorotative landing, but the long line, which remained attached to the helicopter and conductor wire, became taut and caused the helicopter to roll onto its left side. The main rotor blades impacted the ground.

The following figure shows the belly band around the fuselage, the main hook, and long line.

Figure. View of the helicopter at the accident site

Photographs provided by a Federal Aviation Administration (FAA) inspector who examined the helicopter at the accident site found that the helicopter had rolled over and come to rest on its left side, and the long line remained attached from the main hook on the helicopter to the power line. The tail boom and main/tail rotors sustained substantial damage. There was no evidence of fuel spillage at the accident site.
