# Aviation Investigation Final Report

<b>Location:</b>	Hemet, California	<b>Accident Number:</b>	WPR20LA135
<b>Date &amp; Time:</b>	April 30, 2020, 12:30 Local	<b>Registration:</b>	N6521Y
<b>Aircraft:</b>	Piper PA-23-250	<b>Aircraft Damage:</b>	Substantial
<b>Defining Event:</b>	Flight control sys malf/fail	<b>Injuries:</b>	1 Fatal
<b>Flight Conducted Under:</b>	Part 91: General aviation - Other work use

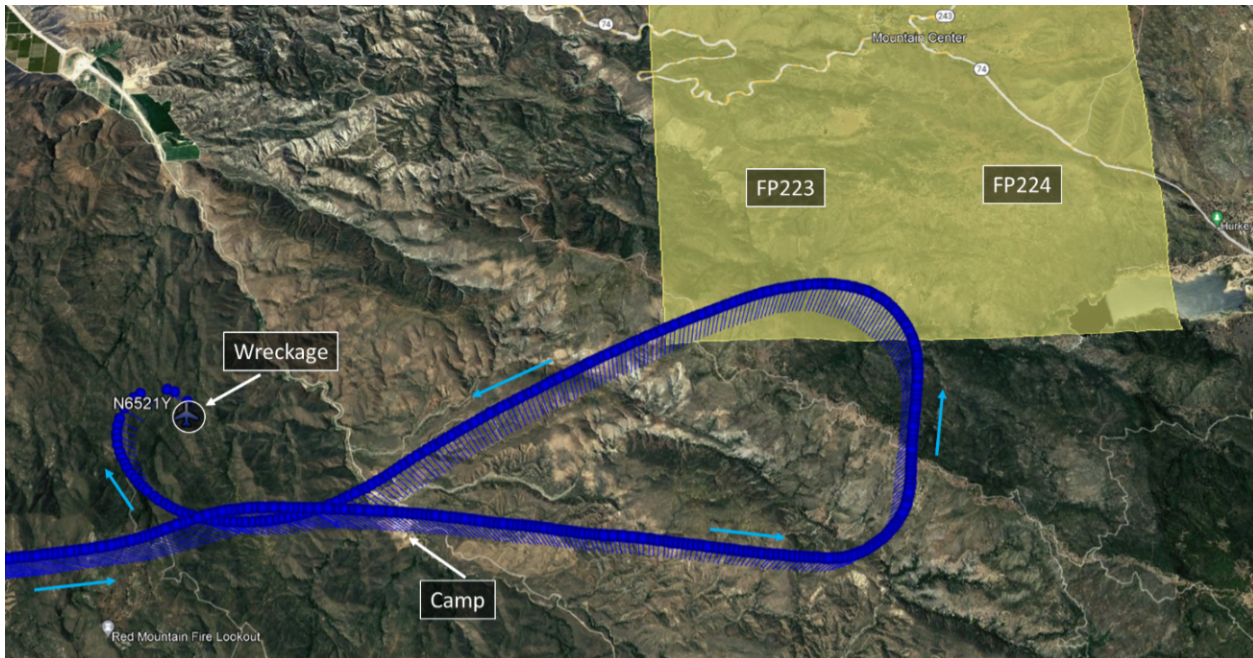
Recorded automatic dependent surveillance-broadcast (ADS-B) data revealed the accident airplane departed CNO about 1131, climbed to an altitude of about 8,500 ft msl, established a ground speed of about 164 knots, and tracked southeast for about 42 miles. About 5 miles northwest of Diamond Valley Lake, the airplane descended to 8100 ft and decelerated to 130 knots before turning east. The airplane proceeded eastward for about 15 miles, passing near a Camp, a cleared area with several buildings located at the base of a valley. The airplane continued east for about 3 miles, then turned north, consistent with tracking toward the FP224’s southern boundary. About 1 minute later, and prior to entering FP224, the airplane began a left turn and a descent. During the left turn, the airplane traversed through FP223 to the southwest and maintained the new heading for about 3.5 miles, until crossing over the Camp again. From there, the airplane began a right turn and continued to descend. The last data point recorded at 1200, revealed the airplane about 4,400 ft mean sea level (msl), or 1,000 ft above ground level (agl), about 177 knots ground speed, and about 950 ft northeast of the accident site. Figure 1 shows the ADS-B derived flightpath.

Figure 1. Capture of ADS-B data. The blue arrows show the direction of flight.

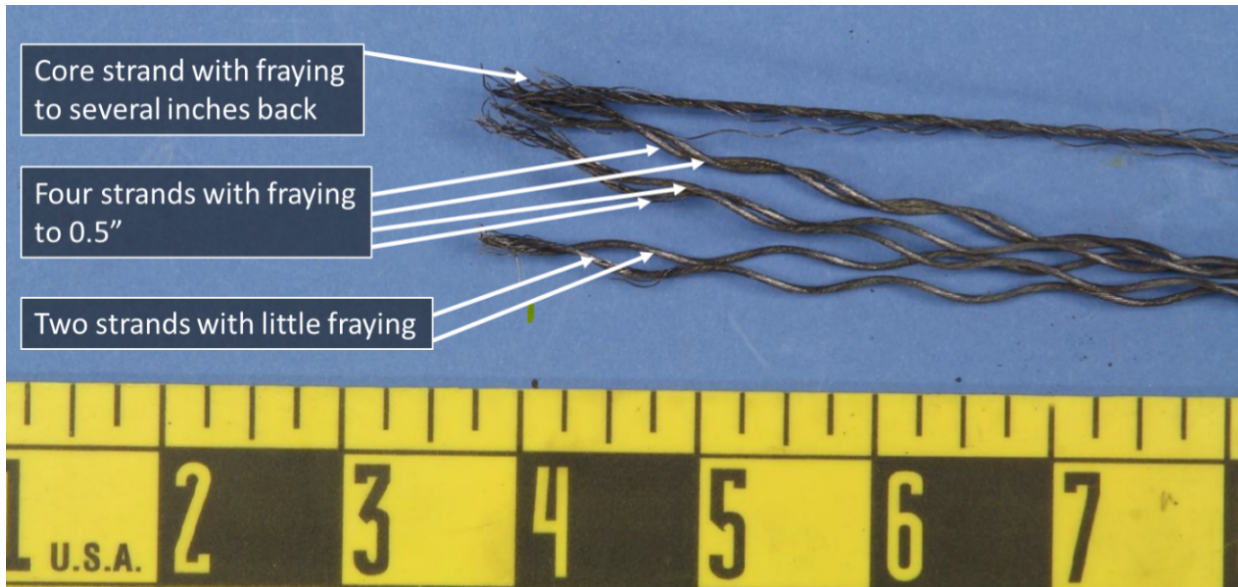
Examination of the aileron control by the NTSB materials laboratory revealed that a cable had broken under fatigue in a location near the aileron control bellcrank, likely resulting in a loss of control of the airplane. The airplane was maintained in accordance with the operator's annual maintenance schedule; however, postaccident examination of the aileron control cable revealed that in addition to the fatigue break, multiple individual broken wires were discovered protruding from the strands, which would have required replacement of the cable upon discovery during required checks of the cable.

Post-accident visual examination of the aileron control cable exhibited multiple broken wires protruding from the strands and a separation fracture located between the left aileron bellcrank and the cable junction for the control yokes. Examination of the cable by the NTSB materials laboratory revealed the cable consisted of six strands wrapped about a central core

strand. All the strands had fractured in approximately the same location, perpendicular to the cable direction. Two of the strands exhibited little fraying of the wires, whereas the other four exhibited local fraying upwards of 0.5 inch from the fracture surface. The core strand exhibited fraying several inches from the fracture surface. Further examination revealed numerous wires fractured by overload and others fractured by fatigue, with some cracked by fatigue and then fractured by overload. Figure 2 is showing the fracture of the aileron cable, and Figure 3 is showing an example of the broken wires on the aileron control cable.

Figure 2. View of the aileron control cable.

Note 9. Examine cables for broken strands by wiping them with a cloth for the entire length. Visually inspect the cable thoroughly for damage not detected by the cloth. Replace any damaged or frayed cables.

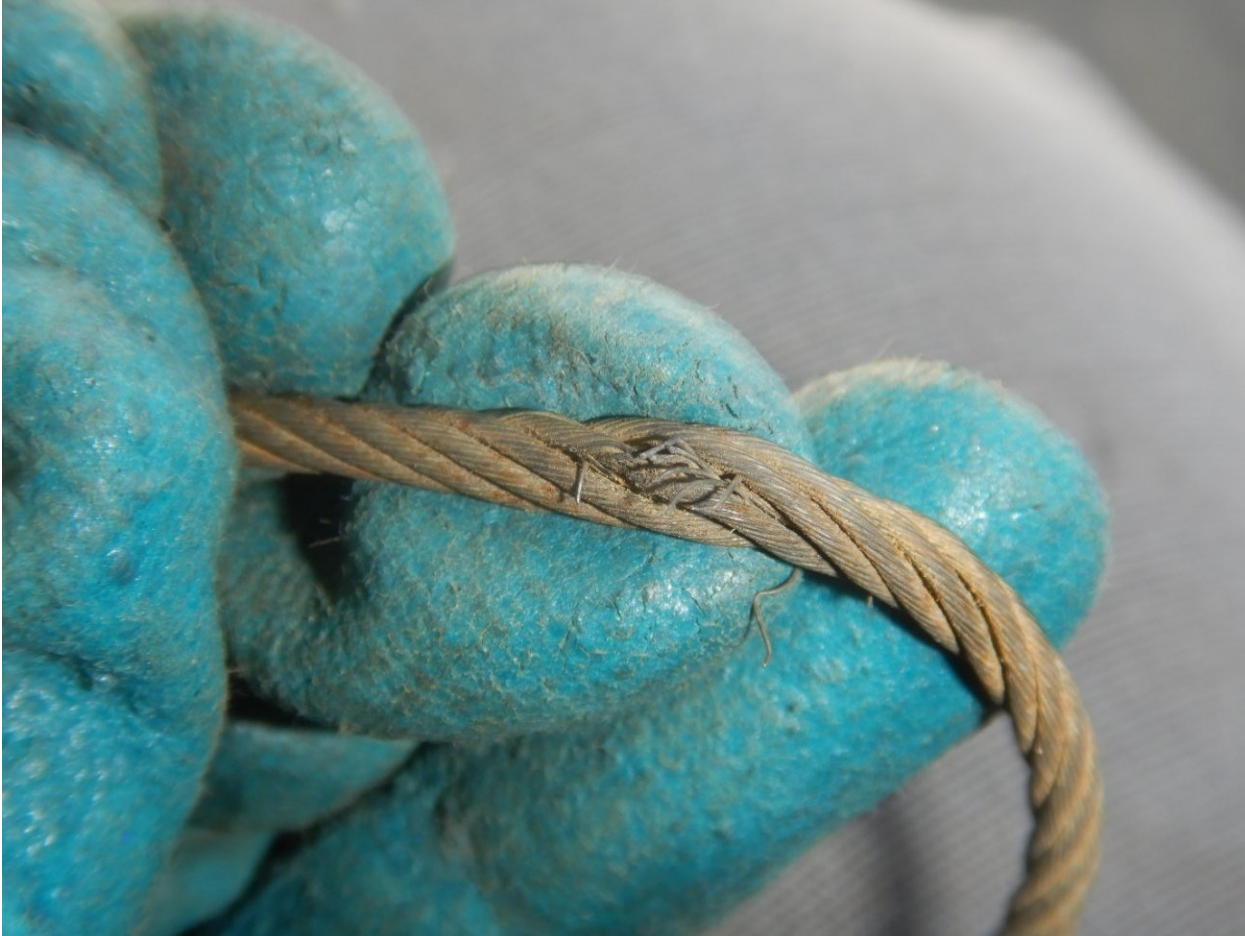
Maintenance personnel's failure to properly inspect and replace damaged aileron control cables, which resulted in fatigue separation of the aileron control cable and loss of control of the aircraft.

Figure 3. The aileron control cable, showing frayed wires.
