Aviation Investigation Final Report

Location:	Clewiston, Florida	Incident Number:	ENG20LA031
Date & Time:	May 3, 2020, 13:15 Local	Registration:	N1WT
Aircraft:	Airbus Helicopters AS350	Aircraft Damage:	None
Defining Event:	Flight control sys malf/fail	Injuries:	1 None
Flight Conducted Under:	Part 91: General aviation - Personal

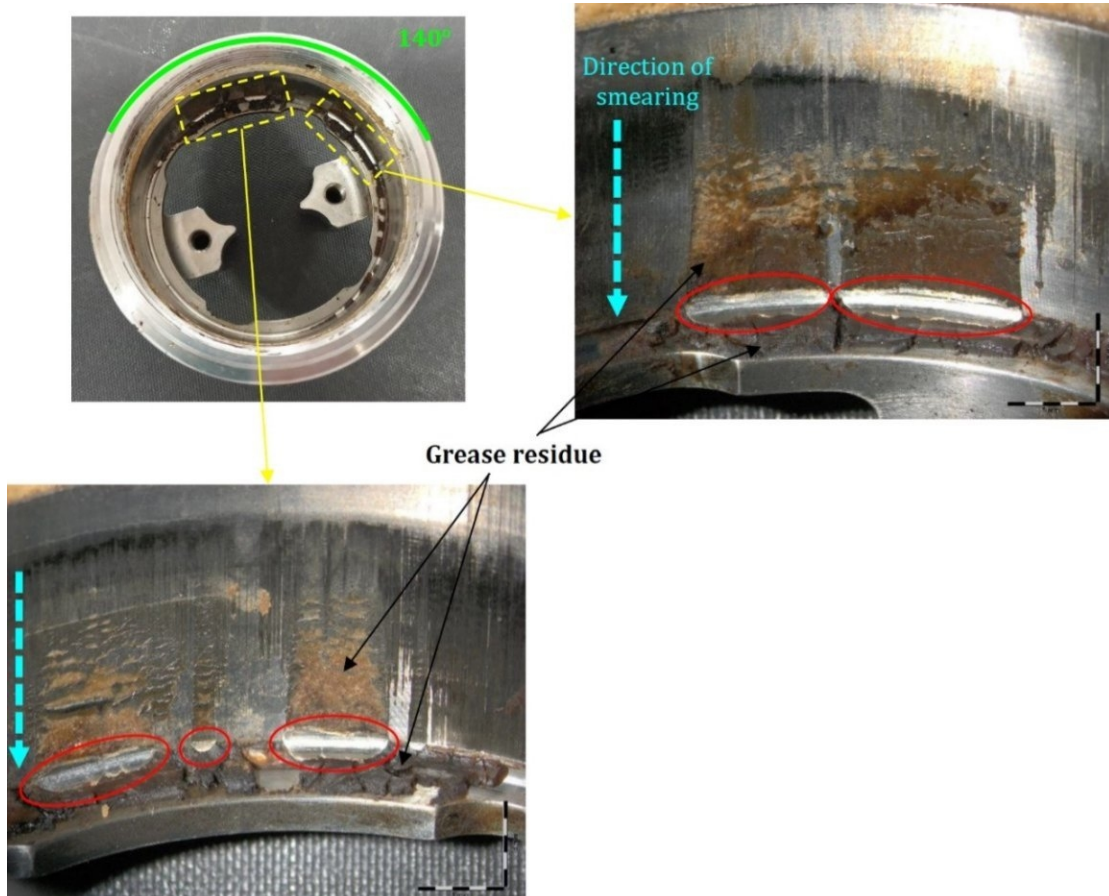
The retained HYD2 components were shipped to Airbus Helicopters' materials laboratory in Marignane, France for examination. The hydraulic pump, once removed from the pulley assembly, was able to be rotated by using its driveshaft, with no evidence of binding or restriction during rotation. The pulley bearing's visible surfaces were thermally discolored. The bearing was removed from the pulley, revealing smearing damage found within a 140° arc on the inner diameter of the pulley, along with residual grease (see *Figure 1*). The direction of the smearing damage was parallel to the bearing's rotational axis. Additionally, longitudinal scratches, also parallel to the bearing's rotational axis, was observed on the inner diameter of the bearing inner ring. The bearing was disassembled and its inner ring, outer rings, cage, and rolling elements exhibited a black-colored residue consistent with thermally degraded grease (see *Figure 2*). After cleaning the inner and outer rings and the rolling elements, examination of their surfaces revealed plastic deformation as well as cage material transfer on the raceways. The cage showed evidence of abnormal contact damage between it and the rolling elements. Hardness testing of the undamaged portions of the inner ring, outer ring, and rolling elements revealed they met drawing requirements.

Figure 1. Longitudinal smearing damage observed on the inner diameter of the pulley. (Image courtesy of Airbus Helicopters)

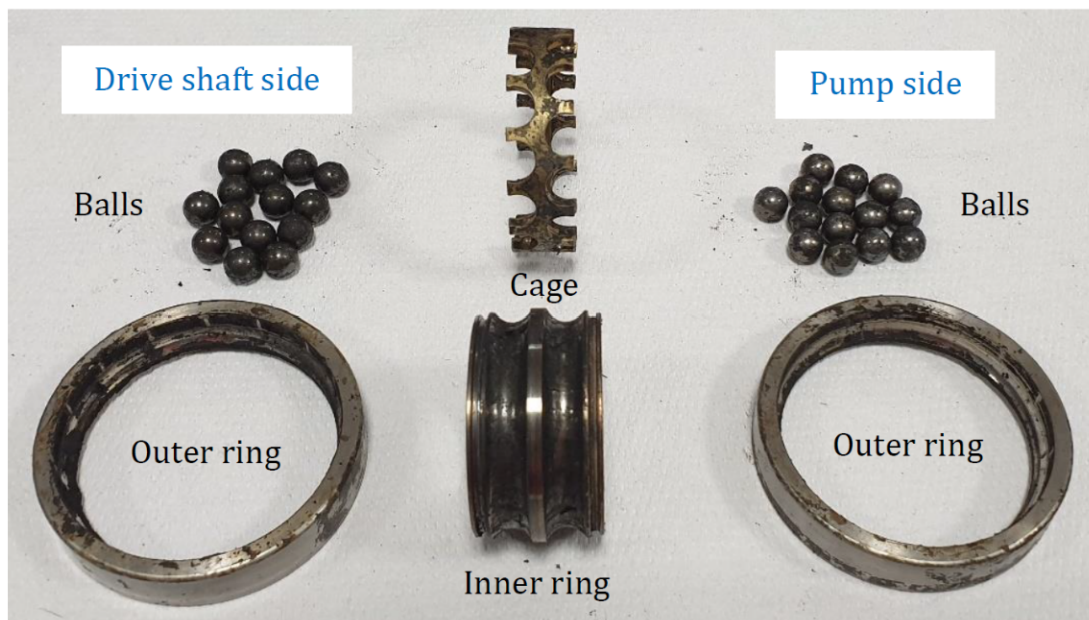
The No. 2 hydraulic system (HYD2) pulley bearing likely failed due to being installed skewed onto its pulley, resulting in abnormal bearing loads which led to its premature failure. The plastic deformation observed on the raceways and rolling elements, as well as contact damage on the bearing cage, were consistent with sliding of the rolling elements against the raceways and cage due to abnormal loading and forced rotation of a seized bearing.

Figure 2. A view of the incident pulley bearing subcomponents. (Image courtesy of Airbus Helicopters)
