Aviation Investigation Final Report

Location:	Byron, California	Accident Number:	WPR20LA141
Date & Time:	May 9, 2020, 13:19 Local	Registration:	N4116Y
Aircraft:	Bellanca 8GCBC	Aircraft Damage:	Destroyed
Defining Event:	Loss of control in flight	Injuries:	1 Fatal
Flight Conducted Under:	Part 91: General aviation - Glider tow

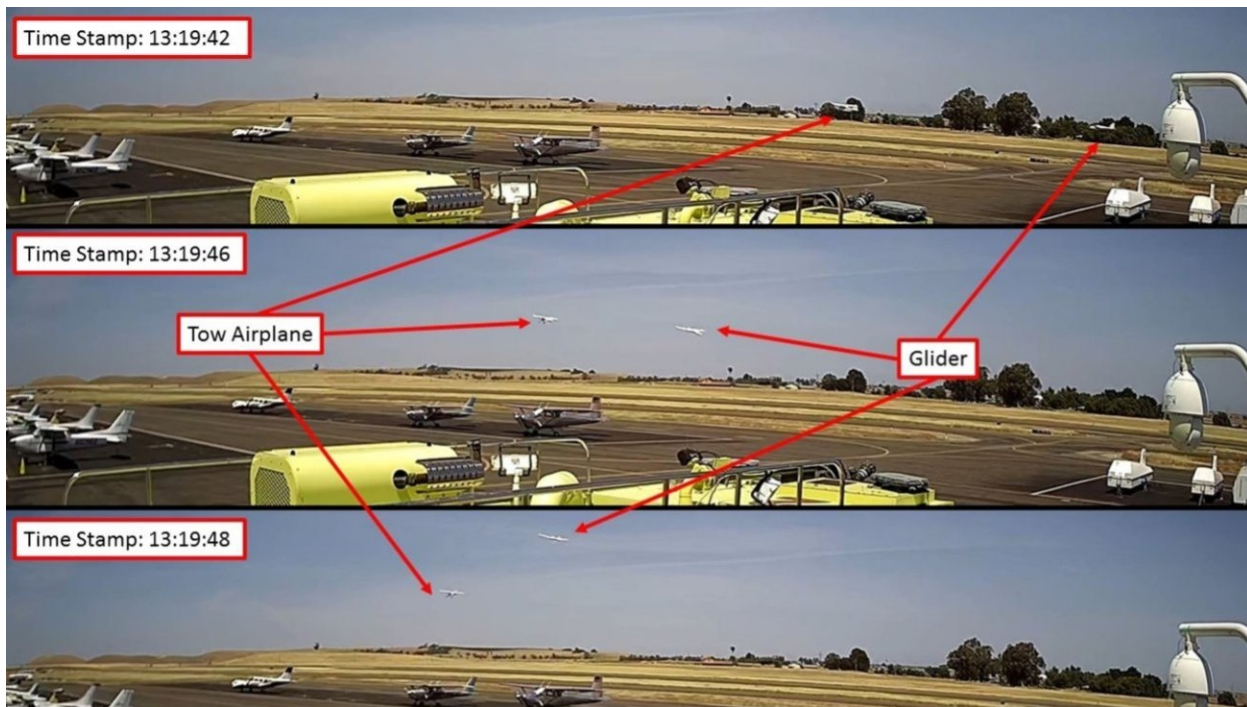
Airport security camera recordings as shown in the figure below, captured the accident sequence. The tow airplane became airborne about midway along the length of the runway and made a shallow climb with the glider in trail at a similar altitude. About 7 seconds after the tow airplane became airborne, the glider pitched upward and ascended to a higher altitude while the tow airplane remained in a shallow climb. Three seconds later, the tow airplane began a shallow descent. About 2 seconds later, the tow airplane and glider appeared to remain level at their respective altitudes, with the glider at a higher altitude than the tow airplane. About 4 seconds later, the tow airplane and glider appeared to descend. The glider then began to ascend about 4 seconds later, while the tow airplane pitched downward to a nose-low attitude. The tow airplane impacted the runway and nosed over, and a postimpact fire ensued. The glider executed a 180° right turn and landed uneventfully on runway 12.

Figure. Screenshots of the accident sequence from a security camera recording (Source: Byron Airport).
