Aviation Investigation Final Report

Location:	Phoenix, Arizona	Accident Number:	WPR20LA144
Date & Time:	May 13, 2020, 08:42 Local	Registration:	N201HH
Aircraft:	Mooney M20J	Aircraft Damage:	Substantial
Defining Event:	Powerplant sys/comp malf/fail	Injuries:	2 None
Flight Conducted Under:	Part 91: General aviation - Personal

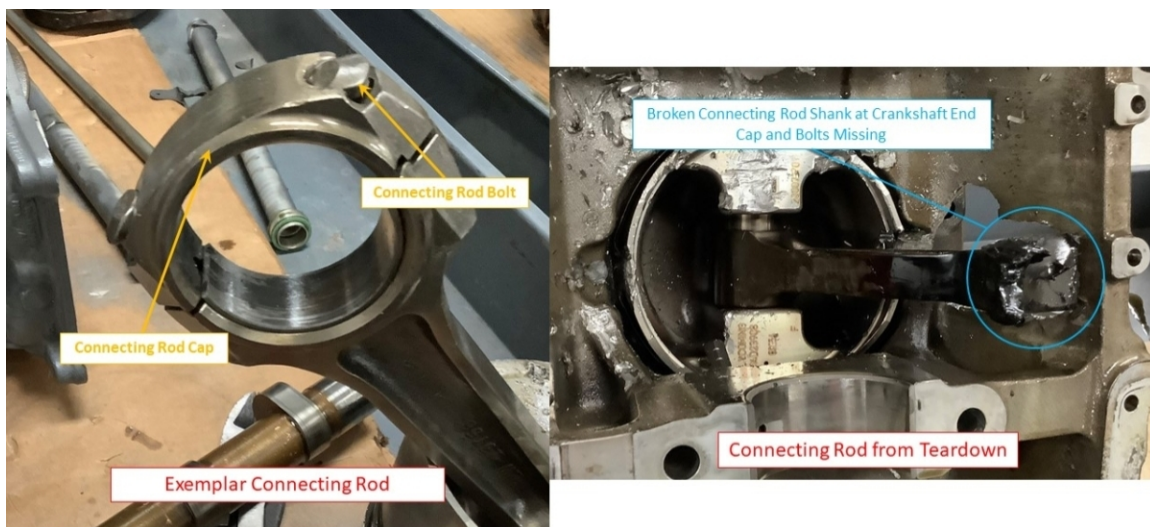
Figure 1: Comparison of Exemplar Connecting Rod and Connecting Rod from Teardown Inspection

An initial inspection of the engine revealed two large holes in the crank case. Additionally, metallic debris was observed throughout the oil pan, and the oil suction screen was obstructed with large metal particles. An interior examination of the mechanical components was performed after the case was disassembled, which showed that the cylinder no. 3 and 4 connecting rod caps and bolts had separated (see figures 1 & 2). According to the FAA's report, evidence showed that the internal damage to the engine was caused by a liberation of the cylinder no. 3 and 4 connecting rods from the crankshaft. The other connecting rods were unremarkable.

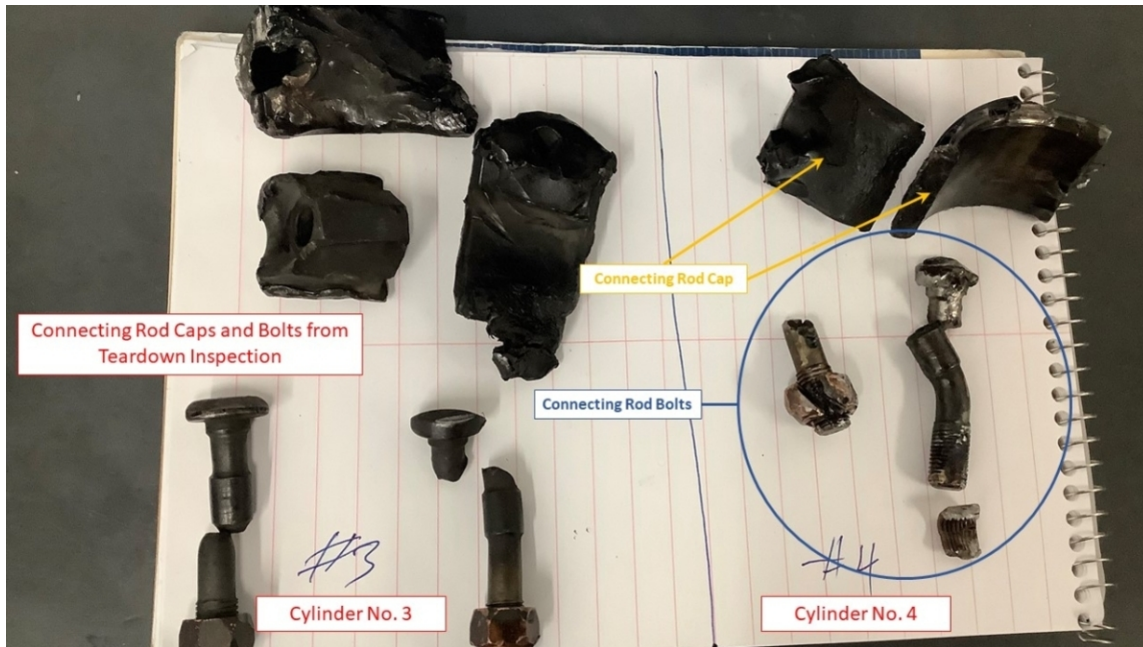
Figure 2: Cylinder No. 3 and 4 Connecting Rod Caps and Bolts Retained from Teardown Inspection

The connecting rod cap and bolts from cylinder nos. 3 and 4 were submitted to the NTSB materials laboratory for examination. Examination of the parts using a scanning electron microscope revealed fatigue striations consistent with fatigue crack propagation on the fracture surface of one of the cylinder no. 4 cap remnants. The cracks were associated with a lack of or missing surface material, consistent with wear or spalling of the surface layer. A metallographic examination of the connecting rod cap showed cracks penetrating the surface, consistent with having initiated at the inner surface and having propagated into the cap material in an intergranular path. Multiple cracks were found oriented parallel to the surface and exhibited branching in multiple directions. The bolts had fractured from overstress, and three of the four nuts remained attached to their bolts. One of the nuts had fractured, but the examination could

not determine if the damage was consistent with post-fracture damage. Chemical analysis of the parts found that the connecting rod remnants were consistent with an alloy steel, but also found indications of lead and bromine. These elements were consistent with combustion products of brominated tetraethyllead additives in aviation fuel.

The engine manufacturer reviewed photographs of the cylinder no. 3 and 4 connecting rod caps and bolts that were provided by the NTSB IIC. He identified evidence of thermal damage to the cylinder no. 3 and 4 connecting rod caps and bolts and some evidence of high heat at the crankshaft. He stated that this was evidence of an absence of lubrication and excessive heat.
