# Aviation Investigation Final Report

<b>Location:</b>	Nuiqsut, Alaska	<b>Accident Number:</b>	ANC20LA046
<b>Date &amp; Time:</b>	May 14, 2020, 22:00 Local	<b>Registration:</b>	N5454E
<b>Aircraft:</b>	Cessna A185	<b>Aircraft Damage:</b>	Substantial
<b>Defining Event:</b>	Controlled flight into terr/obj (CFIT)	<b>Injuries:</b>	1 Fatal, 1 Serious
<b>Flight Conducted Under:</b>	Part 135: Air taxi & commuter - Non-scheduled

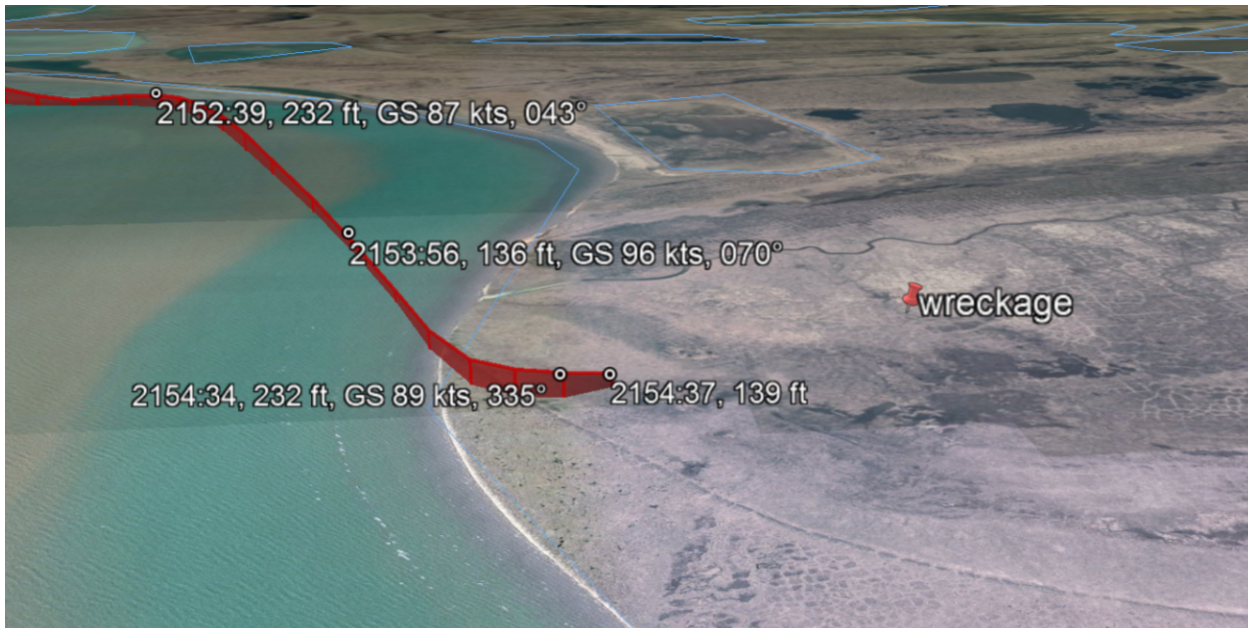
GPS data logs downloaded for the accident flight revealed a date and time that did not correspond to the accident flight. However, a data log was discovered that corresponded to the last flight and ended near the accident location. That data log revealed that the airplane flew along the north shore of Teshekpuk Lake at a GPS altitude of about 136 ft variable to 232 ft before initiating a left turn and descending. The last fully recorded in-flight data point was when the airplane was at a GPS altitude of 232 ft and 89 knots groundspeed on a track of 335° (see figure).

Figure - Last minutes of flight ground track.
