Aviation Investigation Final Report

Location:	Burlington, Wisconsin	Accident Number:	CEN20LA179
Date & Time:	May 15, 2020, 18:15 Local	Registration:	N1JA
Aircraft:	Cessna P210	Aircraft Damage:	Substantial
Defining Event:	Unknown or undetermined	Injuries:	1 Fatal
Flight Conducted Under:	Part 91: General aviation - Personal

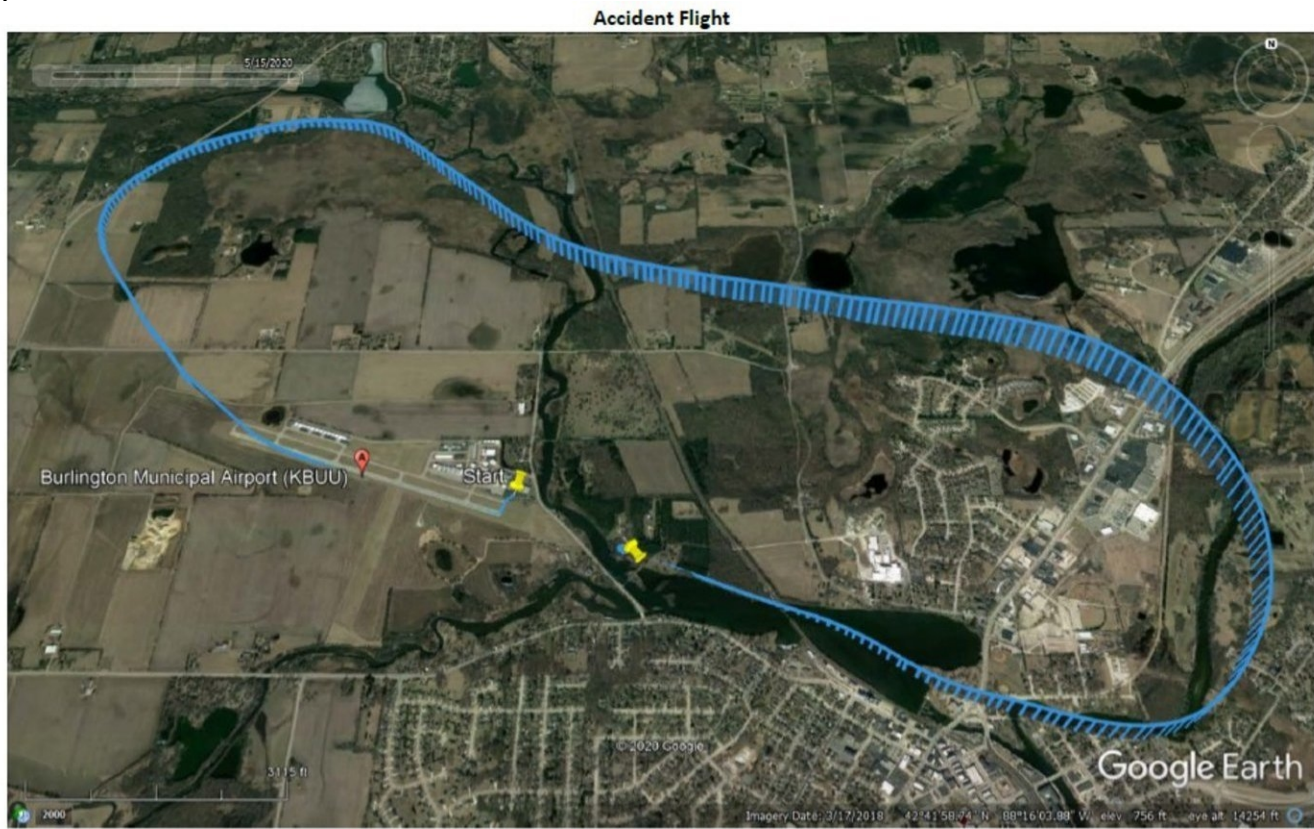
Figure 1. Accident flight.

A review of the air traffic control radar and ADS-B track data showed that after departure about 1808, the airplane entered a right traffic pattern to return to BUU (See Figure 1. Accident Flight). The last 20 seconds of flight track data showed that during the final approach, the ground speed fluctuated between 74 and 78 kts, and the airplane lost altitude. The data discontinued about ½ mile short of the runway and showed the airplane was about 875 ft mean sea level (msl) (airport elevation 780 ft msl), at a ground

speed of 78 kts.

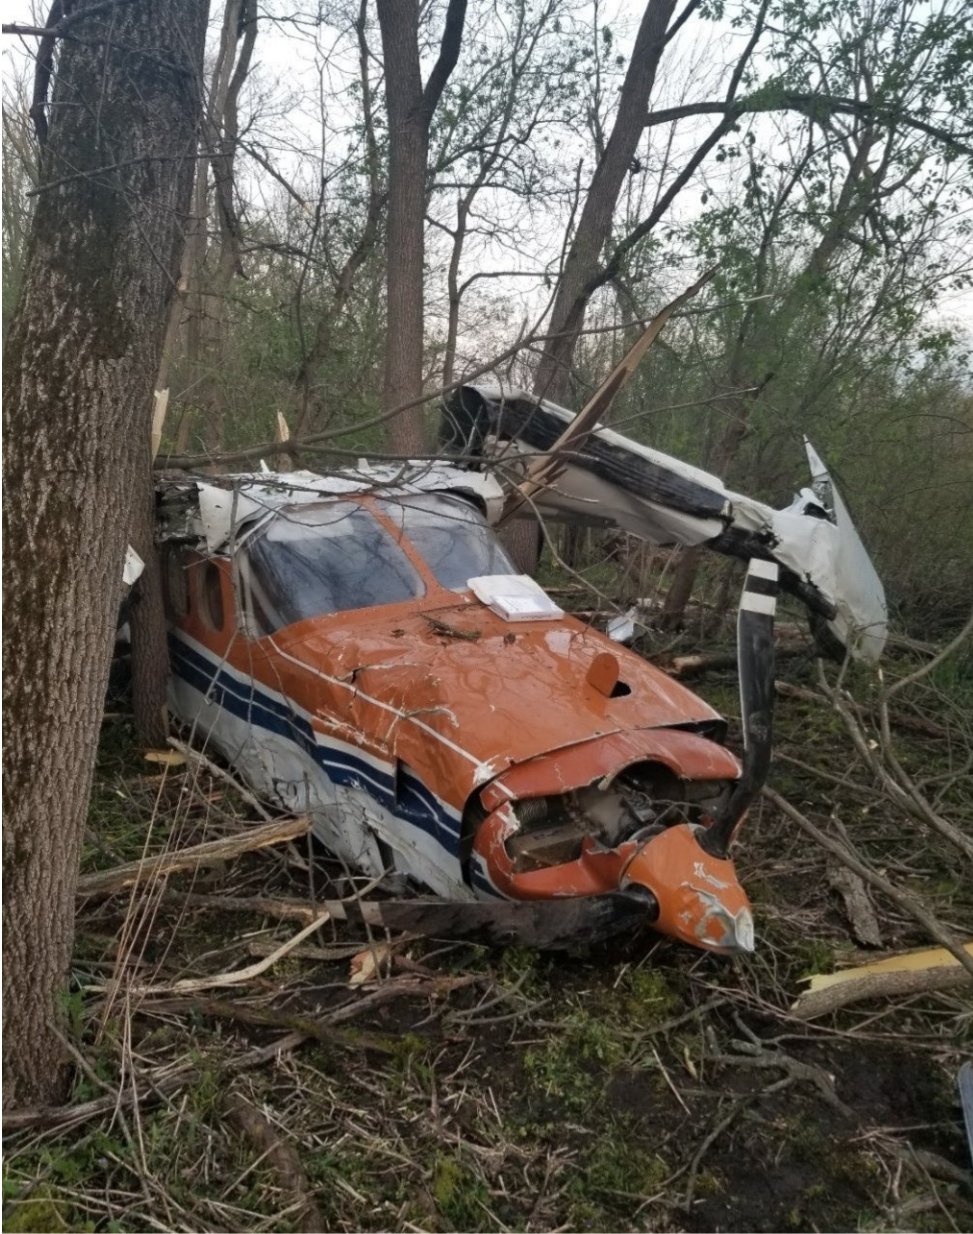
Figure 3. Accident Airplane (Photo courtesy of City of Burlington Police Department)

The airplane came to rest upright in wooded terrain about ¼ mile short of runway 29. Multiple tree impacts and broken tree limbs were noted in the descent flight path, consistent with the damage noted on the leading edges of both wings and horizontal stabilizers.

The left wing was partially separated near the wing root and outboard of the flap control surface. The leading edge was bent, crushed, and distorted. The inboard section of the right wing was partially attached, and the outboard section, to include the aileron, was separated. The leading edge was destroyed. The flap jackscrew was found partially extended about 1.5 inches, which corresponded to a flap setting of about 20°. The empennage remained attached and displayed several dents and damage consistent with tree impacts. The landing gear were extended, and the landing gear struts were bent and distorted.
