Aviation Investigation Final Report

Location:	Victorville, California	Accident Number:	DCA20LA107
Date & Time:	May 19, 2020, 15:16 Local	Registration:	N820TJ
Aircraft:	Boeing 737	Aircraft Damage:	Substantial
Defining Event:	Part(s) separation from AC	Injuries:	95 None
Flight Conducted Under:	Part 121: Air carrier - Scheduled

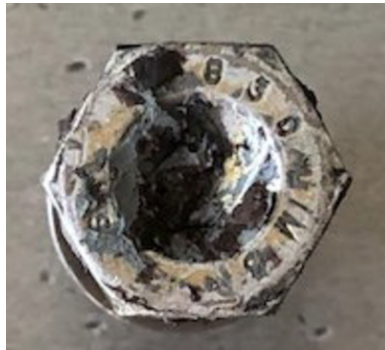
The airplane operator provided photographs of the four installed bolts (7, 9, 11, and 14; see figure 3). The bolt installed in hole 7 was marked NAS6705-9, and the bolts in holes 9, 11, and 14 were each marked NAS6705-12. One of the three loose bolts was marked NAS6705-9, one was marked NAS6705-12, and the marking on the other loose bolt could not be fully discerned but contained an 8, a 3, a 0, the number and letter 1M, and an S (see figure 4).

Figure 4. One of the three bolts found on the interior ceiling panels (Source: Swift Air).
